SERVICE LETTER: #71

TITLE: AT-802 Inspection for Cracks

EFFECTIVITY: All AT-802 aircraft with Wipaire 10000 Floats installed.

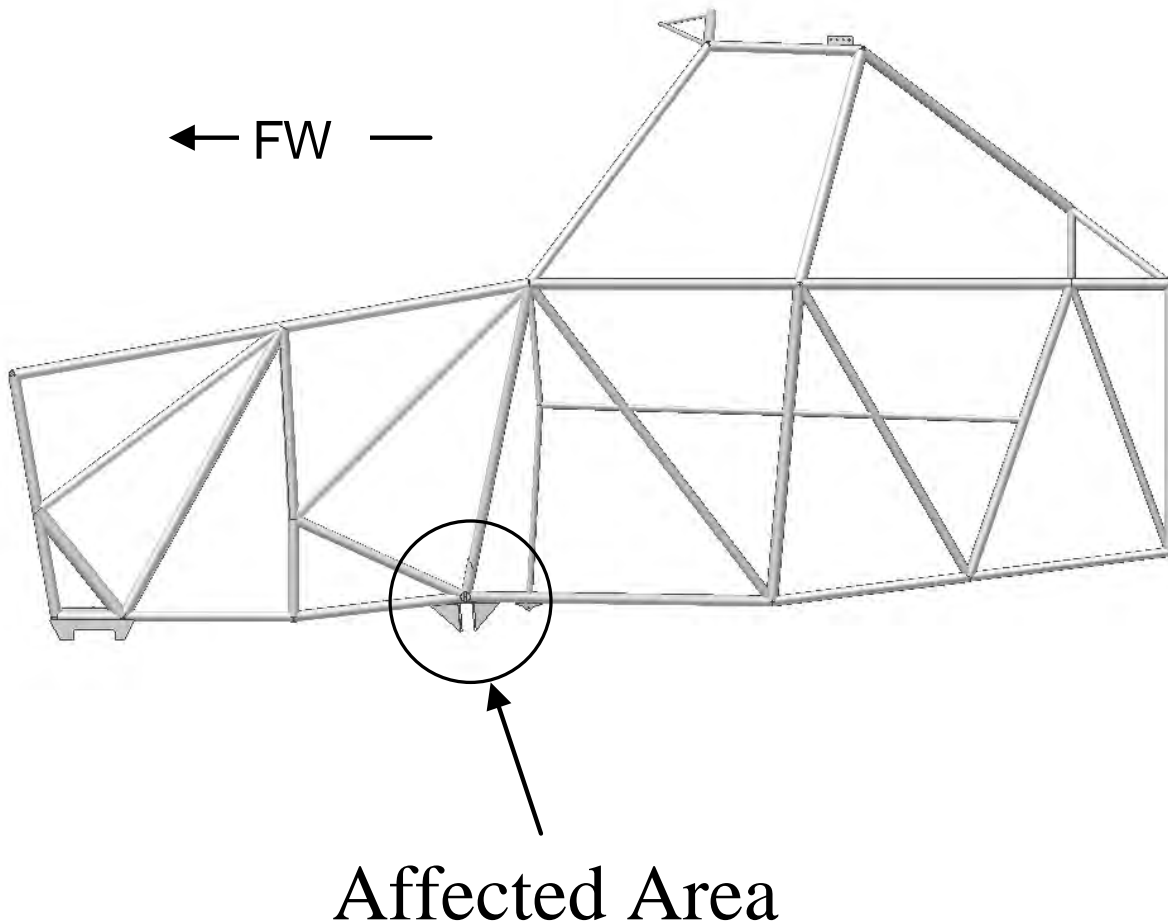
Figure 1

BACKGROUND INFORMATION: Cracks were found after pilot noticed linseed oil leaking from the float fitting at the top of the left-hand pylon, shown in Fig. 1. The cracks were located on the weld, shown in Fig. 2, area D. Further investigation revealed other aircraft with similar cracks either in the same place or on the welds of the attach plate (Fig.3, items 2&3), shown in Fig. 2, area B and C. The cracks are believed to be caused by the welding process and aggravated by normal operations.

METHOD OF COMPLIANCE: Visually inspect lower longeron tube (Fig. 1) and the entire nearby welded tube cluster for signs of cracking on both sides of the aircraft. Pay special attention to areas A, B, C, and D on Fig. 2. If there is doubt about crack presence, strip paint from tubes for better visibility and consider dye penetrant or eddy current inspection. This service letter requires all aircraft to modify the gussets as shown in Fig. 3, Items 1 and 4 to match included drawings p/n 10A02491-006 and 10A02491-005 to alleviate the stress on the longeron tube without regard to crack presence. Figure 5 shows completed gusset modification. If cracks are found, their size and location will determine further action required.

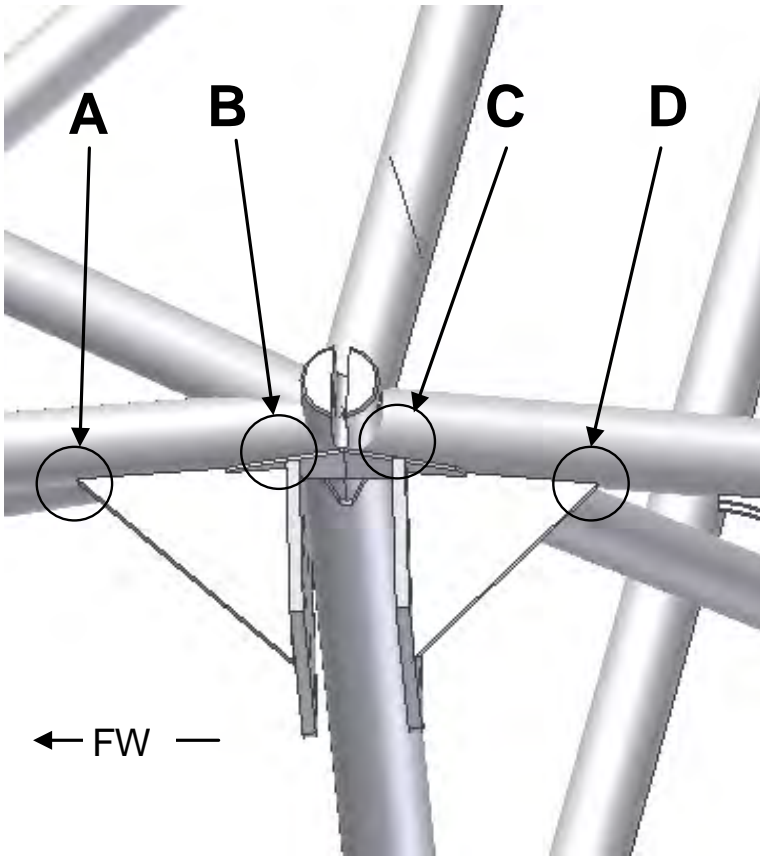
Figure 2

If cracks are found in areas B and C in Fig. 2, and they are smaller than 5/16 inch, and they do not depart the bead of the weld continue inspections on known cracks in locations B and C for growth every 25 hours until the aircraft is in for major repair. At that time, grind off the extended edge of the attach plates (Fig. 4, area 1) so that the doubler (Fig. 4, Item 4) is exposed enough to continue weld across the outboard edge and back inboard in between attach plates (Fig. 4, Items 2 and 3) at least ¼ to ½ inch. If cracks grow larger than 5/16 inch or depart the weld, perform repairs as specified above as soon as practical. Gussets must also be modified as stated earlier in this service letter. Inspect repair every 100 hours.

If there are cracks at the end of the rear gusset (Fig. 2, area D) and they are no longer than 5/16 inch and do not depart the bead of the weld around the edge of the gusset, modify the gussets as stated above, grind out the cracks and fill with weld. Continue visual inspections every 100 hours.

If crack has progressed further than the edge of the weld (Fig. 2, area D) or the front gusset welds are cracked at all (Fig. 2, area A) consult Wipaire Engineering Department immediately for further instructions. A service kit will be issued promptly for these cases.

If no cracks are found, modify both gussets as described above and return to normal operations. Inspect joint for crack presence located at Fig. 2, areas A, B, C and D at 100 hour intervals.

9. Strip paint in all areas requiring welding or stress relieving.
10. Fill fuel tanks.
11. Groove out cracks (Fig. 2, area D) and re-weld.
12. If cracks are found on the ends of the attach plates (Fig. 4, area 4), cut the attach plates back to a location over the bottom doubler on the cluster (Fig. 4, areas 1 & 4). Re-weld attach plates to the doubler and wrap the weld around the inside $\frac{1}{4}$ to $\frac{1}{2}$ inch.
