SERVICE LETTER NUMBER 173
10000 BULKHEAD 7 STIFFENER ADDITION

By: RCG	Aircraft Makes/Model(s): AT-802 AT-802A	Float Model(s): 10000A	Note(s): Mandatory Compliance Service Letter P/N 1009163 ECO 24821
Approved: JRS			
Date: 8/16/2017			
Rev: A

This service letter applies to: Air Tractor models AT802 and AT802A with Wipline 10000A Fireboss Amphibious Floats S/N 10172 and prior installed per STC SA01795CH

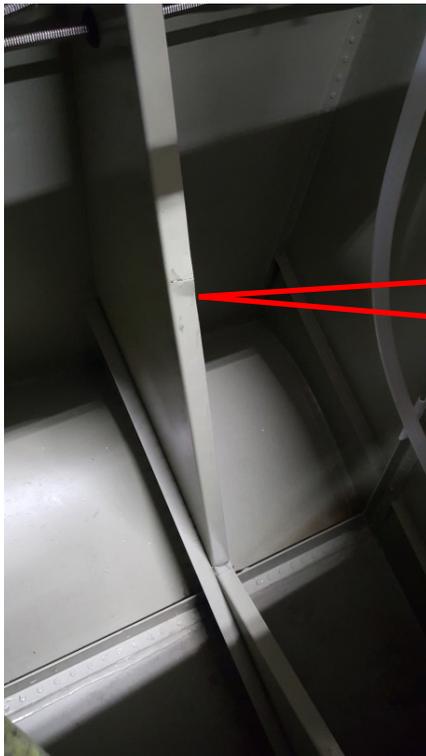
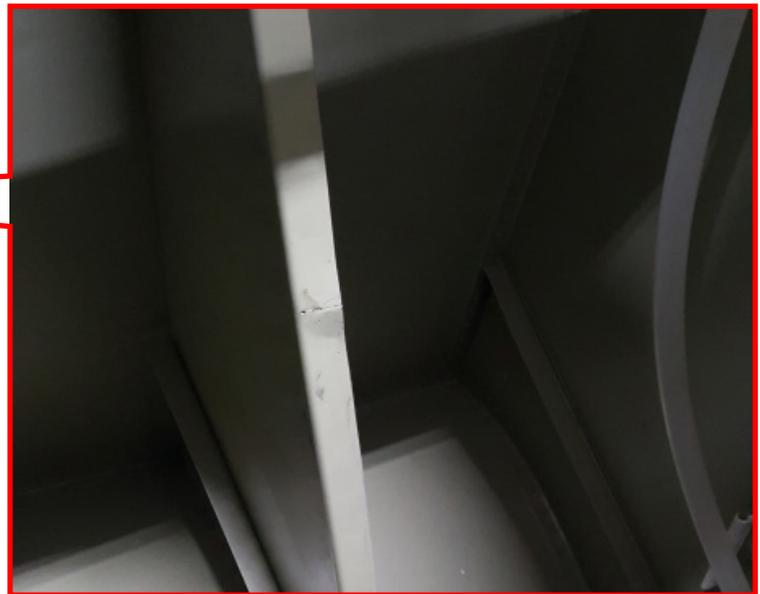
Some floats have been experiencing buckling in bulkhead 7. A stiffener has been added to the bulkhead to provide more strength

Example of cracking in bulkhead 7. The damage is not limited to the area shown. Thoroughly check all of bulkhead 7.

3. If cracking is found in bulkhead 7, perform **method A** for repair. If no cracking is found in bulkhead 7, perform **method B** to prevent cracking
