SERVICE LETTER 167 REVISION A PAGE 1

SERVICE LETTER NUMBER 167 10000 PROBE JACK END PLUG LOOSENING

This service letter applies to: AT802/AT802A with Wipline 10000 Amphibious Floats installed per STC SA01795CH

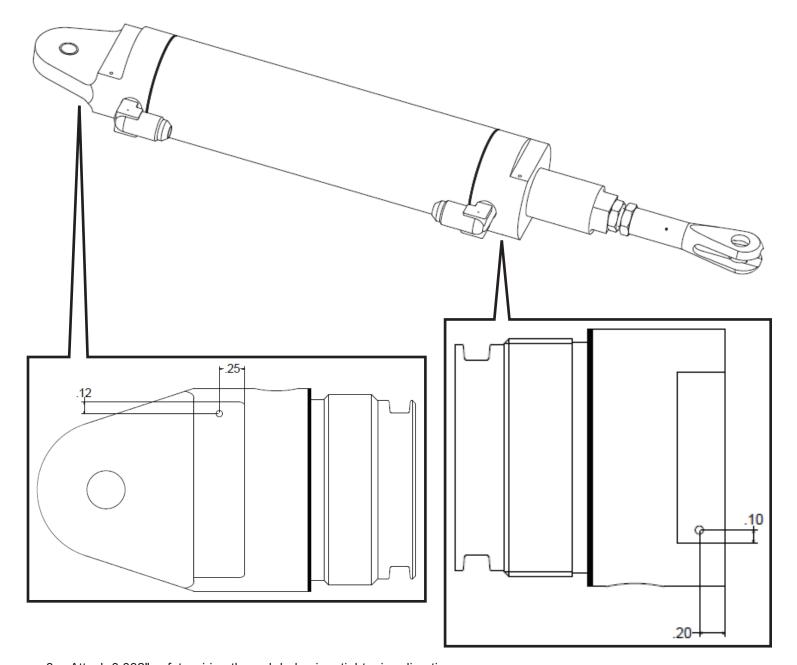
Hydraulic leak near the probe jack cylinder in the float have been reported. Upon further investigation, Wipaire have found that the end plug on the probe jack is coming loose

7. Drill (2) 0.063" holes through probe jack end plug and probe jack front plug where shown

- 8. Attach 0.032" safety wiring through holes in a tightening direction
- 9. Reinstall probe jack cylinder assembly
- 10. Cycle scooping system checking for interference and make any adjustment as required per applicable service manual
- 11. Reassemble float as to return to service
