SERVICE LETTER NUMBER 149

AIR TRACTOR LONG FINLET SUPPORT STRUT

By: MAB	Aircraft Makes/Model(s): AT-802A w/PT6A-67F (1600 HP) AT-802 (2-Place)	Float Model(s): 10000A	Note(s): Mandatory Compliance Service Letter P/N 1006743
Approved: SDW			
Date: 2/3/2021			
Rev: F

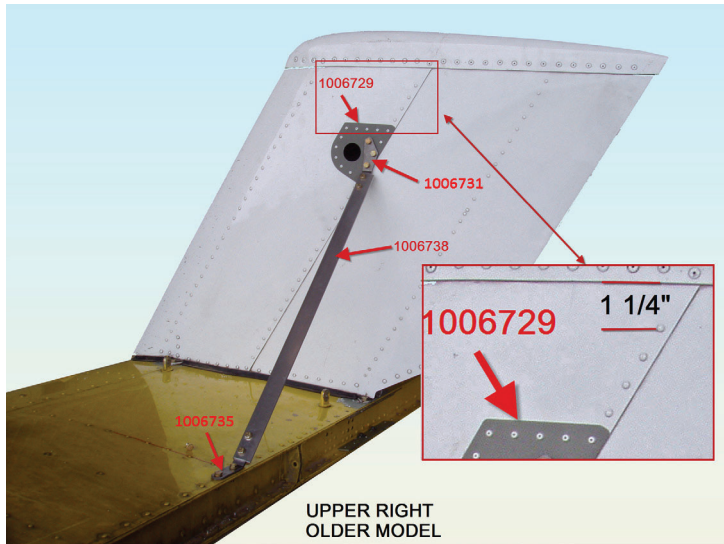
FIGURE 1

NOTE: See figures 1 and 2 to identify older model finlet versus newer model finlet
