SERVICE LETTER 125 PAGE 1 of 2 REV: A

SERVICE LETTER NUMBER 125			
TITLE: BOW BULKHEADS, LOWER FLANGE REINFORCEMENT			
BY: K. TAYLOR	AIRCRAFT MAKE/MODEL(S):	FLOAT MODEL(S):	NOTE(S):
APP: R. ADLER			OPTIONAL COMPLAINCE
DATE: 26-SEP-11	CESSNA 208, CARAVAN	8000S AND 8000A	S/L P/N 1005509
REV: A	VIKING DHC-3, OTTER		ECO 22250

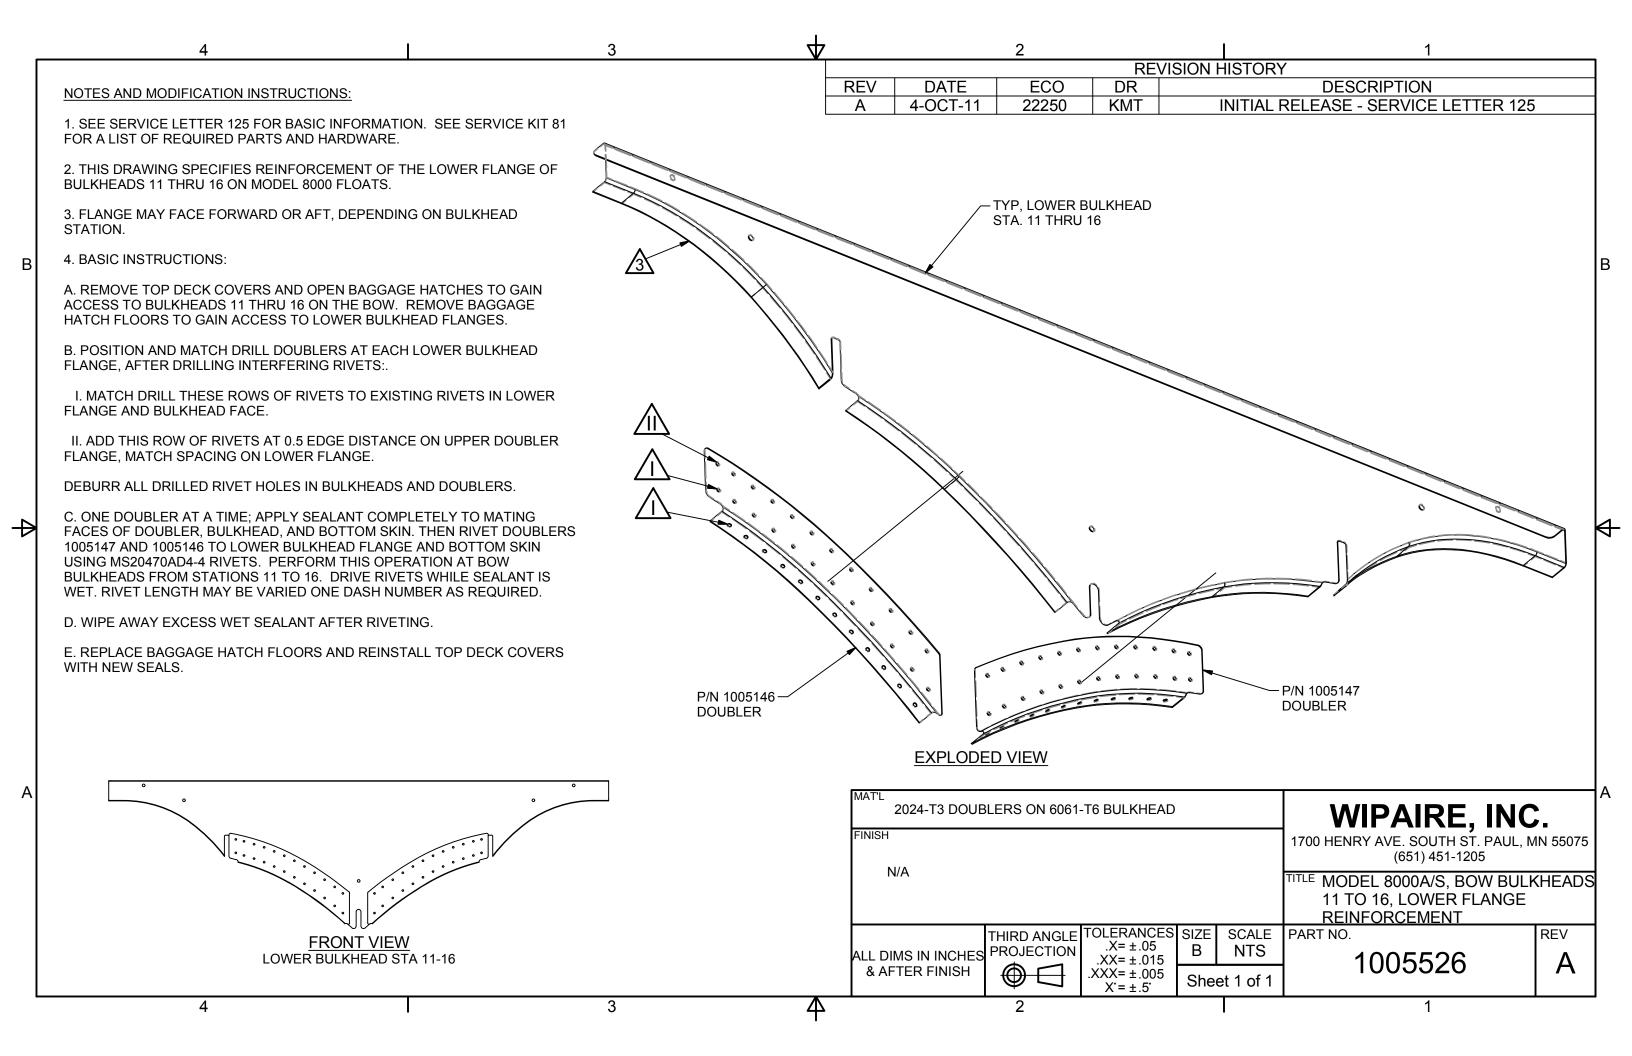
Certain aircraft operated in rough water regularly may experience cracking of the lower bulkhead flanges on the bow area of the float. This service letter and associated kit reinforce the lower bulkhead flanges of the bow bulkheads to assist in load transfer and reduce probability of cracking as a result of operations on rough water.

To accomplish this modification: Install doublers P/N 1005147 and 1005146 on the lower bow bulkhead flanges at stations 11 thru 16 in accordance with drawing 1005526 latest revision. Drawing 1005526 is attached to this service letter.
