SERVICE LETTER 120 PAGE 1 of 4 REV: A

SERVICE LETTER NUMBER 120			
TITLE: Bushing repair for forward, lower center fuselage bow tie mounting plate			
BY: KMT	ACFT MAKE/MODEL(S):	FLOAT MODEL(S):	NOTE(S):
APP: KMT	Viking DHC6 -100, -200	13000	Optional compliance
DATE: 12-Apr-11	and -300		for repair purposes.
REV: A

All Manufacturers Serial Number (MSN) Viking DHC-6-100, -200, and -300 equipped with Wipaire, Inc. model 13000 seaplane or amphibian twin floats.

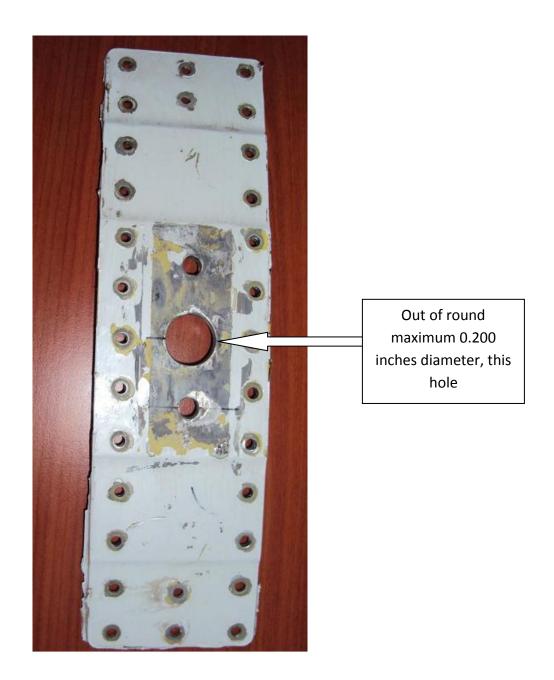
Certain Viking DHC-6-100, -200, and -300 aircraft have exhibited slight bearing wear on part number (P/N) 13A02078-002, bow tie mounting plate. This plate is riveted to the fuselage skin at the center lower forward jury strut mount. The center hole in this part receives the boss on P/N 13A02469-01. This boss is used to carry shear loads and may be slightly deformed or worn for high-time float equipped airframes.

Fig. 1 – P/N 13A02078-002, bow tie attachment plate, as removed from aircraft

- g. The maximum out of round that can be repaired with this SL is a 0.20 inch diameter out of round. I.e. the maximum diameter measured may be 1.20 inches.
- 3. Fabricate a repair bushing part as follows:
 - a. Material 2024-T3 aluminum per AMS QQ-A-250/4 or AMS 4037
 - b. Outside diameter 1.250 +.002 -.000 inches
 - c. Inside diameter ID 1.000 +.002 -.001
 - d. Thickness 0.25 to 0.27 inches
 - e. Break sharp edges to R0.015
 - f. Finish: bare part will be assembled wet
 - g. Dimensional tolerances are tight for the bushing interference fit. Slowly grind bushing to proper dimensions to ensure a good fit.
- 4. Remove P/N 13A02078-002 from the aircraft belly skin by drilling the attaching rivets.

Note: this repair cannot be accomplished while the attachment plate is installed on the aircraft, because it would not be possible to ream the attachment plate hole without potentially damaging the aircraft belly skin and interior fitting.
- 5. Ream the D1.0 inch hole on P/N 13A02078-002 to D1.250 +.000 -.001. Ensure the hole is reamed on center with the existing hole.
- 6. With the hole reamed, new bushing manufactured, and all dimensions double checked: press fit (at room temperature) the replacement bushing into the reamed hole. The bushing should be press fit wet with Mastinox or zinc chromate or epoxy primer for corrosion protection and sealing.
