SERVICE LETTER 139 PAGE 1 of 4 REV: A

SERVICE LETTER NUMBER 139				
TITLE: MAIN LANDING GEAR (MLG) THREADED COUPLER				
BY: S. ST. JACQUE	AIRCRAFT MAKE/MODEL(S):	FLOAT MODEL(S):	NOTE(S):	
APP: D.GARRETT			MANDATORY COMPLIANCE	
DATE: 03/15/13	N/A	2100, 2350	S/L P/N 1005856	
REV: A			ECO 23053

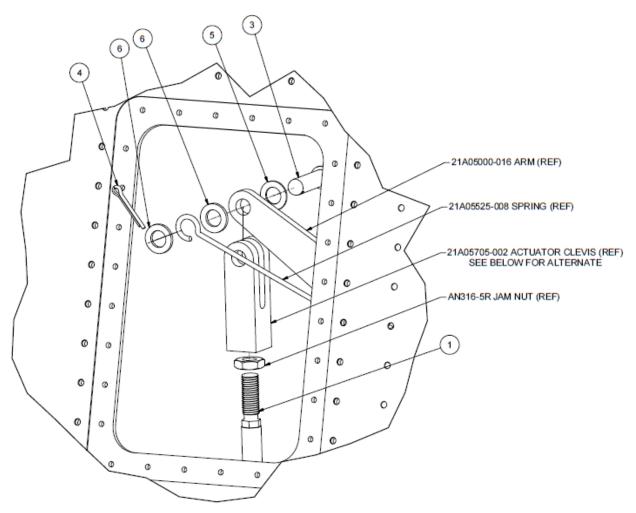
DETAIL A

Corrosion may occur on the threaded connection between the Main Gear Hydraulic Retract Actuator and connecting clevis. This service letter and associated kit replaces the threaded connection with a stainless steel version of the same part. It also replaces the connection hardware with a Clevis Pin instead of a bolted connection.

- 1. Perform the following service procedures after first securing airplane.
- 2. Jack up the Main Gear until the tire is not in contact with the ground. (refer to Float Service Manual Section 4.0)
- 3. Remove access cover as shown.
- 4. Remove Hydraulic Actuator Clevis and connection hardware. Discard hardware.
- 5. Remove and replace ASH-000WA Threaded Coupler with ASH-316WA.
- 6. Reuse jam nut on ASH-316WA.
- 7. Reattach Actuator Clevis to ASH-316WA.
- 8. Adjust rigging per 2100/2350 Wipaire Float Service Manual Section 5.2. www.wipaire.com
- 9. Coat the attach hardware with grease and install as shown.
- 10. Reinstall the access cover.
- 11. Lower float on to Main Gear and repeat the service procedure on the opposite float.
