SERVICE LETTER 199

Main Pylon Attach Point Fuselage Bracket

Aircraft Makes/Model(s):	Float Model(s):	Compliance: Optional	By: MAB
AT-802 & AT-802A	10000A	Part Number: 1011061	Approved: SDW
A1-002 & A1-002A		Date: 7/11/2019	Revision: A

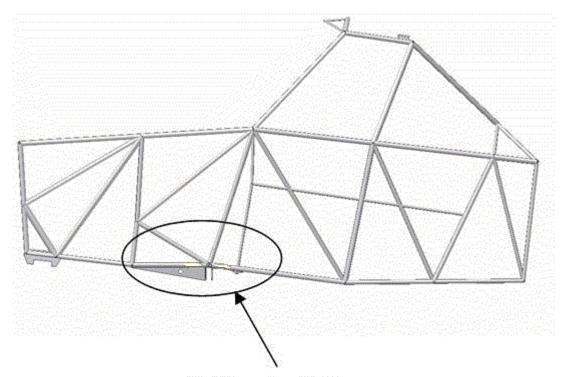
Affected Area
Figure 1

Visually inspect lower longeron tube (Figure 1) and the entire nearby welded tube cluster for signs of cracking on both sides of the aircraft. Pay special attention to areas A and B on Figure 2. If there is doubt about crack presence, strip paint from tubes for better visibility and consider mag particle dye penetrant or eddy current inspection.

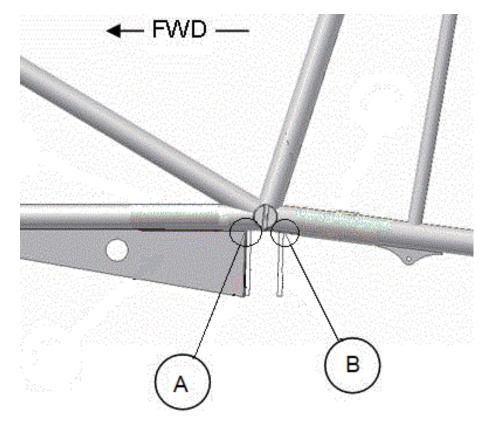
Figure 2

This Service Letter pertains to cracks forming along brackets 1001495, 1001496, 10A02491-003, 10A02491-004 if the bracket doesn't extend to the longeron horizontal centerline. Reference Service Letters 71 and 72 for more information. Service Kits 51, 52, and 53 are associated with this Service Letter.

- 6. Fill fuel tanks. Protect area around weld location to protect from the heat of welding.
- 7. If cracked, groove out cracks (Figure 2, areas B and C) and re-weld.

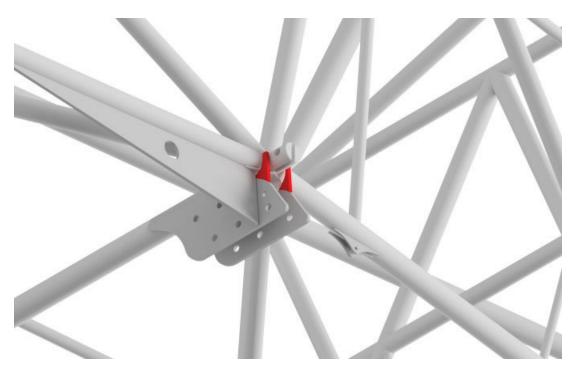
Brackets Added Close Up Left Hand Shown

- 8. Depending on how the existing gussets are shaped, the new gusset brackets may require grinding to fit correctly.
- 9. Carefully fully weld the gusset bracket in place.
