• MANUFACTURERS OF WIPLINE FLOATS & SKIS  
• SPECIALISTS IN AIRCRAFT MODIFICATION

Float / Ski Model  
2100, 2350, 3000 & 3450 Amphibious Floats

SERVICE LETTER #48

TITLE: Addition of Hydraulic Accumulator

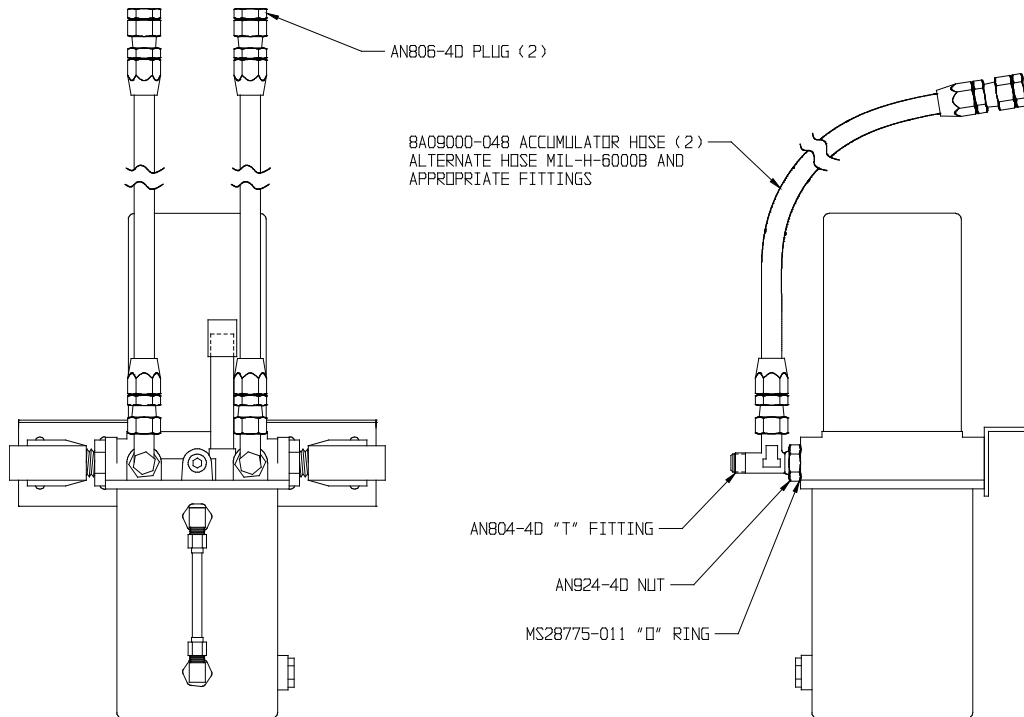
REASON: Aircraft experiencing "hydraulic lockup" (gear does not cycle up unless emergency gear selector handle is cycled) as evidenced by landing gear not retracting due to pressure buildup on back side of piston thereby not allowing opposite pressure switch to make contact.

TYPICAL INSTALLATION OF ACCUMULATOR HOSE – ALL MODELS

METHOD OF COMPLIANCE: Add accumulators per Service Kit #32 and below illustrations.
