SERVICE LETTER #48

TITLE: Addition of Hydraulic Accumulator

EFFECTIVITY: Aircraft with Model 2100, 2350, 3000, or 3450 Floats Installed.

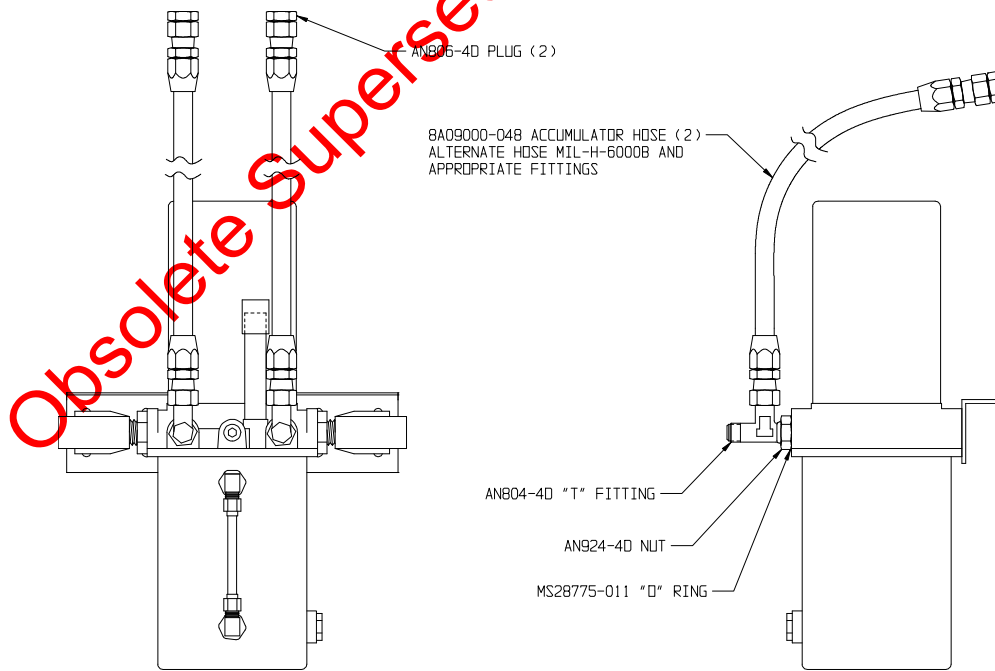
TYPICAL INSTALLATION OF ACCUMULATOR HOSE – ALL MODELS

REASON: Aircraft experiencing "hydraulic lockup" (gear does not cycle up unless emergency gear selector handle is cycled) as evidenced by landing gear not retracting due to pressure buildup on back side of piston thereby not allowing opposite pressure switch to make contact.

METHOD OF COMPLIANCE: Add accumulators per Service Kit #32 and below illustrations.
