<p style="text-align: center;"> • MANUFACTURERS OF WIPLINE FLOATS & SKIS • SPECIALISTS IN AIRCRAFT MODIFICATION </p> <p style="text-align: center; font-size: small;"> 1700 Henry Avenue - Fleming Field South St. Paul, MN 55075 651-451-1205 </p>			Rev
			Date 6/1/07
Prepared by Ellen Parker	Aircraft Make / Model Cessna 208 Caravan	Float / Ski Model 8000 Amphibious floats S/N 80323 & 80324.	Page 1 7
FAA Reviewed <input checked="" type="checkbox"/>	Title Slide Tube End Machining Repair		
ALL INFORMATION IN THIS SERVICE DOCUMENT BASED ON FAA APPROVED DATA

SERVICE LETTER: 95

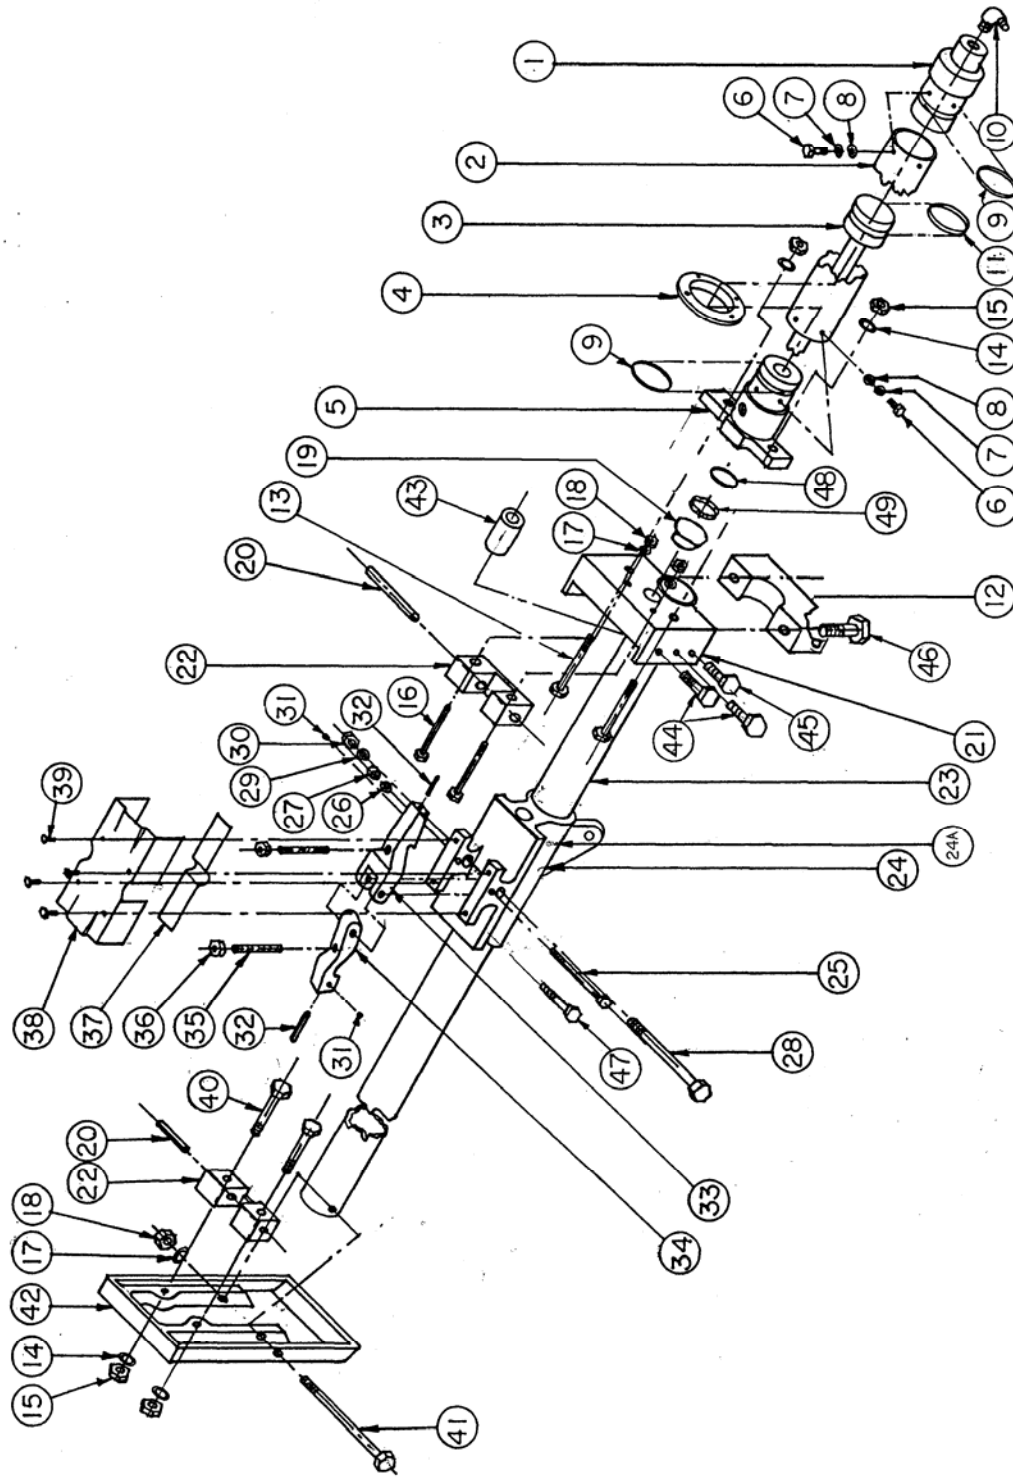
MAIN GEAR SLIDE TUBE ASSEMBLY
FIGURE 11

BACKGROUND INFORMATION: A small number of Part # 6A01201-001 (Figure 11, item 42 in Parts manual) were out of tolerance. All parts that were out of tolerance were located and replaced appropriately before customer delivery of floats with the exception of one set. S/N 80323 & 80324.

This error leaves a small gap between the slide tube and the ears of the machining the slide tube is bolted to (see red arrows). Due to the fact that the aircraft is in operation, this temporary repair will allow continued operation until final repairs can be made.

Remove AN-6-47A bolt (Figure 11, item 41 in parts manual) use NAS1149F0663P & NAS1149F0632P washers as spacers to ensure slide tube is centered and remains centered.

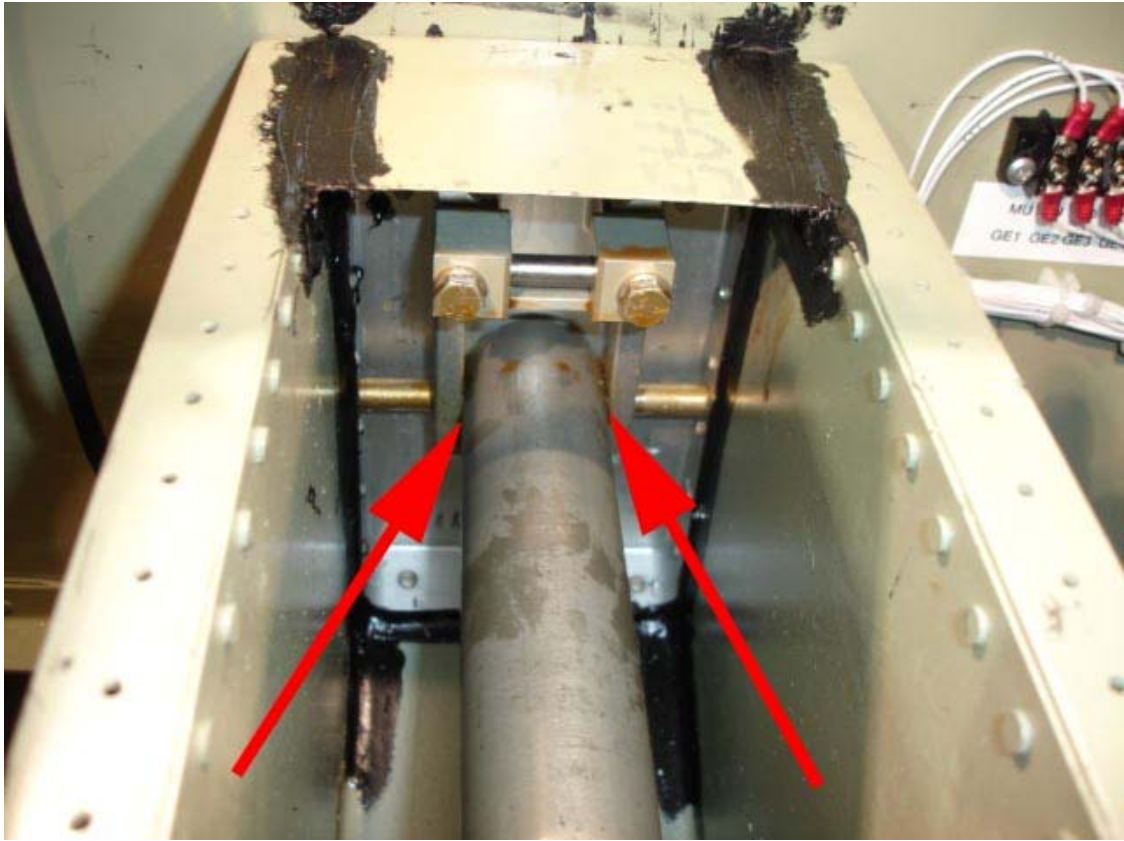
Picture 1

Look for gap between slide tube & 6A01201-001 ears (see arrows on Picture 1, picture shows assembly as it should be with no gap).

Jack or lift aircraft per Service Manual methods.

Re-assemble

Perform gear swing test per service manual to ensure proper gear functionality.

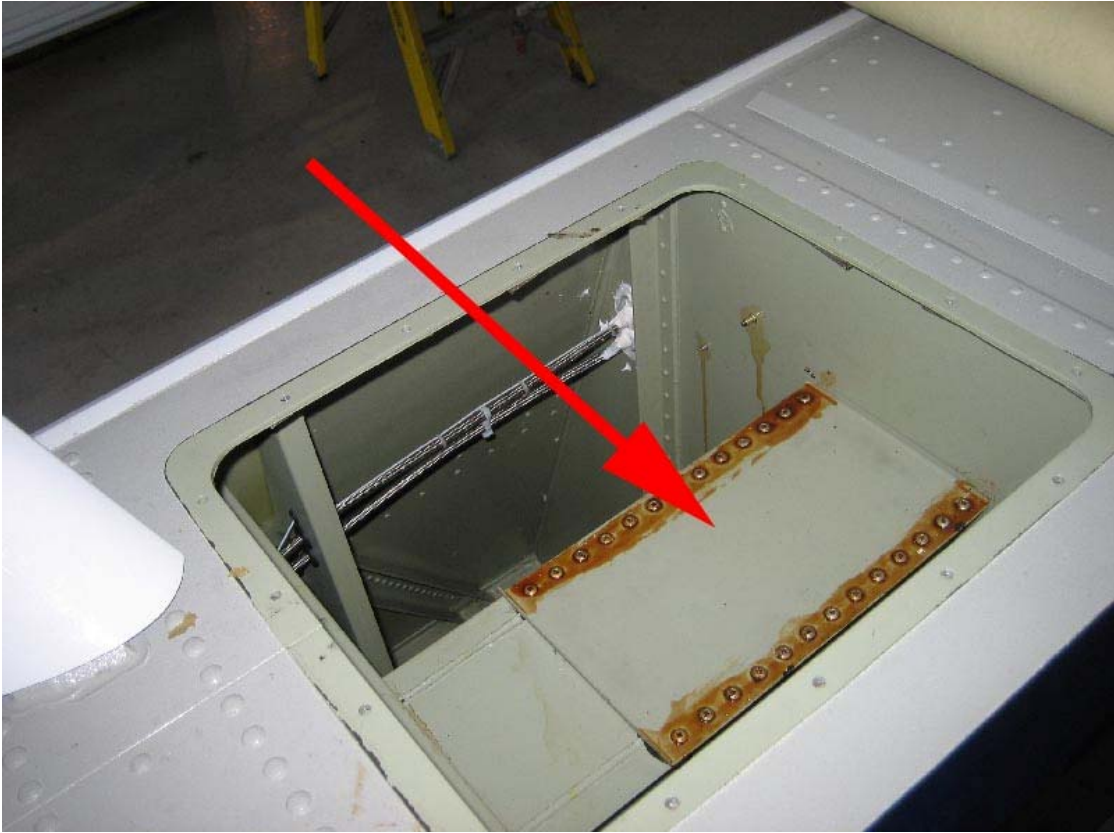
Picture 2

Remove Tunnel cover (see Picture 2)
