<b>SERVICE LETTER NUMBER 98</b>			
<b>TITLE: MAIN GEAR RAM INSPECTION AND IMPROVEMENT</b>			
BY: J. SORTOR	AIRCRAFT MAKE/MODEL(S):	FLOAT MODEL(S):	NOTE(S):
APP: K. TAYLOR			
DATE: 2/1/12			
REV: B			
		ALL AMPHIBIOUS 6100, 8000, 10000 ,13000	MANDATORY S/L P/N 1002759 ECO--21213

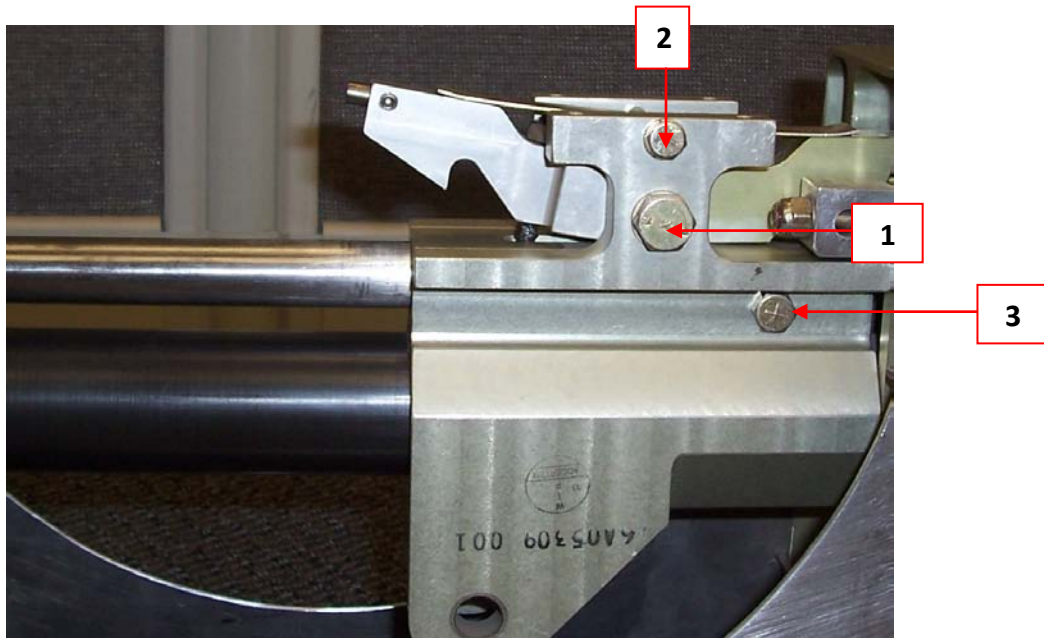
FIGURE 1

1. Jack the aircraft as per the respective Service Manual. Remove the appropriate inspection plate for access to the main gear ram trolley. To get the trolley in the right place, pull the circuit breaker for gear retraction and put the gear switch in the up position. Then just bump the circuit breaker until the trolley is in the window but not in the fully locked position.
2. Remove the main ram catch bolt (Item 3, Figure 1). Lift the down lock and the ram will slide out.

**MAKE SURE NOT TO OVER-TIGHTEN THE TROLLEY BOLT (Item 1&2, Figure 1). THE LOCKING LATCHES SHOULD MOVE FREELEY AFTER THE BOLTS ARE SNUG.**

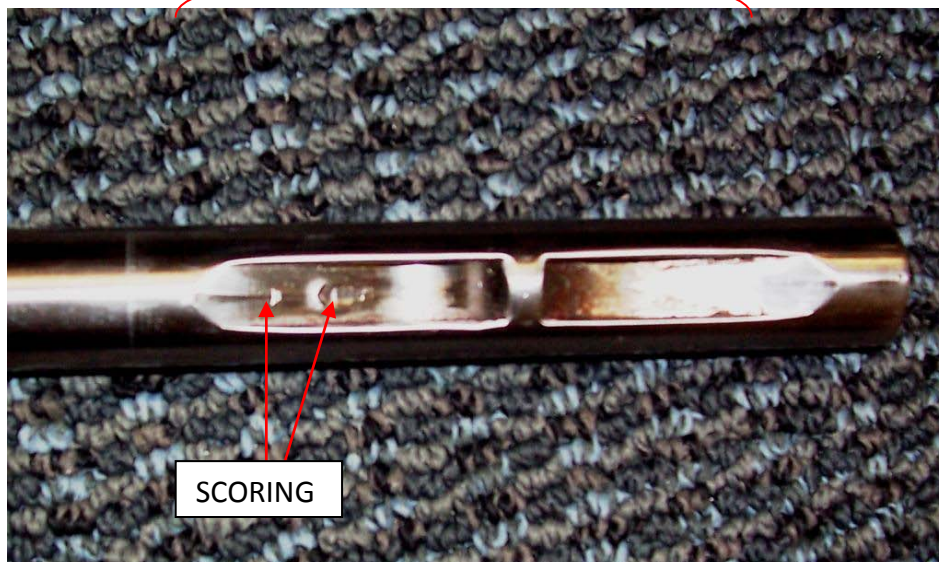
FIGURE 2

**BACKGROUND:** Some of our customers have had main gear trolley failure. This has been linked to uneven scoring and gouging on the main gear ram. It is normal for the set screw to wear into the ram over time, but when that wear becomes jagged or uneven, the set screw breaks and the main gear retraction fails.

DEPRESSION IN GEAR RAM

3. Inspect ram depressions for wear. It will likely appear as scoring; this is from the set screws applying pressure as they slide past the depressions onto the body of the ram. The wear must be smooth without gouging or scoring.
4. If there is no wear, or the wear is smooth and even, fill the depressions with grease, install new set screws that have the smooth ends and put everything back together.

**COMPLIANCE METHOD:** The main gear actuating ram needs to be inspected under the trolley gear lock. If there is uneven wear or pocketing from the set screw on the ram, as in Figure 2, the rod must be polished smooth or replaced. We authorize and encourage customers to polish the ram when possible. The set screws must be replaced if they have a dimple in the end as they have been improved by removing the machined dimple and polishing

5. If there is uneven wear on the ram, it will have to be polished smooth or replaced.
6. When parts are received, put back together and fill ram depressions with grease before final assembly.
7. When this Service Letter has been complied with, make an entry in the logbook as to its completion and whether or not the ram and set screws were replaced

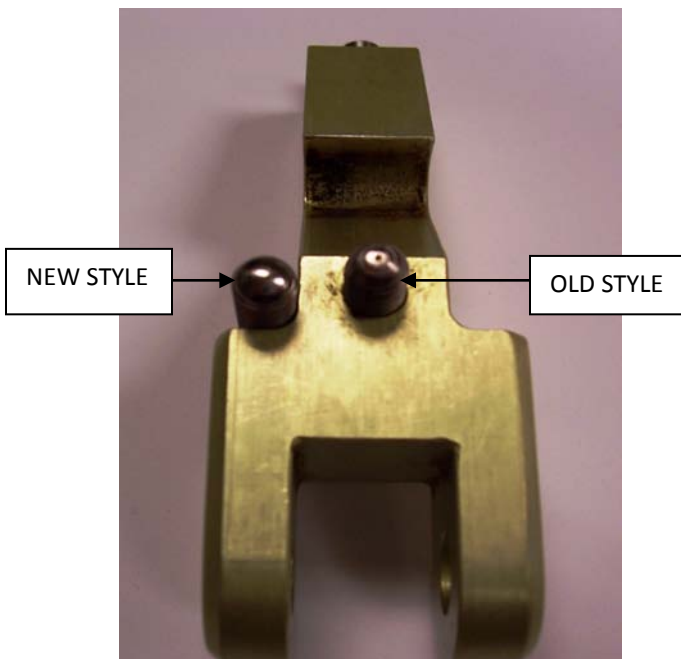
FIGURE 3

8. The product improvement part of this Service Letter is that the set screw is now manufactured so that there is no indent at the tip. Figure 3 illustrates the difference
