Prepared by Kyle Taylor	Aircraft Make / Model (multiple)	Float / Ski Model Amphibious float models 3000A, 3450A, 6000A, and 8000A	Page 1 1
----------------------------	-------------------------------------	--	----------------

Title
Grease seal vent hole addition for main landing gear bearings

SERVICE LETTER No. 114

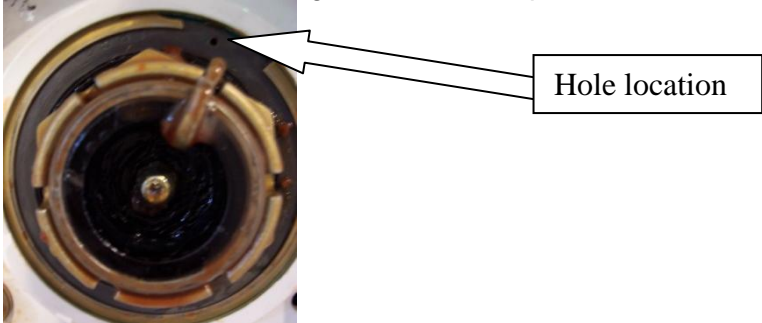
EFFECTIVITY	This service letter is effective for all float models listed above. Floats manufactured after approximately 2006 should already be equipped with this vent hole. An external visual inspection will quickly identify if a vent hole(s) are already installed.
COMPLIANCE	Compliance is optional for all aircraft equipped with the float models listed above.
BACKGROUND	A #50 drain hole has been added to the outboard wheel grease seal on the main landing gear for the affected float models. The hole was added such that grease has an escapement when the wheel axle grease fitting is serviced. Without the hole, and with over pressuring of the grease fitting, it is possible to blow out the grease seals. Addition of the hole improves wheel bearing life.
COMPLIANCE METHOD	<ol style="list-style-type: none"> 1. Remove wheel nut and cotter pin. 2. Remove wheel. 3. Remove snap ring and grease seal on the <i>side opposite from the brake caliper</i>. 4. Drill #50 hole in grease seal P/N 472469, located in the "O" of "National Oil" as printed on the seal. 5. Reinstall grease seal and snap ring. 6. Reinstall wheel, retaining nut, and cotter pin. <div style="text-align: center;">
