**SERVICE LETTER NUMBER 121**

**TITLE: Fuselage modification, Sta. 228, empennage/tail wheel attach bulkhead fastener replacement to facilitate inspection for AD 99-15-07 compliance**

SERVICE LETTER P/N: 1005428 for ECN 10081

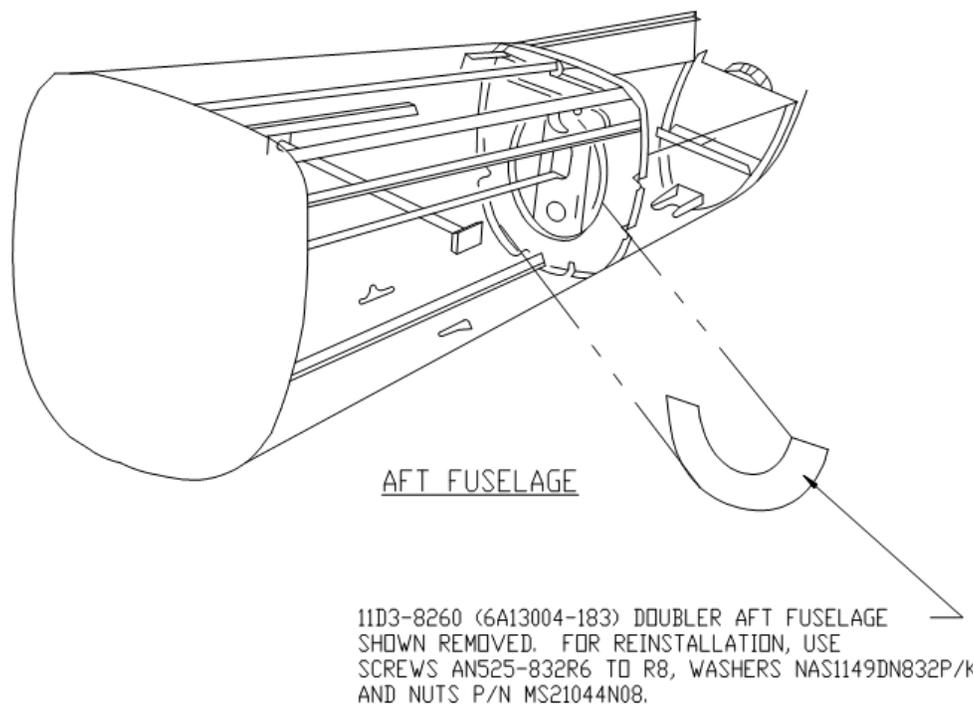
2. Prepare aircraft for access to doubler:
  - a. Remove tail cone
  - b. Remove horizontal tail
3. Drill rivets connecting the forward lower doubler, Wipaire P/N 11D3-8620, to the Sta. 228 bulkhead and aft doubler P/N 11C3-8261. See figure 1 and drawing 11D1-8015

- a. Note: the aft doubler stays in place for this modification – drill only the rivets attaching the forward lower doubler.
4. While the forward lower doubler is removed, accomplish inspection tasks in AD 99-15-07. The Sta. 228 bulkhead is completely visible from the front with the forward lower doubler removed, to allow for inspections operations required by the AD.

Fig. 1 – Doubler shown removed

6. Reinstall doubler P/N 11D3-8260 with the following hardware; install all hardware wet with epoxy or zinc chromate primer, or Mastinox.. ensure that washers do not interfere with the radius of the bulkhead or aft doubler.
  - a. Screws P/N AN525-832R6 to R8 length
  - b. Washers P/N NAS1148DN832N or K
  - c. Nut, nylon locking, P/N MS21044N08
