SERVICE LETTER NUMBER 140			
TITLE: MAIN LANDING GEAR (MLG) THREADED COUPLER			
BY: S. ST. JACQUE	AIRCRAFT MAKE/MODEL(S): N/A	FLOAT MODEL(S): 3000, 3450	NOTE(S): OPTIONAL COMPLIANCE S/L P/N 1005862 ECO 23053
APP: D. GARRETT			
DATE: 03/15/13			
REV: A

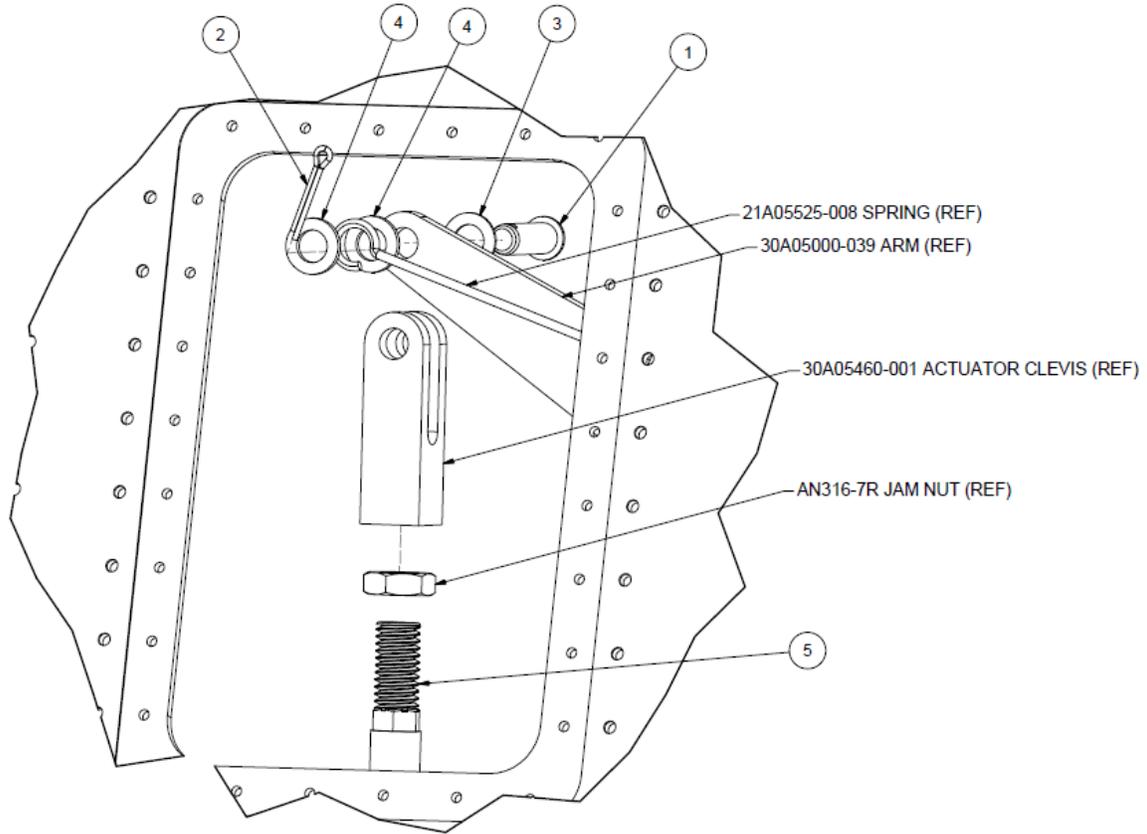
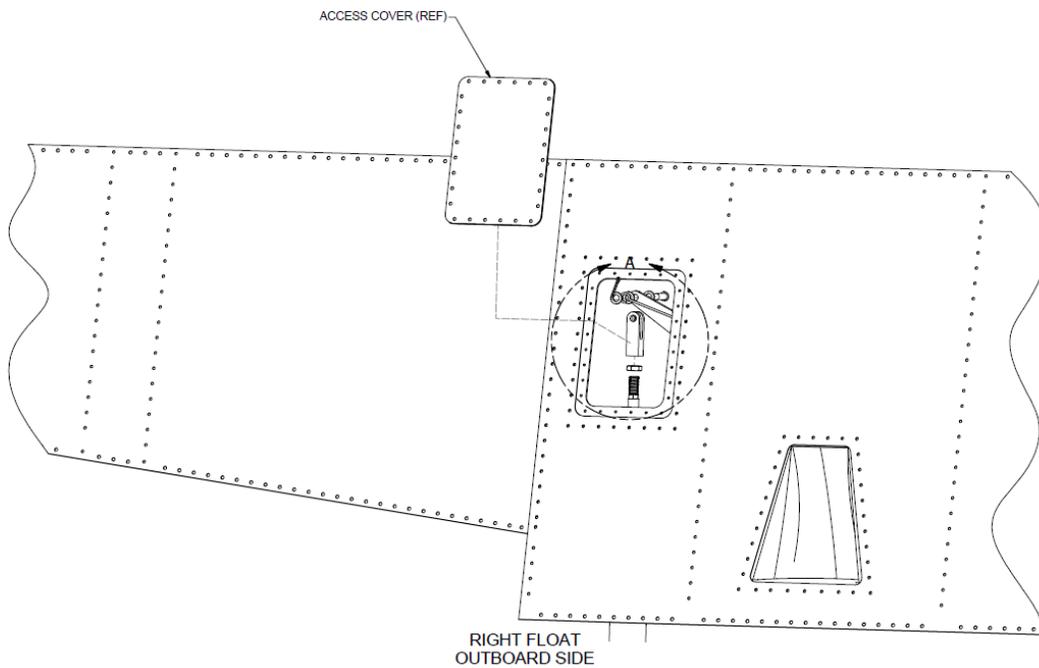
DETAIL A

Corrosion may occur on the threaded connection between the Main Gear Hydraulic
Retract Actuator and connecting clevis. This service letter and associated kit replaces
the threaded connection with a stainless steel version of the same part. It also replaces
the connection hardware with a Clevis Pin instead of a bolted connection.

1. Perform the following service procedures after first securing airplane.
2. Jack up the Main Gear until the tire is not in contact with the ground. (refer to Float Service Manual Section 4.0)
3. Remove access cover as shown.
4. Remove Hydraulic Actuator Clevis and connection hardware. Discard hardware.
5. Remove and replace ASH-001WA Threaded Coupler with ASH-316ST.
6. Reuse jam nut on ASH-316ST.
7. Reattach Actuator Clevis to ASH-316ST.
8. Adjust rigging per 3000/3450 Wipaire Float Service Manual Section 5.2. www.wipaire.com
9. Coat the attach hardware with grease and install as shown.
10. Reinstall the access cover.
11. Lower float on to main gear and repeat the service procedure on the opposite float.
