SERVICE LETTER NUMBER 144			
TITLE: DRAG STRUT ATTACHMENT, WASHER REPLACEMENT			
BY: MAB	AIRCRAFT MAKE/MODEL(S):	FLOAT MODEL(S):	NOTE(S):
APP: SDW	FIREBOSS AIR TRACTOR 802 & 802A	10000	MANDATORY COMPLIANCE S/L P/N 1005968
DATE: 5/21/2019			
REV: C.1

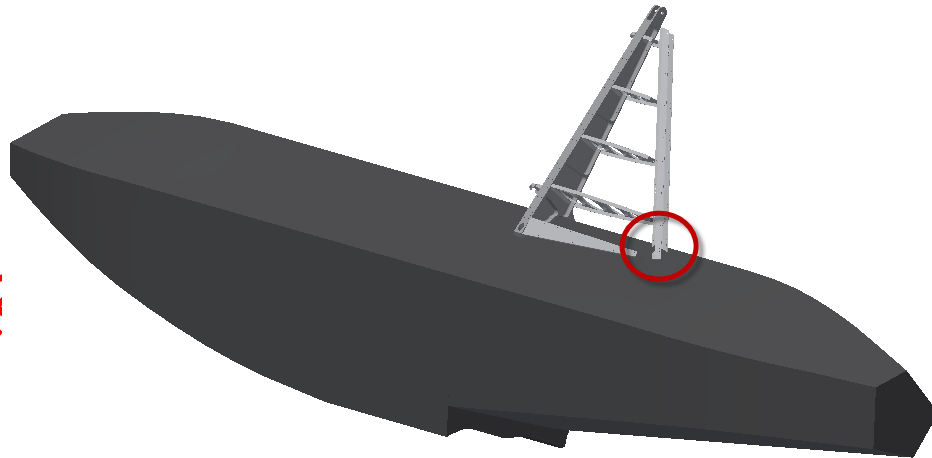
Figure 1: Attachment Location (Strut Fairings Removed)

The bolted attachment of the drag strut to the float has been found to cause coning of the flat washers both under the bolt head and the nut. Deformation of the washers in turn results in a loose bolted attachment.

1. Position aircraft safe for maintenance.
2. Provide for support of float and remove Drag Strut attachment nut, bolt, and washers.

Note: Inspect drag strut attach point for hole elongation. If hole is found to be elongated, comply with service letter 145 (P/N 1005968).
