<b>SERVICE LETTER NUMBER 156</b>			
<b>TITLE: PLUGGED BULKHEAD SEALANT REMOVAL</b>			
BY: M.DILLON	AIRCRAFT MAKE/MODEL(S):	FLOAT MODEL(S):	NOTE(S):
APP: C.WOKEN	Quest Kodiak 100	7000	MANDATORY COMPLIANCE
DATE: 03/19/14	Cessna 208 Series	8750	<b>S/L P/N 1008025</b>
REV: A	Cessna 208B Series		<b>ECO- 23612</b>

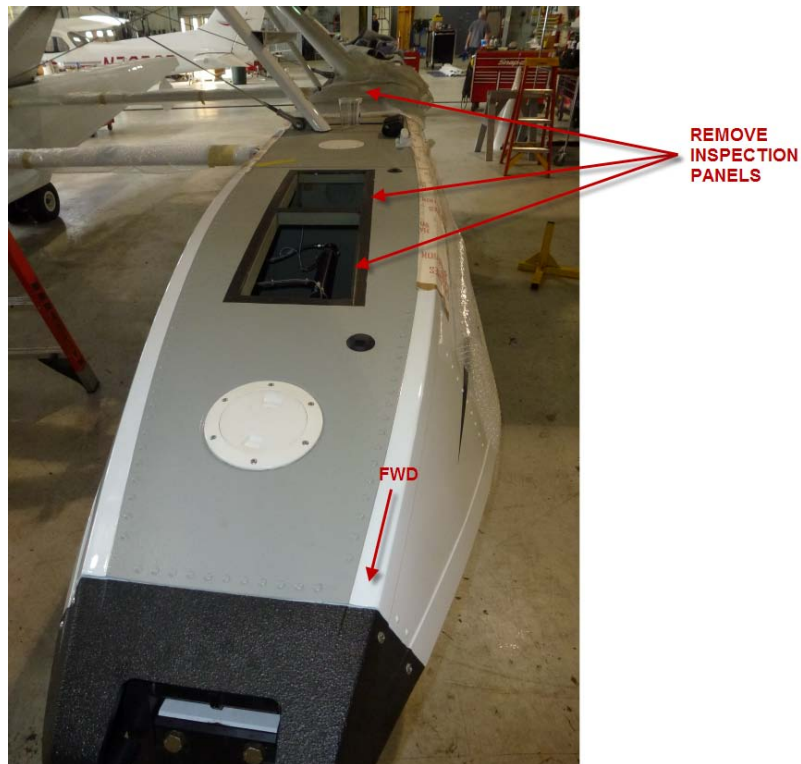
1. Remove covers from compartments between bulkheads #2 and #4 and the two baggage compartments in each float. A total of three bulkheads in each float will need to be inspected and repaired:
  - a. 8750 floats – bulkheads 3, 6, 8
  - b. 7000 floats – bulkheads 3, 5, 8

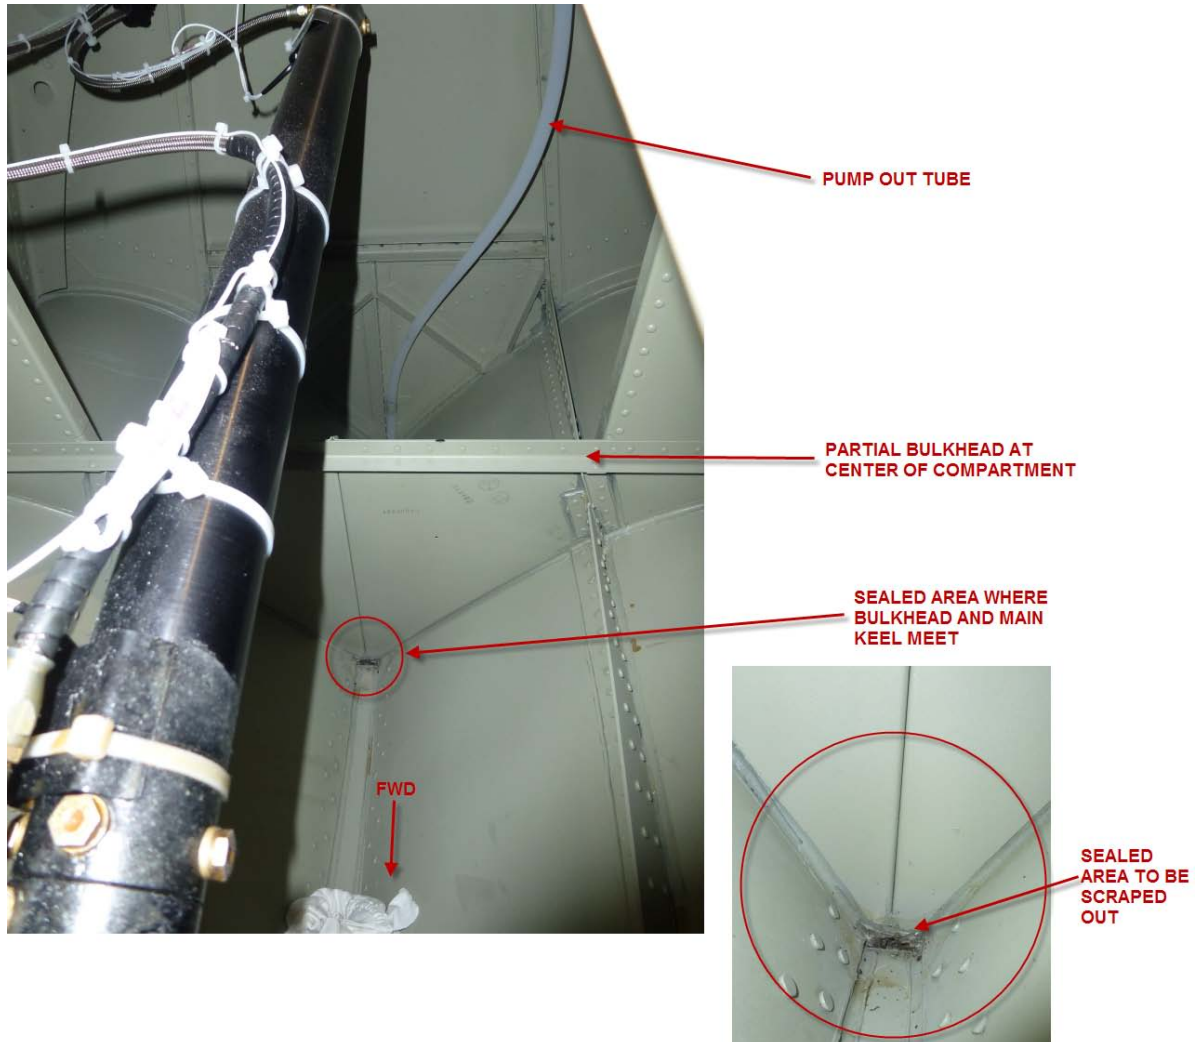
The partial bulkhead in the forward and baggage compartments of Wipline 7000 and 8750 floats has been found to be sealed to the bottom of the float keel thereby preventing water that enters the compartment forward of the partial bulkhead from reaching the pump out tube. As a result, water has the potential to collect in the compartments thereby adding to the overall weight of the floats and increasing the risk of corrosion.

2. Inspect partial bulkheads (8750- #3, 6, 8 or 7000- #3, 5, 8) located in the middle of the compartments to confirm whether there is a complete seal between the bulkhead and main keel that will prevent water from flowing through to the pump-out tube. If there is no opening, proceed to Step 3.

3. Using an awl, perforate the existing sealant and work it loose. Use a small scraper or blade to remove the fragments until there is a clear area of approximately  $\frac{1}{4}$ " between the bulkhead and main keel to allow water to pass through.  
**NOTE: Use caution when removing sealant to avoid scraping or chipping the primer.**
4. Remove all sealant debris from float compartment.

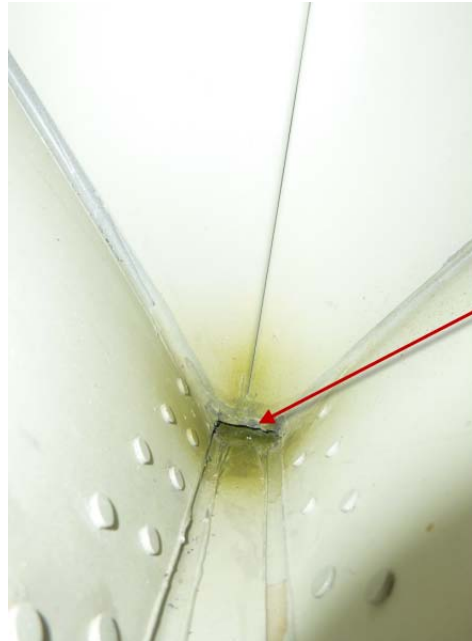
AREA AFTER REMOVAL OF  
SEALANT AND PRIMER  
RE-APPLIED

5. If the primer was scraped in the removal process, re-prime the areas of bare metal after the sealant is removed.
