SERVICE LETTER 114

Grease Seal Vent Hole Addition For Main Landing Gear Bearings

Aircraft Makes/Model(s):	Float Model(s):	Compliance: Optional	By: MAS
Multiple	3000A, 3450A, 6000A, & 8000A	Part Number: 1005168	Approved: DRH
		Date: 5/24/2023	Revision: B

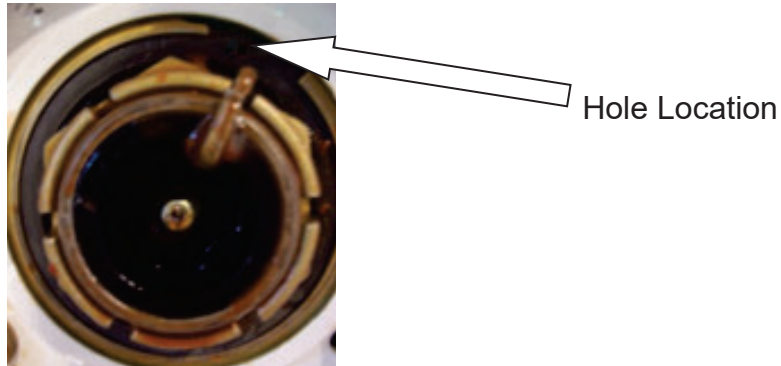
A #50 drain hole has been added to the outboard wheel grease seal on the main landing gear for the affected float models. The hole was added so that grease has an escapement when the wheel axle grease fitting is serviced. Without the hole, and with over pressuring of the grease fitting, it is possible to blow out the grease seals. Addition of the hole improves wheel bearing life.

1. Remove wheel nut and cotter pin.
2. Remove wheel.
3. Remove snap ring and grease seal on the side opposite from the brake caliper.
4. Drill #50 hole in grease seal P/N 472439, located in the "O" of "National Oil" as printed on the seal.
5. Reinstall grease seal and snap ring.
6. Reinstall wheel, retaining nut, and cotter pin.
