SERVICE LETTER 145

Drag Strut Attachment, Top Deck Repair

Aircraft Makes/Model(s):	Float Model(s):	Compliance: Recommended	By: MAB
Air Tractor AT-802 & AT-802A	10000A	Part Number: 1005996	Approved: SDW
		Date: 12/21/2020	Revision: C

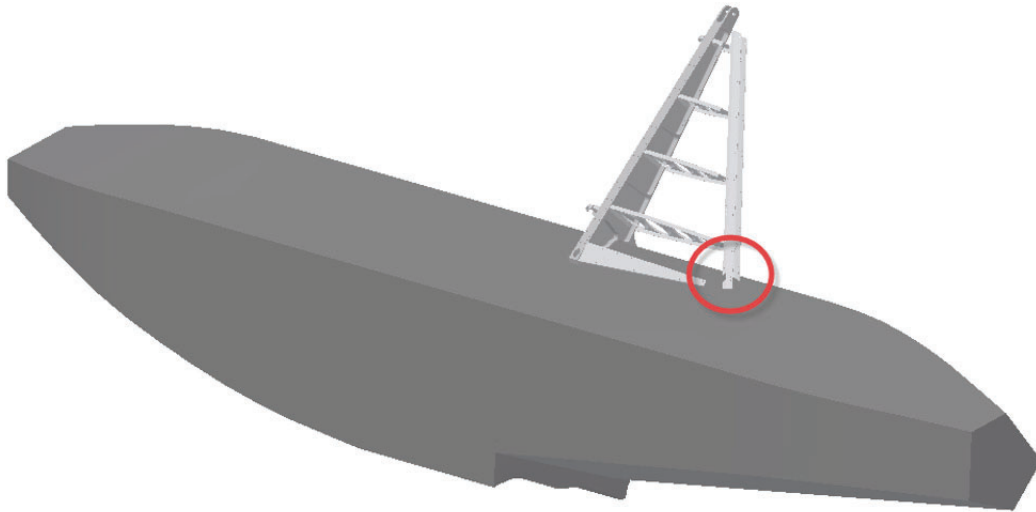
Figure 1 - Attachment location (Strut Fairings Removed)

The bolted attachment of the drag strut to the float can become worn at the top deck, drag strut, and drag strut attach channel.

This repair is only applicable if the maximum wear opening is less than 1.19" in top deck, and 0.60" in drag strut.
(All dimensions are in inches)

Remove pylon assembly connecting the float to the aircraft. Ream hole in top deck and drag strut attach channel, to suggested size, then fabricate plug. Ream hole in drag strut to suggested size, then press fit suggested bearing flange side up. Install a "locally fabricated" doubler on the underside of the top deck. Discard machined part 13A02070-004 (bathtub support fitting).
