SERVICE LETTER 190

8750 SERIES BONDED STIFFENER CORROSION

Aircraft Makes/Model(s):	Float Model(s):	Compliance: Mandatory	By: MAS
Textron Aviation 208 and 208B	8750 Series	Part Number: 1009944	Approved: DRH
		Date: 4/17/2023	Revision: D

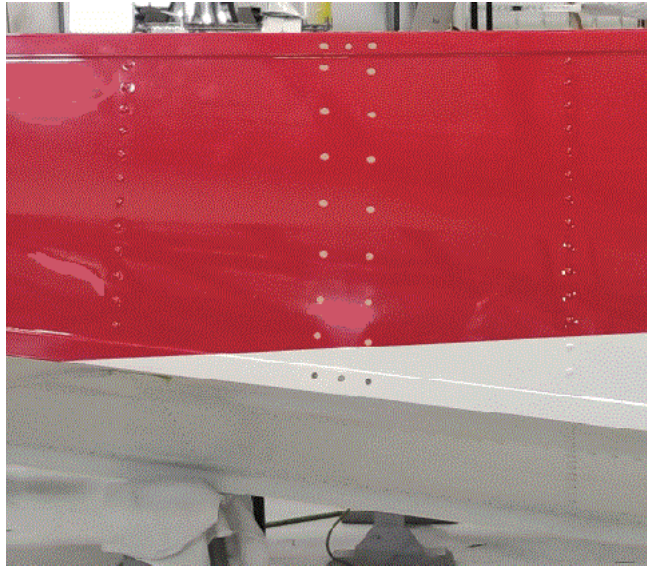
Performed if corrosion is visible under stiffener and corrosion has spread more than 50% of skin thickness for a total length of more than 20% of the stiffener length through the skins.

9. Rivet stiffeners to side skins, gunwall, and chine. Match previously installed rivet type for gunwall and chine. Use MS20470AD4 for side skin locations. See below.
