SERVICE LETTER 202

8750 Pylon Hydraulic Routing

Aircraft Makes/Model(s):	Float Model(s):	Compliance: Optional	By: MAB
208, 208B	8750	Part Number: 1011124	Approved: SDW
		Date: 10/17/2019	Revision: A

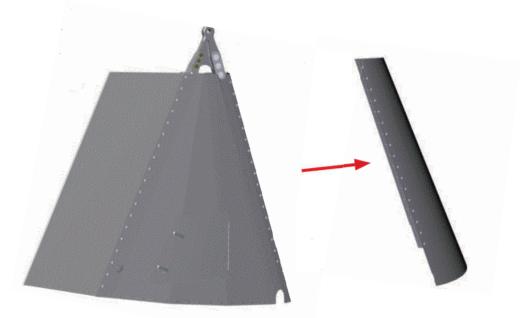
RH Float Shown, LH Float Similar

1. Remove the leading edge skin from the pylon.

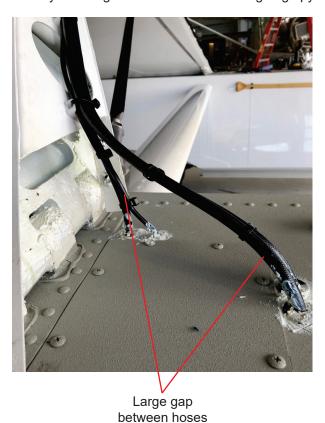
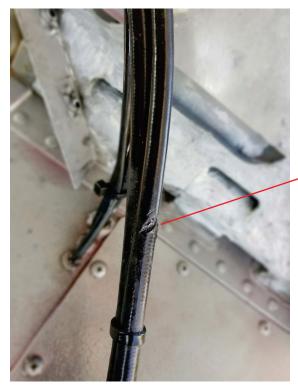
Hydraulic hoses are chaffing against the leading edge bottom rib of both LH/RH pylons. This service letter alleviates the risk of further damage.

Chaffing in the hose line

2. Inspect the hydraulic hose lines running through the top deck. If hoses create a large gap away from each other, chaffing may occur against the rib of the leading edge pylon skin.

3. To alleviate chaffing, use a zip tie to attach forward hose to the aft hose close to the float top deck as shown below.
