WIPLINE FLOATS • SKIS • MODIFICATIONS • AIRCRAFT SALES
AVIONICS • INTERIOR • MAINTENANCE • PAINT REFINISHING

SERVICE LETTER 211

3000/3450 SERIES BONDED STIFFENER CORROSION

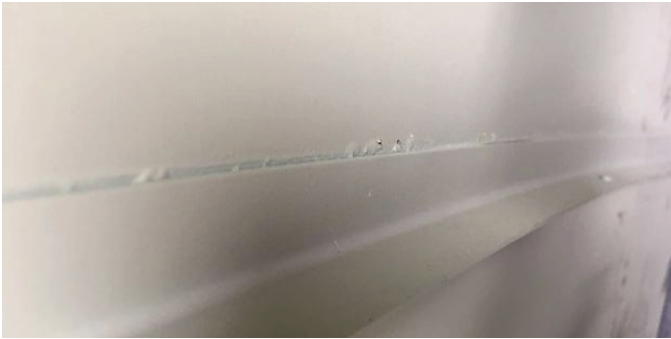
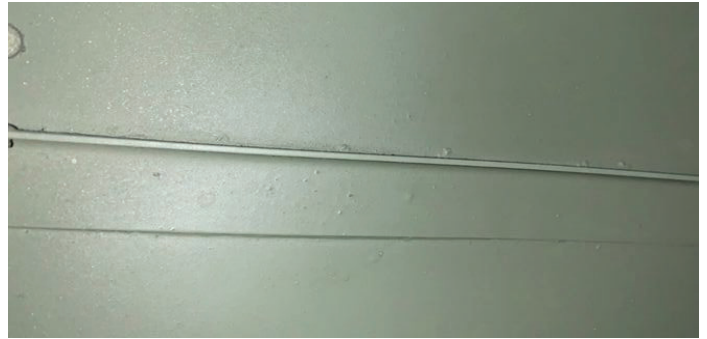
Method A - No corrosion or minimal superficial corrosion is present.

- Perform Work Instruction - Method A below.

Perform if no corrosion or minimal superficial corrosion is present.

1. Do not remove stiffener. Clean, alodine and prime any visible corrosion found on the interior of the side skin or the stiffener.
2. Seal the sides of stiffener with PR 1422-B2 or equivalent.

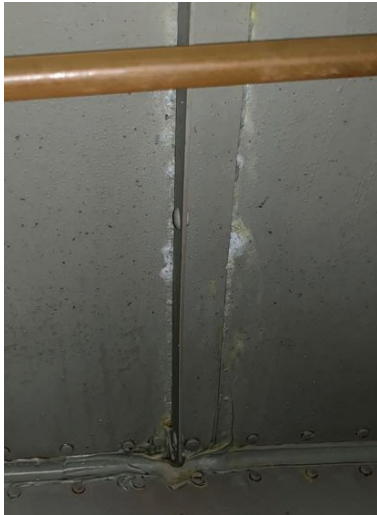
Method B - Corrosion is visible around the stiffener, and the stiffener will need to be removed for further inspection and repaired or corrosion has spread into the skins.

- Perform Work Instruction - Method B below.

Perform if corrosion is visible around the stiffener or if corrosion has spread more than 50% of skin thickness for a total length of more than 20% of the stiffener length through the skins.

1. Each stiffener is attached to the gunwall and chine with 2 to 3 rivets and adhesive. Remove rivets, if stiffener does not come off easily, use a heat gun on skin exterior to soften the adhesive (do not exceed 200°F) and remove each stiffener showing signs of corrosion.
2. Remove any corrosion on side skins and clean. Make sure to not remove any more material than necessary.
3. In some cases, there may be a pinhole through the skin, in which case, it is acceptable to backdrill through the pinhole and through the stiffener to 1/8" and install a rivet.
4. Alodine and prime cleaned surface.
5. Fit up replacement stiffener to skin, mark and remove any interfering existing rivets.
