SERVICE LETTER 211

3000/3450 SERIES BONDED STIFFENER CORROSION

Aircraft Makes/Model(s):	Float Model(s):	Compliance: Mandatory	By: MAS
Textron Aviation 180, 182,185, 206 Maule M-6-235, M-7-235, -B, -C, M-7-260, -C, M-7-420A, -AC, MT-7- 235, MT-7-260, MX-7-235	3000 and 3450 Series	Part Number: 1011440	Approved: DRH
		Date: 4/17/2023	Revision: B

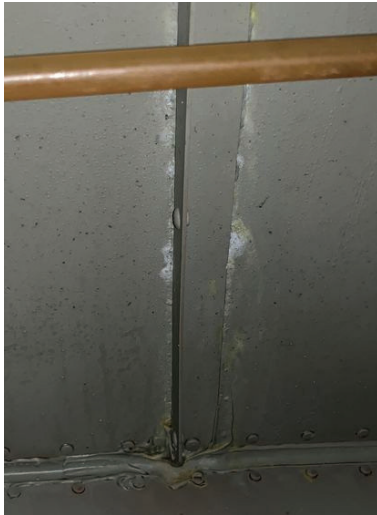
Method B - Corrosion is visible around and/or under the stiffener. The stiffener will need to be removed for replacement.

- Perform Work Instruction - Method B below.

1. Each stiffener is attached to the gunwall and chine with 2 to 3 rivets and adhesive. Remove rivets, if stiffener does not come off easily, use a heat gun on skin exterior to soften the adhesive (do not exceed 200°F) and remove each stiffener showing signs of corrosion.
2. Remove any corrosion on side skins and clean. Make sure to not remove any more material than necessary.
3. In some cases, there may be a pinhole through the skin, in which case, it is acceptable to drill it out and install a #4 rivet.
4. Alodine and prime cleaned surface.
5. Fit up replacement stiffener to skin, picking up existing stiffener rivet locations. Ensure proper edge distance per AC 43.13-1B. Mark and remove any interfering existing rivets.

6. Backdrill side skin to match rivet rows in stiffener.
7. Generously apply PR 1422-B2 or equivalent and attach the stiffeners to the side skin.

8. Rivet stiffeners to side skins, gunwall, and chine. Match previously installed rivet type at gunwall and chine. Use MS20470AD4 rivets for side skin locations.
9. Paint as desired.
