SERVICE LETTER 224

Sealing 3730A Float Nose Gear Retraction System

Aircraft Makes/Model(s):	Float Model(s):	Compliance: Mandatory	By: MAB
Texton Aviation	3730A	Part Number: 1011794	Approved: SDW
185 Series & 206 Series		Date: 1/7/2021	Revision: A

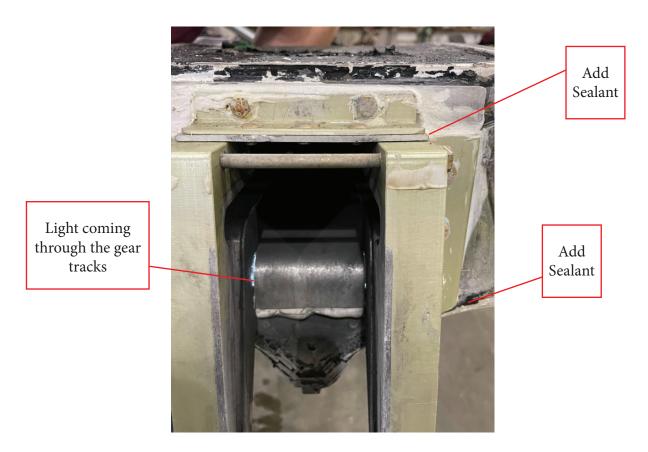
1. If needed, remove the nose cap to gain access to the front of the nose gear box. Inspect the attaching nose box flange for proper amount of sealant. An example of a flange that needs more sealant is shown in Figure 1. Below is a list of approved float sealants.

Figure 1: Nose Box with missing sealant around attachment flange

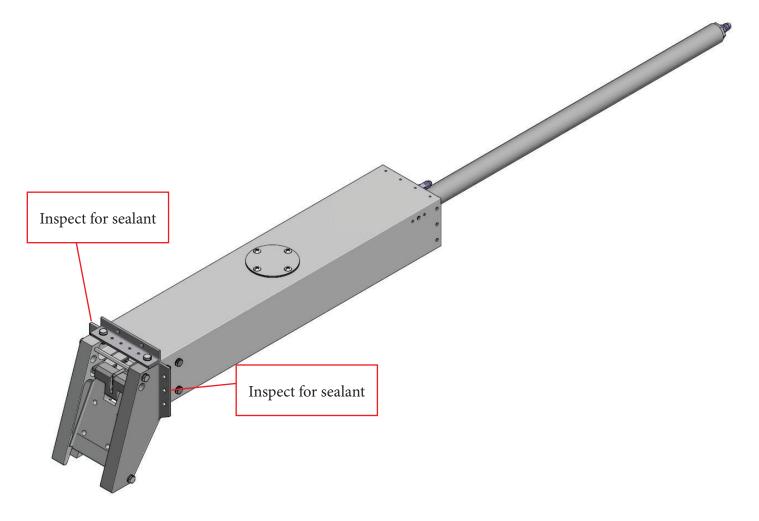
- 890 B2 or B4, Pro Seal Company
- PR 1440 C, PPG Aerospace
- 1422 B2, B4 or B6, Pro Seal Company
- RTV Silicones, General Electric
- SIKAFLEX 201 or 252, Sika Manufacturing
- 2. Inspect the exterior of the gear box from inside the FWD most float compartment. Shine a flashlight to check for missing sealant. Figure 1 shows light from the float compartment entering the nose tracks. In this example, as shown in Figure 2, the gear track attach locations could be missing sealant.

Figure 2: Gear Track Attach Locations

3. For future inspections of proper sealant around the nose box and the entire hull, see "Float Hull Maintenance" section in the Service Manual found on the Wipaire website.
