## SERVICE LETTER 216

### Cessna 208 Caravan 8000A & 8750A Hydraulic Pump Replacement

<b>Aircraft Makes/Model(s):</b>	<b>Float Model(s):</b>	<b>Compliance:</b> Optional	<b>By:</b> MAS
Textron Aviation 208	8000A & 8750A	<b>Part Number:</b> 1011602	<b>Approved:</b> DRH
		<b>Date:</b> 4/29/2024	<b>Revision:</b> C

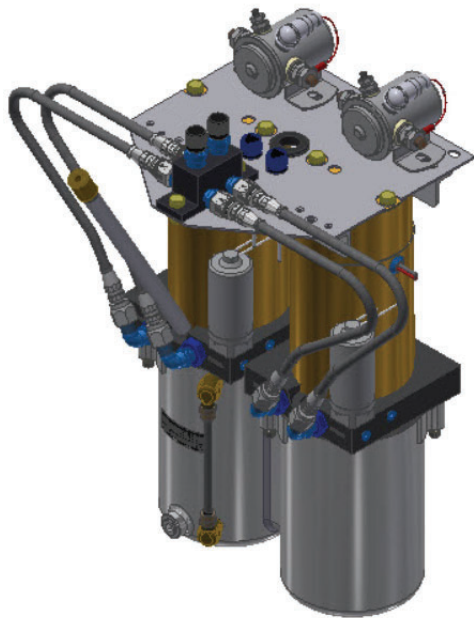
Hydraulic Pump Assembly p/n 8A09000-031 has been discontinued. This service letter provides the option to replace it with a new pump p/n 1011404.

**DISCONTINUED**  
**HYDRAULIC PUMP 8A09000-031**

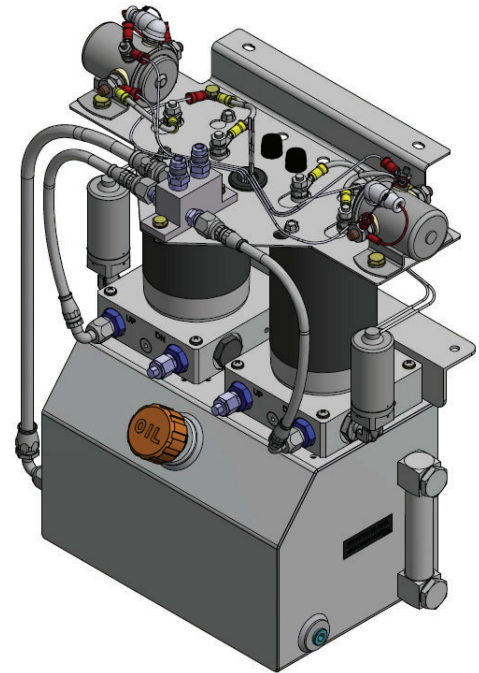
**NEW**  
**HYDRAULIC PUMP 1011404**
