SERVICE LETTER 199

Main Pylon Attach Point Fuselage Bracket

Aircraft Makes/Model(s):	Float Model(s):	Compliance: Optional	By: MAB
AT-802 & AT-802A	10000A	Part Number: 1011061	Approved: SDW
		Date: 1/21/2022	Revision: D

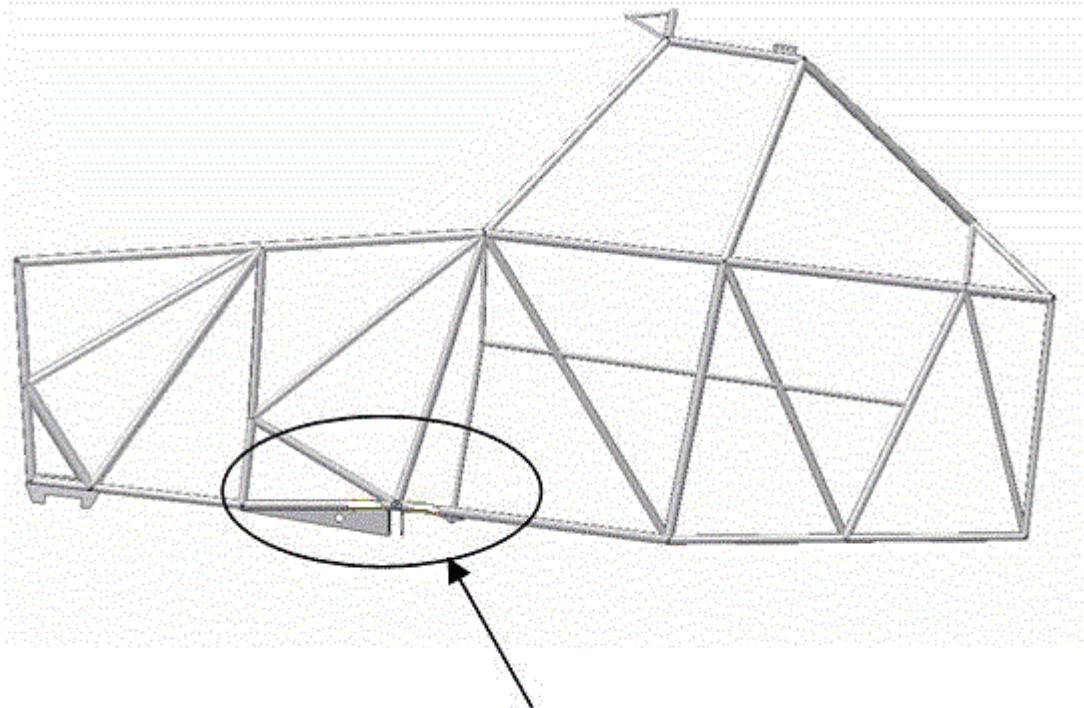
Figure 1

This Service Letter pertains to cracks forming along float attach brackets 1001495, 1001496, 10A02491-003, 10A02491-004 if the original bracket does not extend upward to the horizontal centerline of the longeron. Reference Service Letters 71 and 72 for more information. Service Kits 51, 52, and 53 are associated with this Service Letter.

1. Visually inspect lower longeron tube (Figure 1) and the entire nearby welded tube cluster for signs of cracking on both sides of the aircraft. Pay special attention to areas A and B on Figure 2. If there is doubt about crack presence, strip paint from tubes for visual inspection and consider magnetic particle, dye penetrant, or eddy current inspection.
2. If cracks are found, repair cracks per AC 43.13-1B and Wipaire Service Letter 71 before accomplishing the work instruction of this service letter. If cracks are not found installation of the gussets per the work instruction of this service letter is recommended but not required.

Affected Area
