SERVICE LETTER 223

Scout 8GCBC Hydraulic Pump Replacement on 2100A Floats

This service letter applies to American Champion model Scout 8GCBC with Wipline 2100 Amphibian Floats installed per STC SA00763CH.

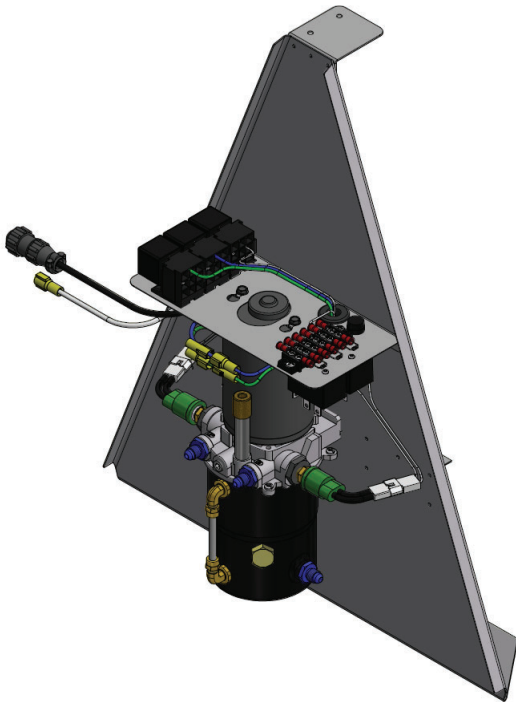
DISCONTINUED
HYDRAULIC PUMP 21A09000-216

The Hydraulic Pump Assembly p/n 21A09000-216 has been discontinued. This service letter provides the option to replace it with pump p/n 1011760.
