## SERVICE LETTER 248

### Water Deflection Panel (Bulkhead #17) Reinforcement

<b>Aircraft Makes/Model(s):</b>	<b>Float Model(s):</b>	<b>Compliance:</b> Optional	<b>By:</b> MAS
Air Tractor AT-802 and AT-802A	10000A	<b>Part Number:</b> 1012082	<b>Approved:</b> DRH
		<b>Date:</b> 10/25/2022	<b>Revision:</b> C

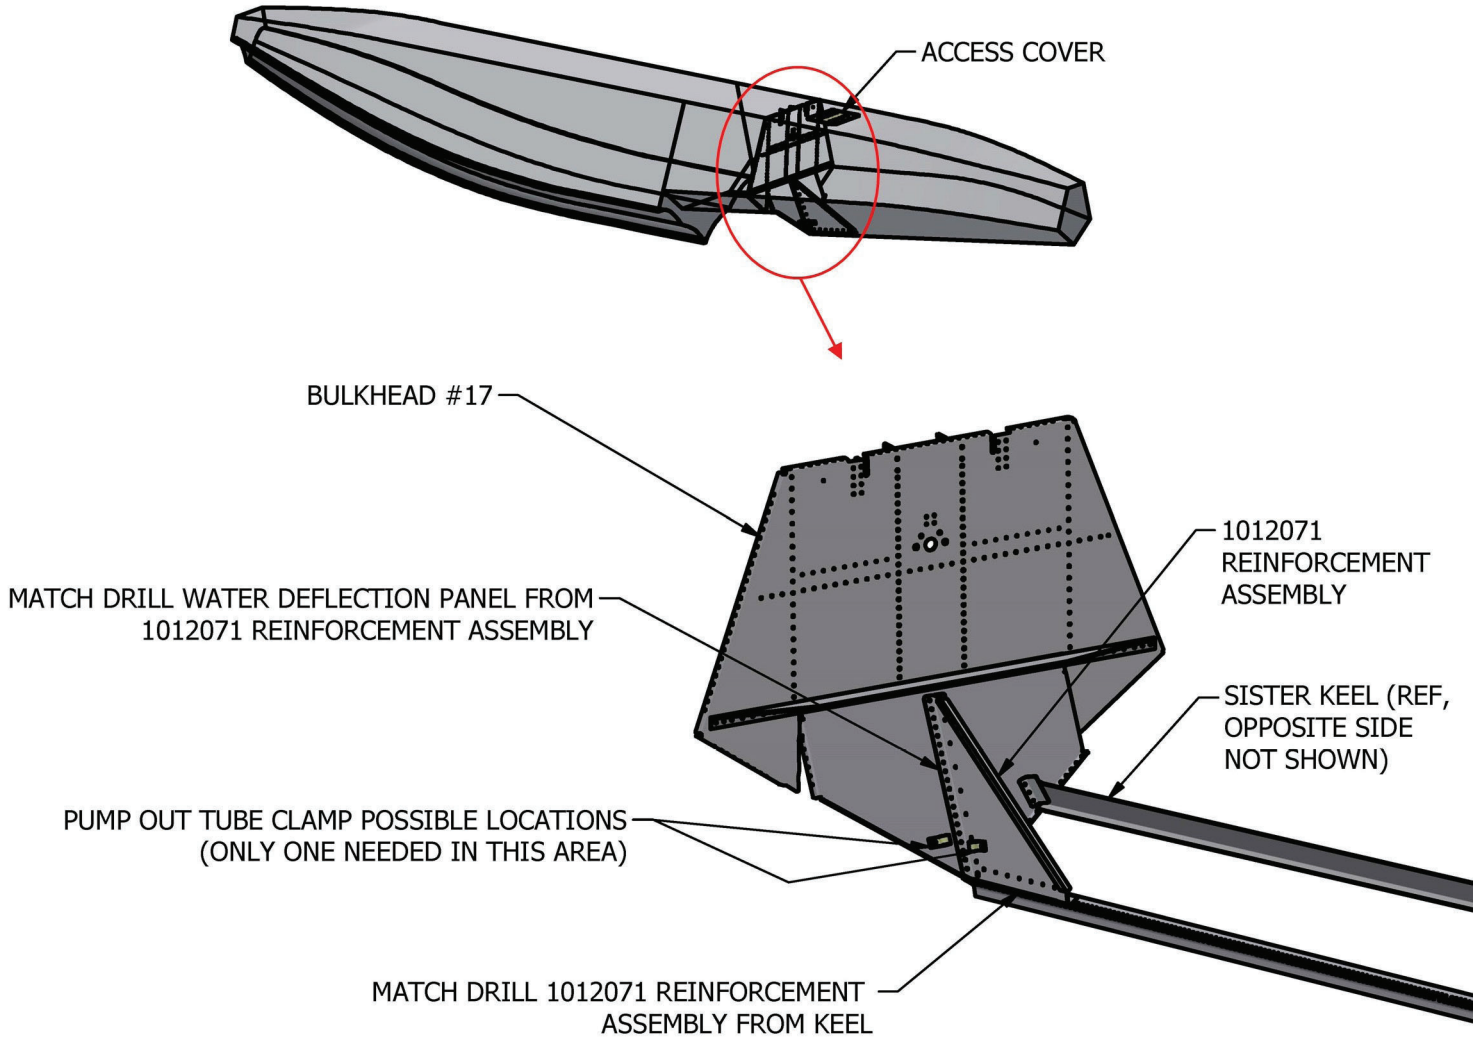
Figure 1

The water deflection panel (bulkhead #17, aft of wheel well) may experience deformation during water operations.

If the extent of deformation allows, install internal reinforcement assembly 1012071 (one per float) in accordance with the Work Instructions provided in this service letter.

1. Position and prepare aircraft for safe maintenance.
2. Remove top deck cover to gain access to bulkhead #17. See Figure 1.
3. Remove pump-out tube from bottom of float bay. Remove tube clip and plug rivet holes if clip conflicts with reinforcement assembly (if within ~1" of bulkhead centerline).
4. Remove rivets from keel between the flanges of bulkheads #17 and #18.
5. Remove sealant in the area as required.
6. Match drill holes from keel into reinforcement assembly 1012071.
