SERVICE LETTER 233

Cessna 170 Hydraulic Pump Replacement on 2100A Floats

Aircraft Makes/Model(s):	Float Model(s):	Compliance: Optional	By: MAB
Textron Aviation 170A & 170B	2100A	Part Number: 1011890	Approved: SDW
		Date: 6/10/2021	Revision: A

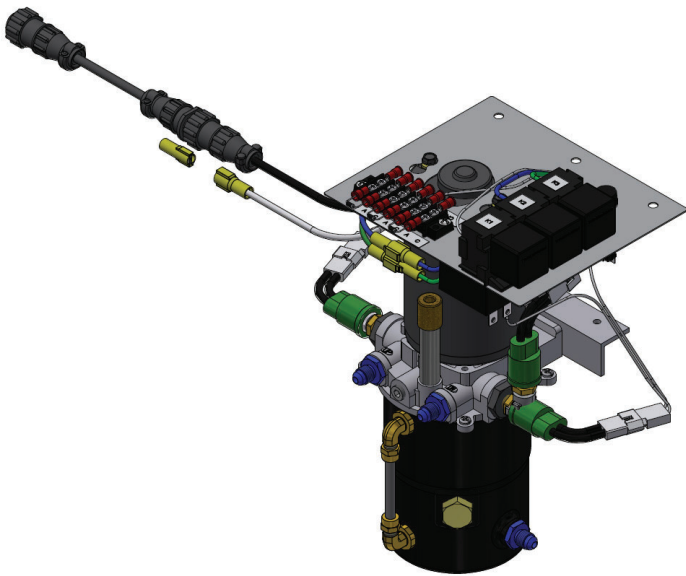
**DISCONTINUED 12 VDC
HYDRAULIC PUMP 21A09000-279**

Textron Aviation (Cessna) 170A and 170B Hydraulic Pump Assembly 21A09000-279 has been discontinued. This service letter provides the option to replace it with pump 1011887.
