SERVICE LETTER 242

Cessna 206H Soloy Hydraulic Pump Replacement Near Firewall on 3450A Floats

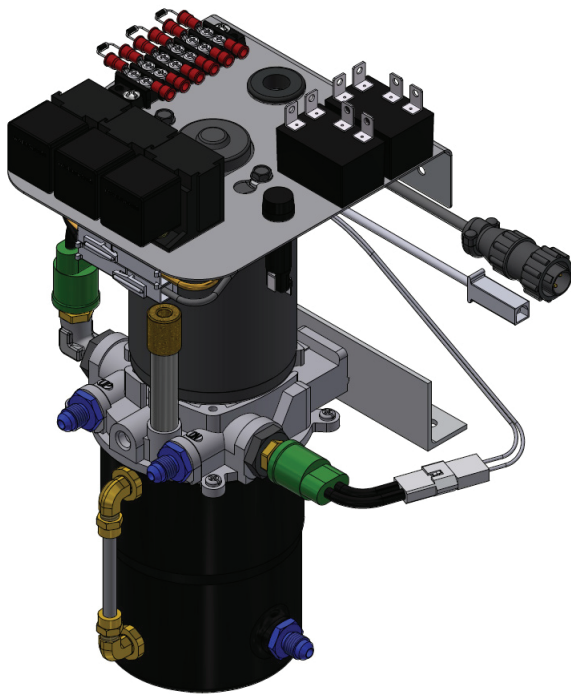
**DISCONTINUED OILDYNE
HYDRAULIC PUMP 1009225**

Textron Aviation (Cessna) 206 Hydraulic Pump Assembly p/n 1009225 has been discontinued. This service letter provides the option to replace it with pump p/n 1011945.
