SERVICE LETTER 246

E-Dump System, Water Rudder Retract Cable Interference

Aircraft Makes/Model(s):	Float Model(s):	Compliance: Optional	By: MAS
Air Tractor	10000A	Part Number: 1005051	Approved: SDW
AT-802 and AT-802A		Date: 4/14/2022	Revision: B

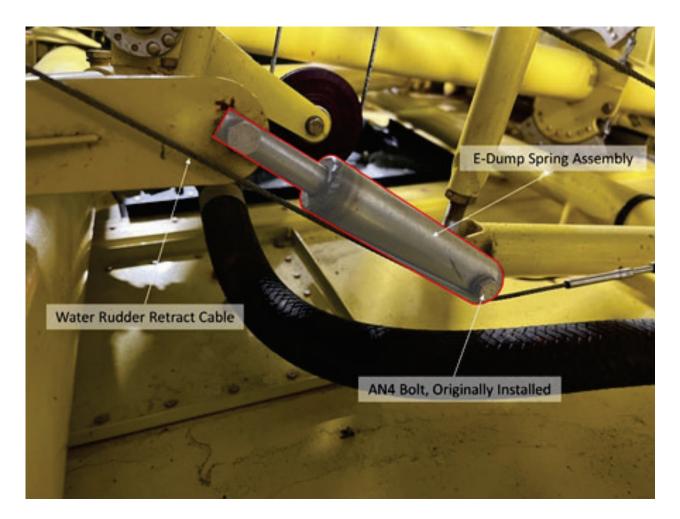
The water rudder retract cable may become caught on the Emergency Dump Spring Assembly (Air Tractor PN 71134-1), especially with the manual (non-electric) rudder retract system due to the water rudders being able to "bounce" while in the retracted position, creating momentary slack in the cable.

Figure 1 – Example of Interference

- 1. Position and prepare aircraft for safe maintenance.
- 2. Remove panel(s) as needed to gain access to area aft of hopper on L/H side.
- 3. Replace the originally installed AN4 bolt and MS21044N4 nut at the aft end of the E-Dump Spring Assembly (Air Tractor PN 71134-1) with AN24-36A clevis bolt and MS21083N4 nut and NAS1149F0463P washers as required. Do not overtighten, as doing so may restrict movement of the linkage. Refer to Figures 1 and 2. Cable pulleys and adjacent fuel line may be massaged slightly for additional clearance.
- 4. Actuate E-dump handle to test for interference and proper range of motion and make any necessary adjustments.
- 5. Reinstall aircraft panels.

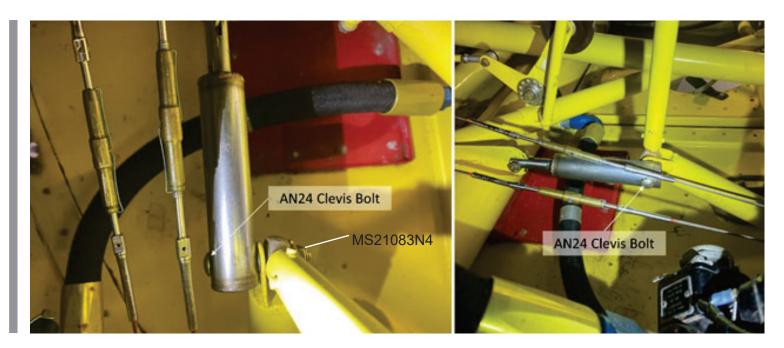
Figure 2 – Clevis Bolt Installed
