SERVICE LETTER 253

Horizontal Stabilizer Spar Cracking At Finlets

Aircraft Makes/Model(s):	Float Model(s):	Compliance: Mandatory	By: MAS
Air Tractor AT-802 & AT-802A	10000A	Part Number: 1012347 Date: 4/5/2023	Approved: DRH Revision: A

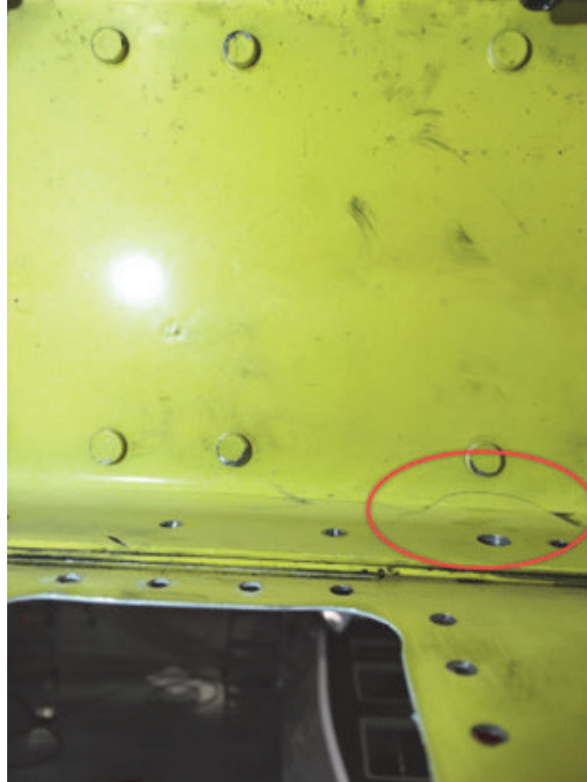
Figure 3

5. Clean the area that is to be inspected.
6. Visually inspect for cracks on the forward horizontal stabilizer spar, including both upper and lower flanges and the web area between. Two primary varieties of cracks have been observed. These are described below to aid inspection, but the entire area is to be thoroughly examined:
 - a. A crack originating in the spar web above the forward, outboard mount bolt of the lower finlet. See Figures 3 and 4.
 - b. A crack near the forward, inboard mount bolt, typically within the radius of the spar, and perhaps centered at the corner of the strut brace shim plates. See Figure 5.

Crack above lower finlet forward, outboard mount bolt location (spar strap removed)

Any cracks discovered in this area of the horizontal stabilizer spar necessitate replacement or repair of spar; the procedure for replacing or repairing the spar is beyond the scope of Service Letter 253.

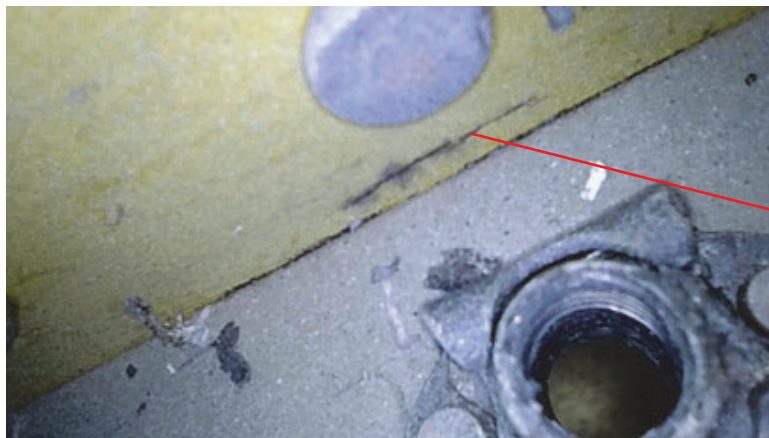
Figure 4

Early-Stage
Crack

Early-stage crack above lower finlet forward, outboard mount bolt location (shown here with spar strap in place)

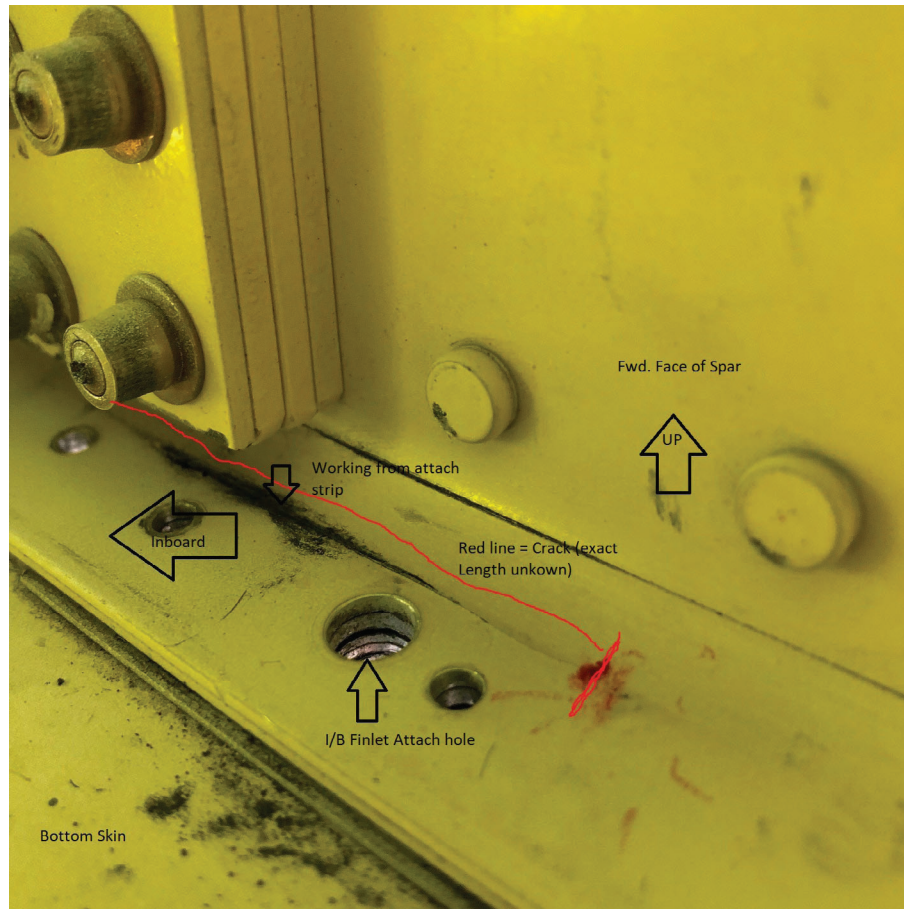
Figure 5

Crack at lower finlet forward, inboard mount bolt location (spar strap removed)
