SERVICE LETTER 253

Horizontal Stabilizer Spar Cracking At Finlets

Aircraft Makes/Model(s):	Float Model(s):	Compliance: Mandatory	By: DRH
Air Tractor	10000A	Part Number: 1012347	Approved: DRR
AT-802 & AT-802A		Date: 7/27/2023	Revision: B

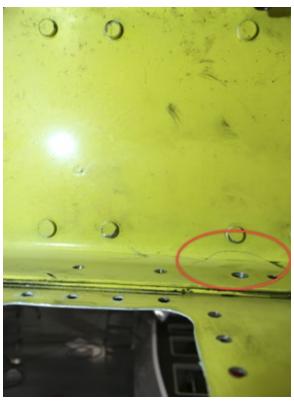
Instances of cracked horizontal stabilizer spars have been observed, primarily on the forward spars near both the lower and upper finlet mounting locations, at/near the spar bend radii.

Figure 4
Crack above lower finlet forward, outboard mount bolt location (spar strap removed)

Any cracks discovered in this area of the horizontal stabilizer spar necessitate replacement or repair of spar; the procedure for replacing or repairing the spar is beyond the scope of Service Letter 253.

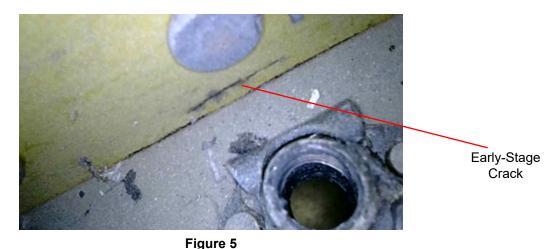
Early-stage crack above lower finlet forward, outboard mount bolt location (shown with spar strap in place)

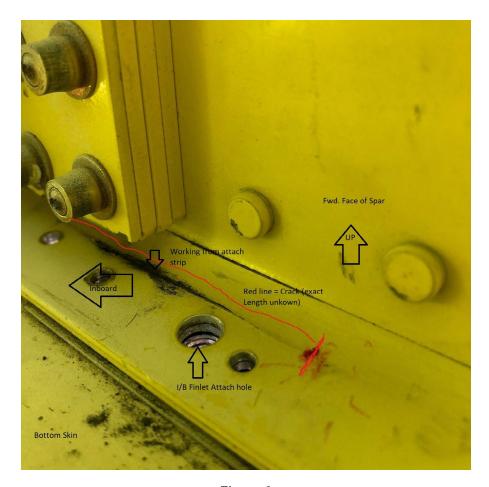
- 5. Clean the area that is to be inspected.
- 6. Visually inspect for cracks on the forward horizontal stabilizer spar, including both upper and lower flanges and the web area between. Two primary varieties of cracks have been observed. These are described below to aid inspection, but the entire area is to be thoroughly examined:
 - a. A crack originating in the spar web above the forward, outboard mount bolt of the lower finlet. See Figures 4 and 5.
 - b. A crack near the forward, inboard mount bolt, typically within the radius of the spar, and perhaps centered at the corner of the strut brace shim plates. See Figure 6.

Figure 6
Crack at lower finlet forward, inboard mount bolt location (spar strap removed)
