SERVICE LETTER 253

Horizontal Stabilizer Spar Cracking At Finlets

Aircraft Makes/Model(s):	Float Model(s):	Compliance: Mandatory	By: MAS
Air Tractor AT-802 & AT-802A	10000A	Part Number: 1012347	Approved: DRH
		Date: 3/5/2025	Revision: E

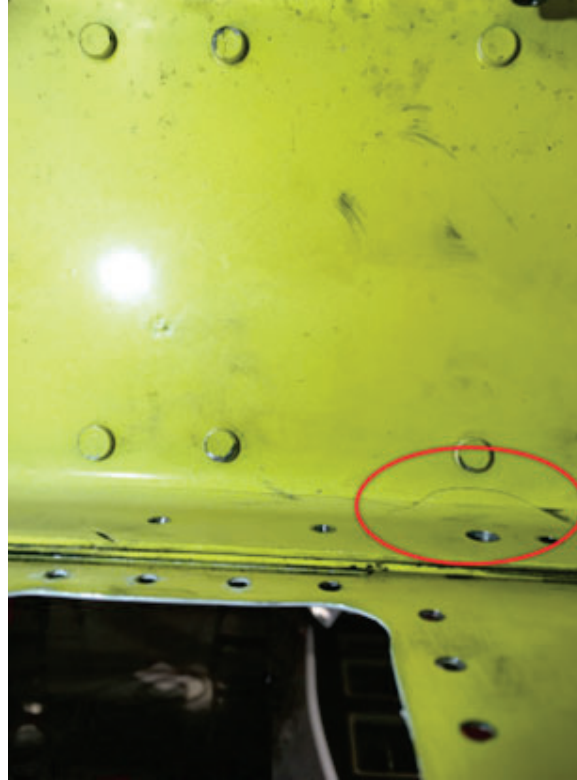
Figure 4

Instances of cracked horizontal stabilizer spars have been observed, primarily on the forward spars near the finlet mounting locations, at/near the spar bend radii. The installation method has since been changed. This service letter supports a phase-out of the prior method while also describing the retrofit process and its altered, ongoing maintenance requirements.

5. Clean the area that is to be inspected.
6. Visually inspect for cracks on the forward and aft horizontal stabilizer spars, including both upper and lower flanges and the web area between. Two primary varieties of cracks have been observed. These are described below to aid inspection, but the entire area is to be thoroughly examined:
 - a. A crack originating in the spar web above the forward, outboard mount bolt of the lower finlet. See Figures 4 and 5.
 - b. A crack near the forward, inboard mount bolt, typically within the radius of the spar, and perhaps centered at the corner of the strut brace shim plates. See Figure 6.

Crack above lower finlet forward, outboard mount bolt location (spar strap removed)

Any cracks discovered in this area of the horizontal stabilizer spar necessitate replacement of spar; the procedure for replacing the spar is beyond the scope of this service letter. Forward spar assemblies may be ordered directly through Wipaire. See the parts list in the WORK INSTRUCTIONS – INSTALL BATHTUB FITTINGS section.

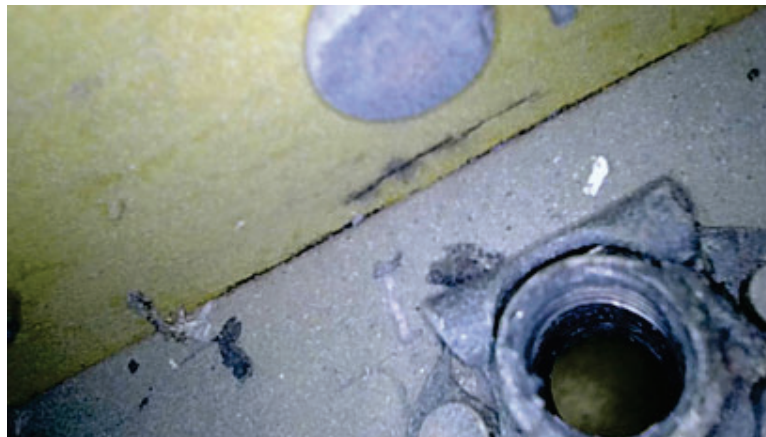
Figure 5

Early-stage crack above lower finlet forward, outboard mount bolt location (shown with spar strap in place)
