## SERVICE LETTER 253

### Horizontal Stabilizer Spar Cracking At Finlets

<b>Aircraft Makes/Model(s):</b>	<b>Float Model(s):</b>	<b>Compliance:</b> Mandatory	<b>By:</b> MAS
Air Tractor AT-802 & AT-802A	10000A	<b>Part Number:</b> 1012347	<b>Approved:</b> DRH
		<b>Date:</b> 6/4/2026	<b>Revision:</b> F

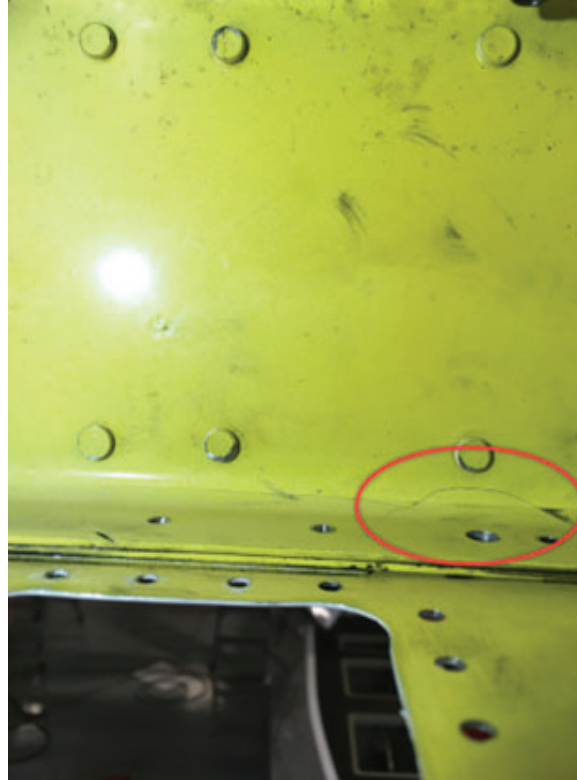
**Figure 4**

5. Clean the area that is to be inspected.
6. Visually inspect for cracks on the forward and aft horizontal stabilizer spars, including both upper and lower flanges and the web area between. Two primary varieties of cracks have been observed. These are described below to aid inspection, but the entire area is to be thoroughly examined:
  - a. A crack originating in the spar web above the forward, outboard mount bolt of the lower finlet. See Figures 4 and 5.
  - b. A crack near the forward, inboard mount bolt, typically within the radius of the spar, and perhaps centered at the corner of the strut brace shim plates. See Figure 6.

**Crack above lower finlet forward, outboard mount bolt location (spar strap removed)**

Any cracks discovered in this area of the horizontal stabilizer spar necessitate replacement of spar; the procedure for replacing the spar is beyond the scope of this service letter. Forward spar assemblies may be ordered directly through Wipaire. See the parts list in the WORK INSTRUCTIONS – INSTALL BATHTUB FITTINGS section.

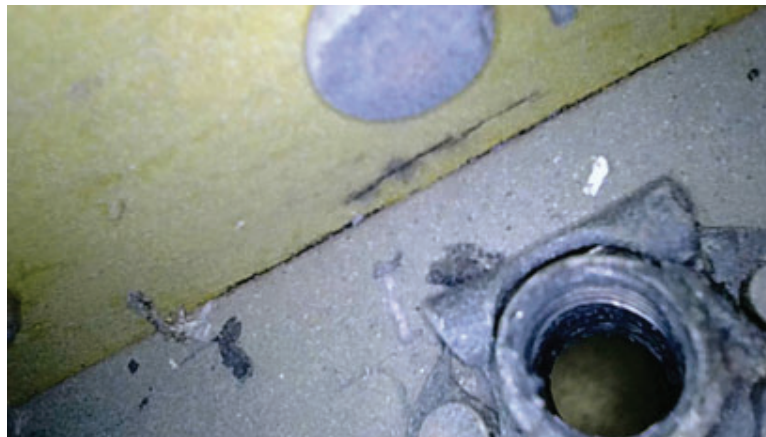
**Figure 5**

**Early-stage crack above lower finlet forward, outboard mount bolt location (shown with spar strap in place)**
