WIPLINE FLOATS | MODIFICATIONS | AIRCRAFT SALES  
AVIONICS | INTERIORS | MAINTENANCE | PAINT

## SERVICE LETTER 253

### Horizontal Stabilizer Spar Cracking At Finlets

| Aircraft Makes/Model(s): | Float Model(s): | Compliance: Mandatory | By: MAS |

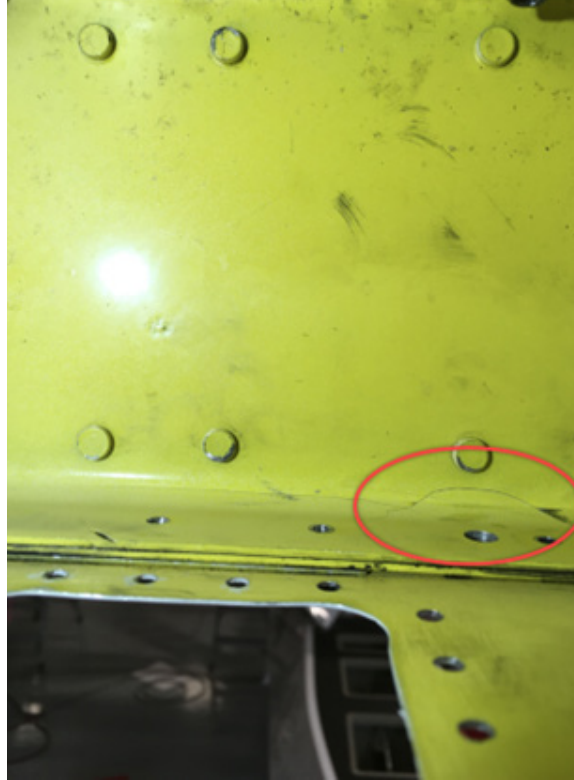
**Figure 4**

**Crack above lower finlet forward, outboard mount bolt location (spar strap removed)**

Any cracks discovered in this area of the horizontal stabilizer spar necessitate replacement of spar; the procedure for replacing the spar is beyond the scope of this service letter. Forward spar assemblies may be ordered directly through Wipaire. See the parts list in the WORK INSTRUCTIONS – INSTALL BATHTUB FITTINGS section.

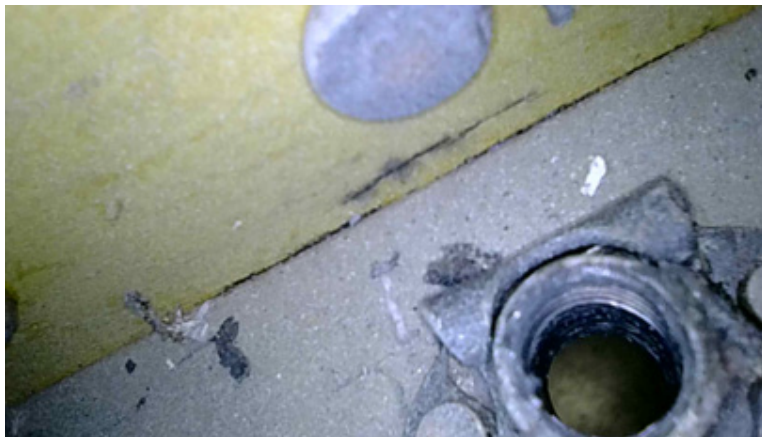
**Figure 5**

**Early-stage crack above lower finlet forward, outboard mount bolt location (shown with spar strap in place)**

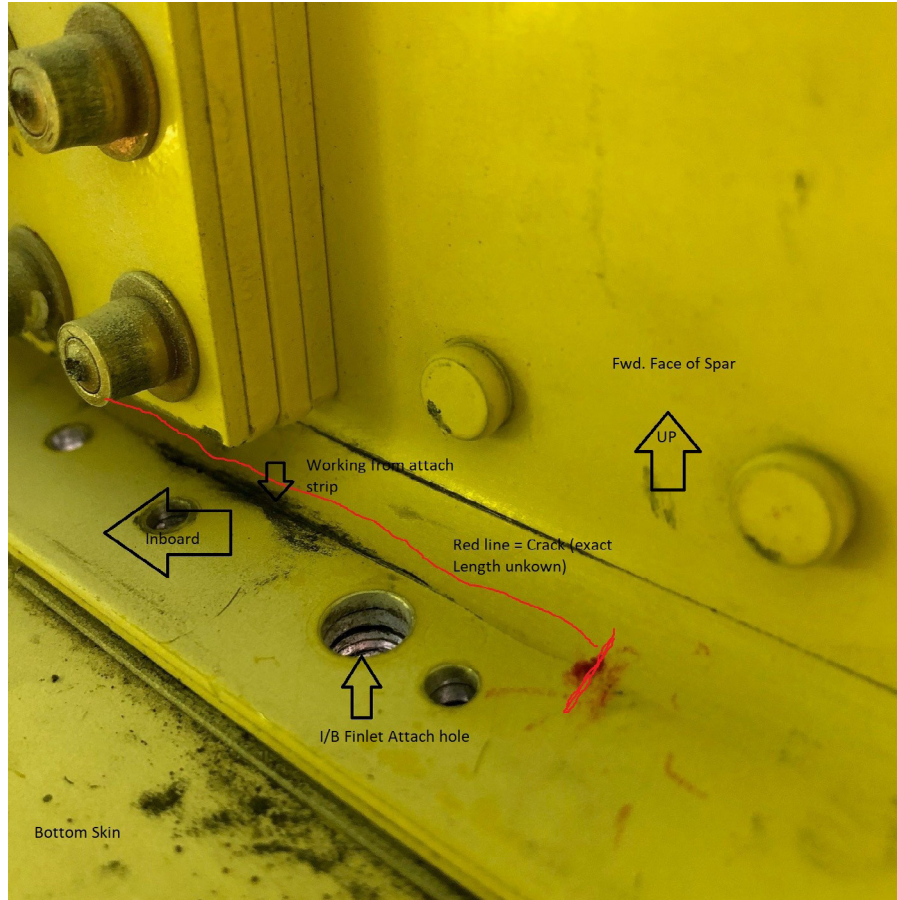
**Figure 6**

**Crack at lower finlet forward, inboard mount bolt location (spar strap removed)**

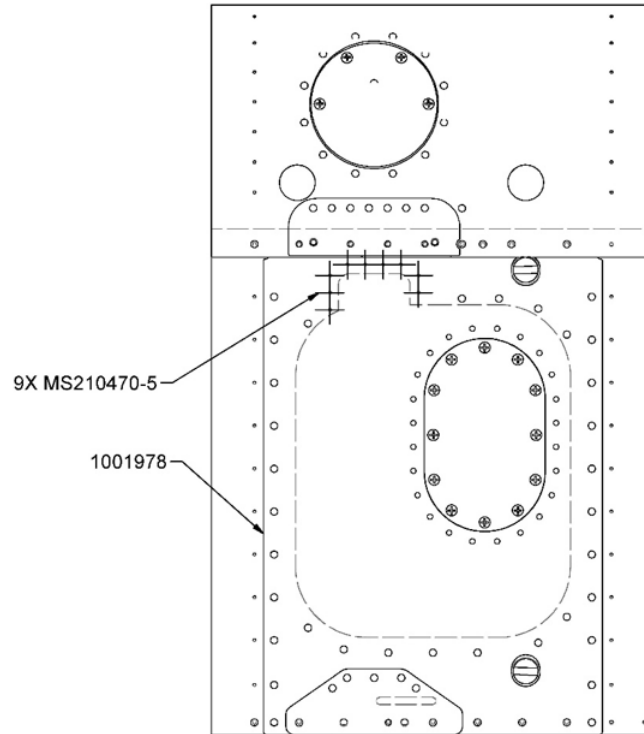
**Figure 9**  
**Alternate Skin Patch**

**Note:** Service Letter kit utilizes an alternate skin patch to accommodate prior modification of stabilizer skin. (1001978 in place of 1001971)
