SERVICE LETTER 256

208/208B on 8000/8750 Floats - Add Protective Sleeve to Water Rudder Steering Cable Spring

Aircraft Makes/Model(s):	Aircraft Makes/Model(s): Float Model(s):		By: MAS
Textron Aviation 208 and 208B	8000 and 8750 Series	Part Number: 1012384	Approved: DRH
		Date: 8/29/2023	Revision: A

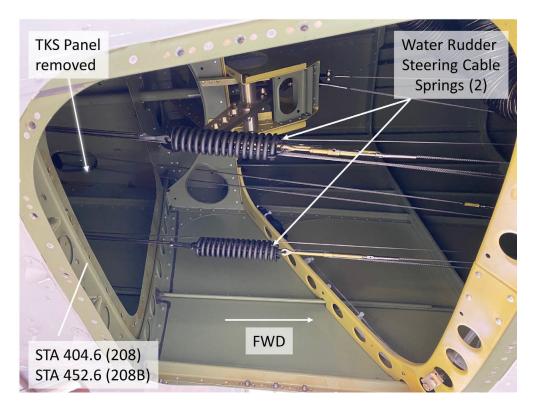
Figure 1 – Overview, Looking Up Through Tailcone Access Panel

Water rudder steering cable springs located within the aircraft empennage may catch on the flange of an adjacent bulkhead, potentially affecting control of the aircraft.

- 1. Position and prepare aircraft for safe maintenance.
- 2. Remove tailcone access panel located ahead of FS 404.6 (208) / FS 452.6 (208B). Refer to Figure 1.
- 3. If present, remove TKS panel from bulkhead at FS 404.6 (208) / FS 452.6 (208B).

Note: Earlier revisions of Wipaire Install Drawing 1004806 described trimming this panel for clearance rather than removing it. It is to be removed as part of this Service Letter regardless. Panel is reinstalled if converting to landplane.
