SERVICE LETTER 262

3000/3450 MAIN GEAR ACTUATOR REPLACEMENT

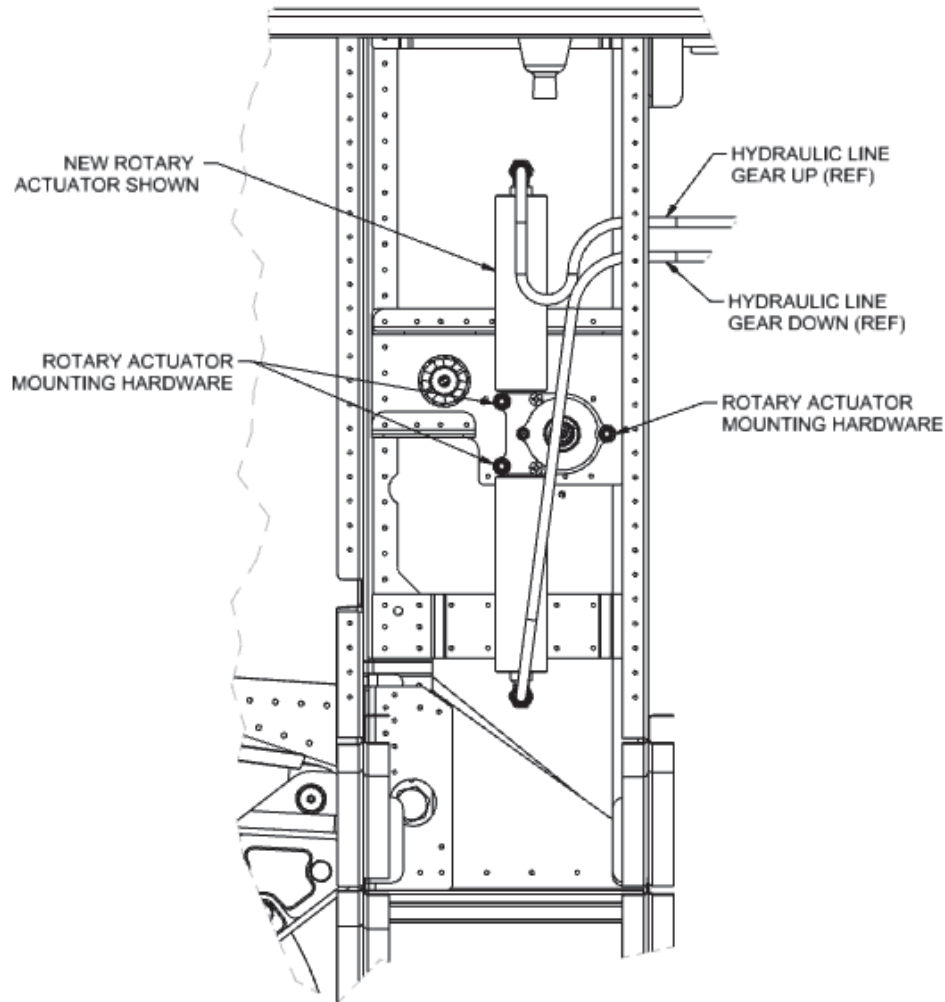
WHEEL WELL SIDE PANEL - SIDE SKIN REMOVED FOR CLARITY
INBOARD LEFT FLOAT
OUTBOARD RIGHT FLOAT

Some 3000A and 3450A model main gear rotary actuator assemblies are leaking hydraulic oil around the end adjustment bolts. This service letter provides the option to replace the actuator assemblies with assemblies that have internal adjustment bolts.

6. Gain access to the covers by removing the float side skin access covers to access the actuators, inboard side for left float, outboard side for right float.

7. Remove the two hydraulic lines from the rotary actuator. Note the hydraulic line going to the top of the rotary actuator is gear up and the hydraulic line going to the bottom of the rotary actuator is gear down.
8. Remove the three mounting nuts and washers from the rotary actuator. The rotary actuator should be ready to be removed.

9. Install the new rotary actuator with the existing hardware. When installing the rotary actuator arm to the shaft, align the shaft with the keyway and insert the key before tightening the hardware.
