SERVICE LETTER NUMBER 174

3000A/3450A MAIN LANDING GEAR SHAFT REPLACEMENT

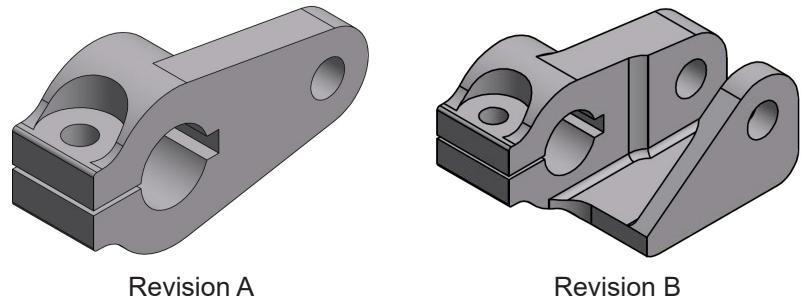
Revision A

¹ 1005280 gear actuator arm could be revision A or B depending on when the floats were manufactured. This work instruction shows revision B. If revision A is installed, use following images for reference only as NAS6206-21 bolt could be an AN bolt and installed from the opposing direction

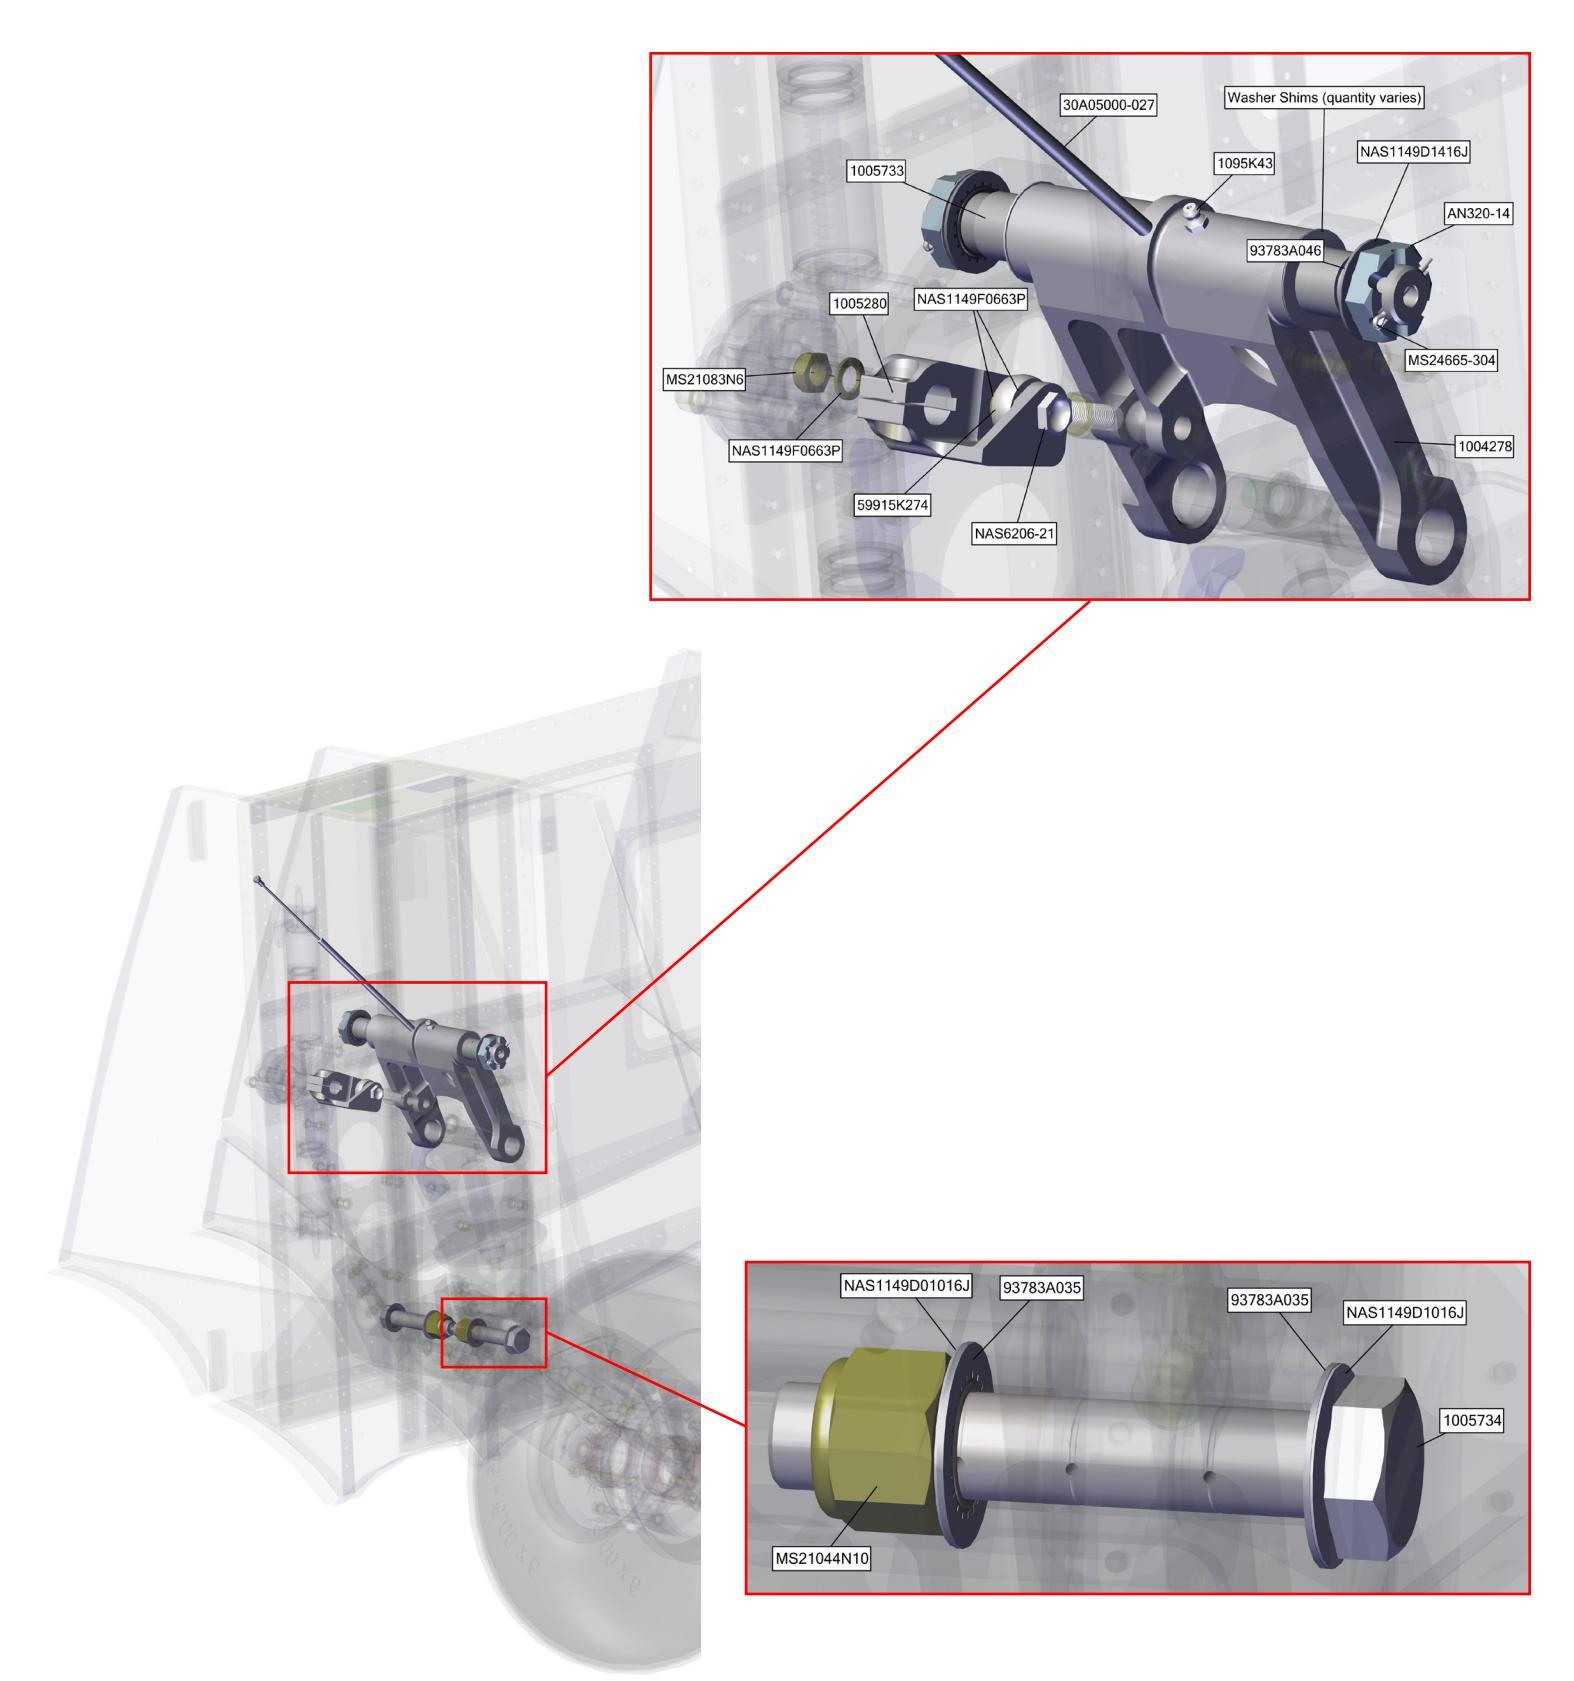
FIGURE 1: DRAG LINK, SHOCK STRUT, AND UPPER SHOCK ARM ASSEMBLY REMOVAL

Some 3000A and 3450A model main gear assemblies were produced with main landing gear shafts that were not heat treated to proper specifications and need to be replaced

- 4. Remove brake caliper back plate assemblies by removing the (4) MS bolts and associated washers on each caliper
- 5. Leaving the brake line still connected, relocate and secure brake line and calipers assembly to float as to not interfere with further disassembly of the main gear

- 6. Remove the left, right and top main gear access covers on the side skins and the top deck of the float
- Disconnect the 30A05000-027 gear indicator 7.

- Remove the 1095K43 grease zerk from the 1005733 upper shock arm 8.
- 9. Remove the MS21083N6 nut, (3) NAS1149F0663P washers, and the NAS6206-21 bolt¹ that connects the 59915K274 male rod end to the 1005280 gear actuator arm

- 10. Cut the MS24665-304 cotter pins and remove AN320-14 castle nuts and associated NAS1149D1016 washers and 93783A046 sealing washers from each end of the 1005733 upper pivot shaft and slide 1005733 upper pivot shaft out

NOTE: Washer shims are located on the inside of each 1004278 upper shock arm. Note the location of the shims so that the gear proximity switches will not require readjustment after the gear is reassembled

11. Remove the MS21044N10 nuts and 1005734 lower drag link pivot bolt and associated NAS1149D1016J washers and 93783A035 sealing washers from each side of the wheel well
