SERVICE LETTER 172 8750A BULKHEAD 9 CRACKING

By: RCG	Aircraft Makes/Model(s):		
Approved: JRS	Cessna 208	Float Model(s):	Note(s): Mandatory Compliance Service Letter P/N 1008990
Date: 11/30/2017	Cessna 208B	8750A 7000A	
Revision: C	Quest Kodiak 100

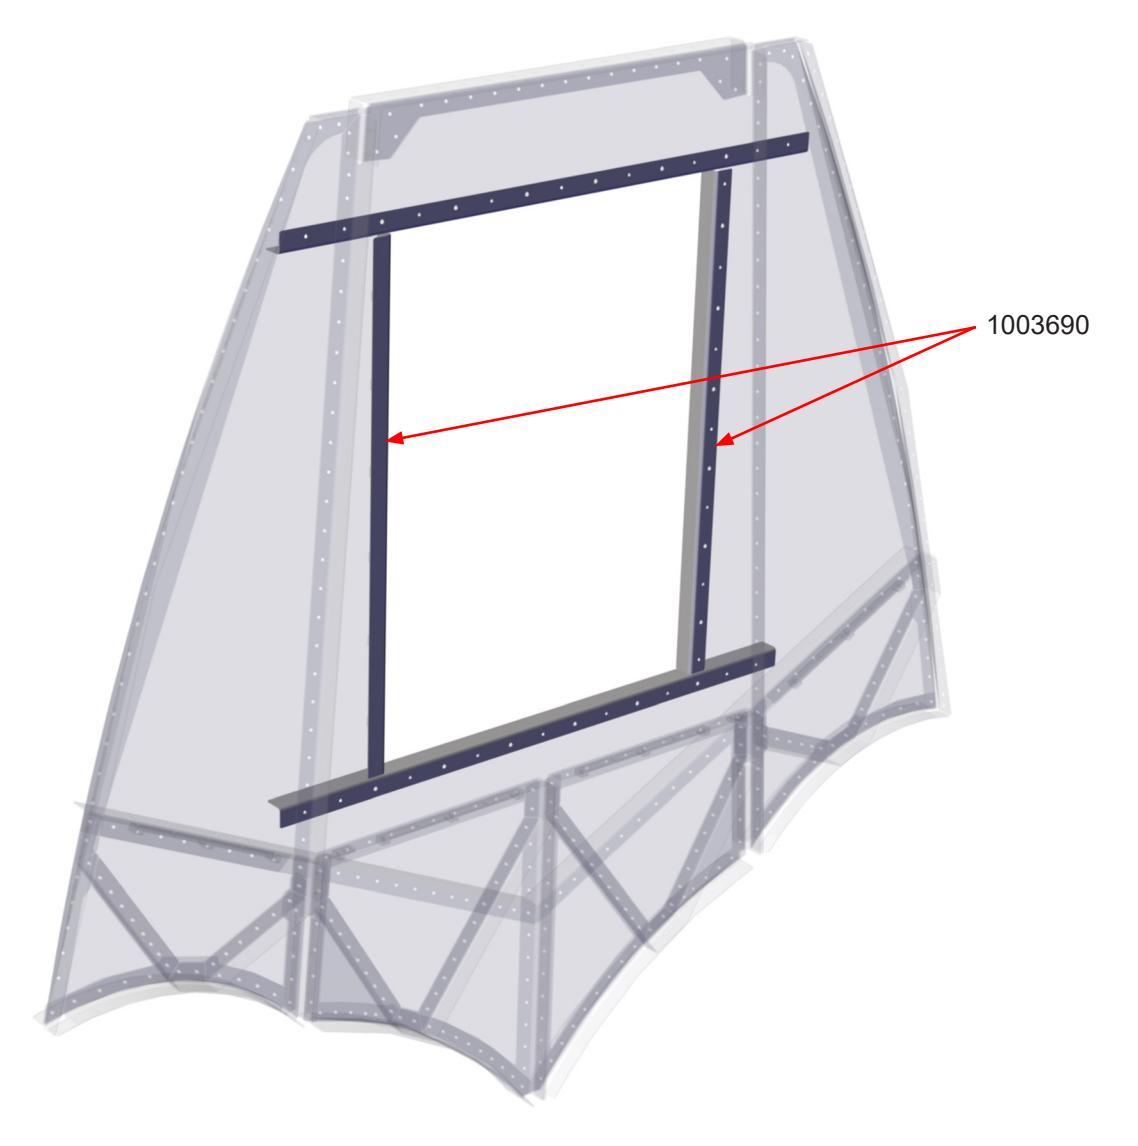
Cracking has been found on the 1006080 Bulkhead 9 Main Panel. The 1003690 Vertical Stiffeners have been revised to include a flange that will be riveted to the Horizontal Stiffeners for additional support

- 1. Gain access to the bulkhead 9 assembly through the aft baggage compartment and remove 1003688 Bulkhead 9 Access Panel. Discard (24) AN526-832R6 screws
- 2. Drill out (2) 1003690 Vertical Stiffeners

3. Inspect 1006080 Bulkhead Main Panel for cracking. If cracking is found, contact Wipaire Customer Service to receive additional instruction for repair. If no cracking is found, proceed to the next step
