# **SERVICE LETTER NUMBER 169**

# 8750 PYLON NUTPLATE CORROSION

By: BGLASS	Aircraft Makes/Model(s): Cessna 208 Cessna 208B	Float Model(s): 8750A	Note(s):
Approved: JRS			Mandatory Compliance Service Letter P/N 1008954 ECO 24652
Date: 8/17/2016			
Rev: A

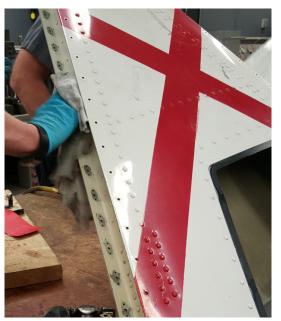
The current MS21059L08 steel nutplates on the pylon assemblies may have corrosion and need to be replaced with MS21060L08 stainless steel nutplates. Corrosion may extend further onto the skins, drag strut channels, main pylon struts and other areas and further disassembly may be needed to remove the corrosion

Clean applicable surfaces and inspect pylon for corrosion. Lap joints, machinings, skins, and all areas with dissimilar contacting metal should be checked thoroughly. Remove all corrosion or replace corroded components per <u>AC43.13-1B</u> or later FAA approved revision guidelines and the <u>Structural Repair Manual for Wipline Aluminum Floats</u> Wipaire part number 1008274. Apply Alodine to all bare metal
