SERVICE LETTER 189

8750 AMPHIBIOUS CARRY THROUGH STRAP DOUBLER INSTALLATION

Aircraft Makes/Model(s):	Float Model(s):	Compliance: As required	By: RCG
Textron Aviation 208 and 208B	8750 Amphibious	Part Number: 1009949	Approved: SDW
		Date: 12/19/2018	Revision: A

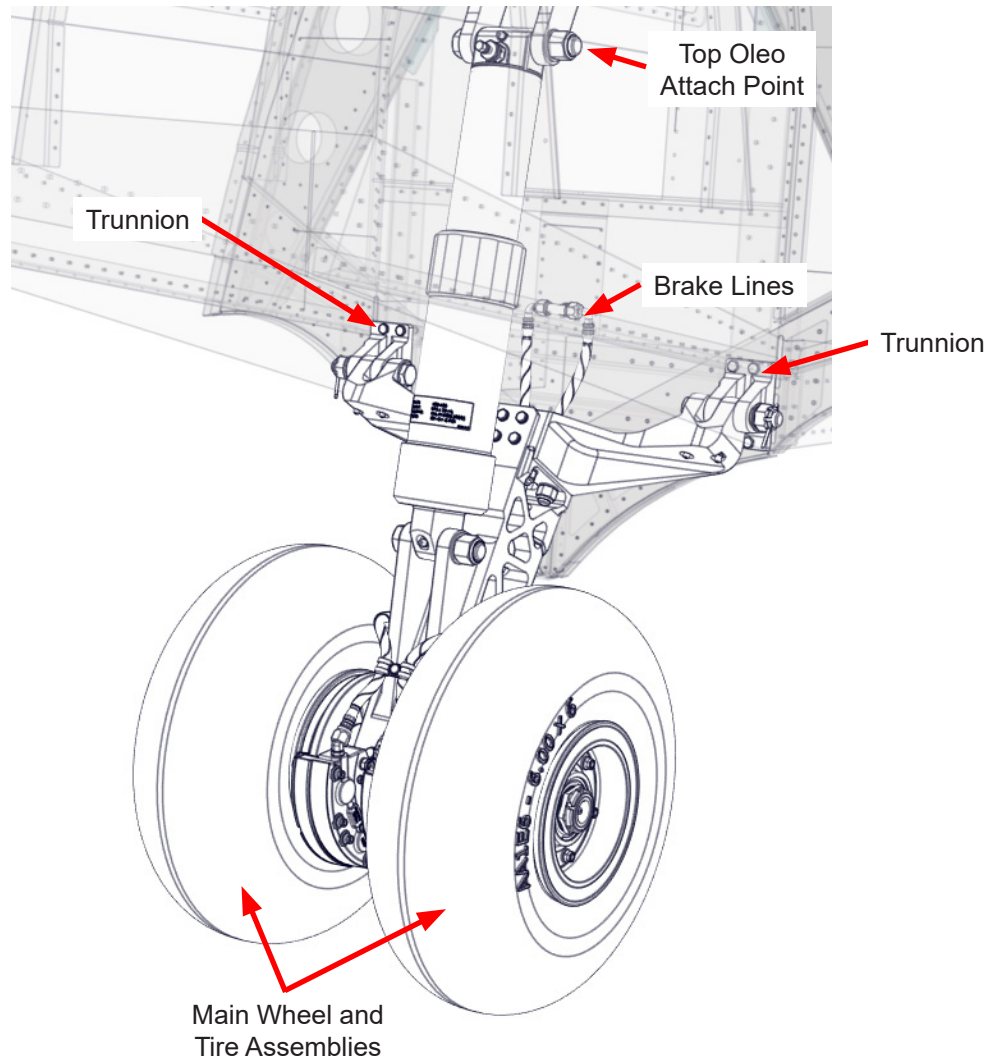
4. Disconnect brake lines at bulkhead 10 and cap each end of hydraulic bulkhead tee fitting and plug each hydraulic brake line.
5. Remove main wheel and tire assemblies.
6. Remove cotter pin, nut, and washer from each AN bolt at each trunnion attach point.
7. Remove cotter pin, nut, washers, and NAS bolt at the top oleo attach point.

8. Remove each AN bolt at the trunnion attach point and remove main gear drag link assembly from float.
9. Using a slow speed drill and a 1 1/8" reamer with a 5/8" guide, ream out the bolt hole using the trunnion as a guide.

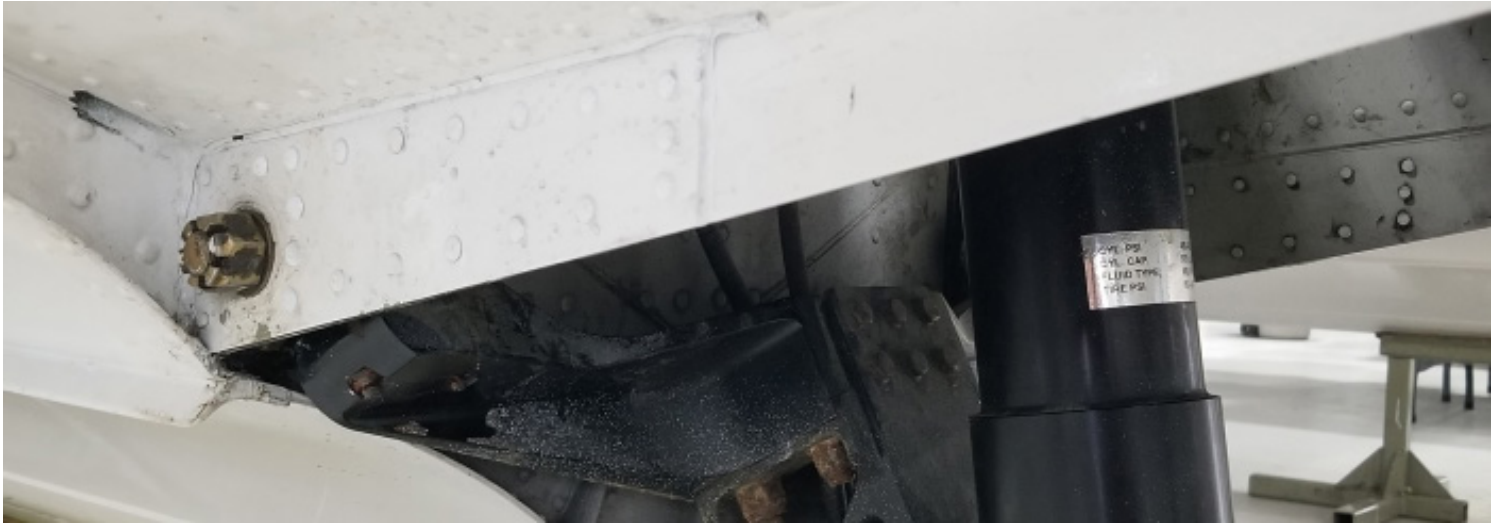
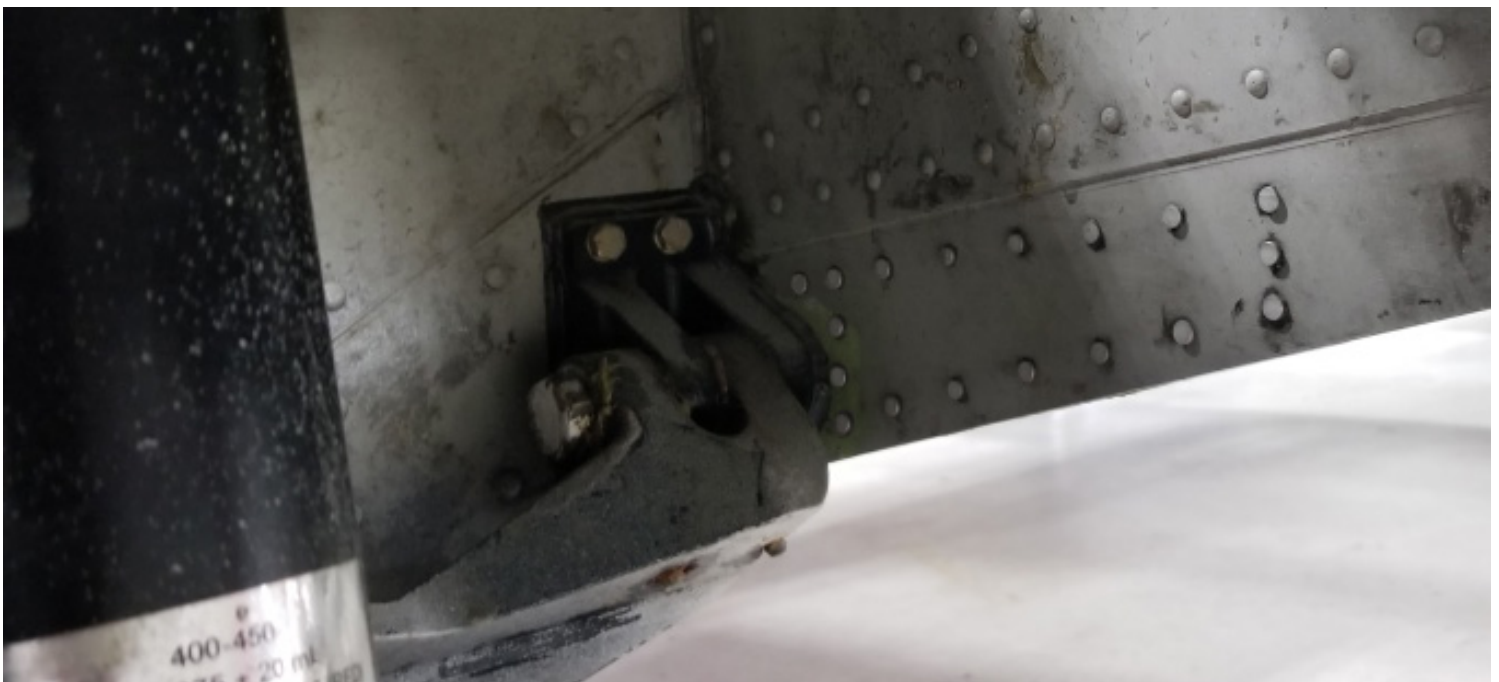
See last page
for completed
installation photos

20. Reinstall each trunnion, sealing any part of the trunnion that contacts the carry through strap, and seal all edges around trunnion with PR 1422-B2 or equivalent.
21. Apply a light coating of grease or equivalent to each trunnion attach point.
22. Install main gear assembly without wheels at each trunnion attach point using (2) AN bolts.
23. Apply a light coating of grease or equivalent to the bolt and pivot points at the oleo attach point.
24. Connect the oleo assembly to the main gear assembly using NAS bolt, washers, nut, and new cotter pin.
25. Install nuts, washers, and new cotter pins on each AN bolt at each trunnion attach point.
