## SERVICE LETTER 189

### 8750 AMPHIBIOUS CARRY THROUGH STRAP DOUBLER INSTALLATION

This service letter applies to Textron Aviation 208 and 208B with Wipline 8750 Amphibious floats installed per STC SA1311GL.

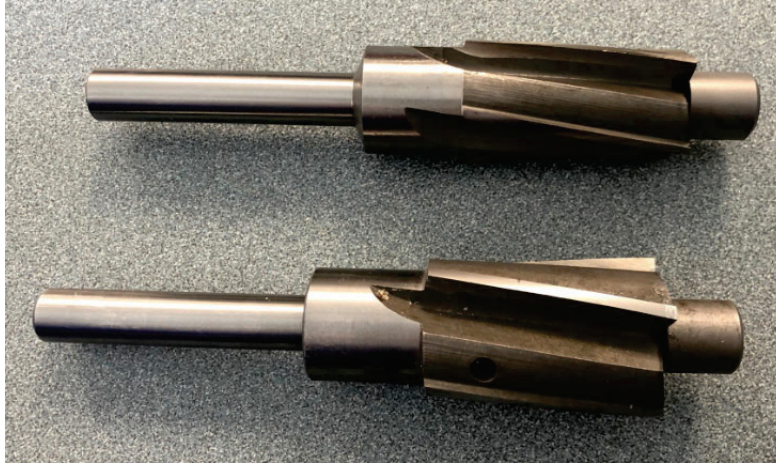
**Example Reamer**

1. Temporarily install each trunnion.
2. Using a slow speed drill and a 1 1/8" or 1 3/8" reamer with a 5/8" guide, ream out the bolt hole using the trunnion as a guide. Contact Wipaire Customer Service regarding tool use.

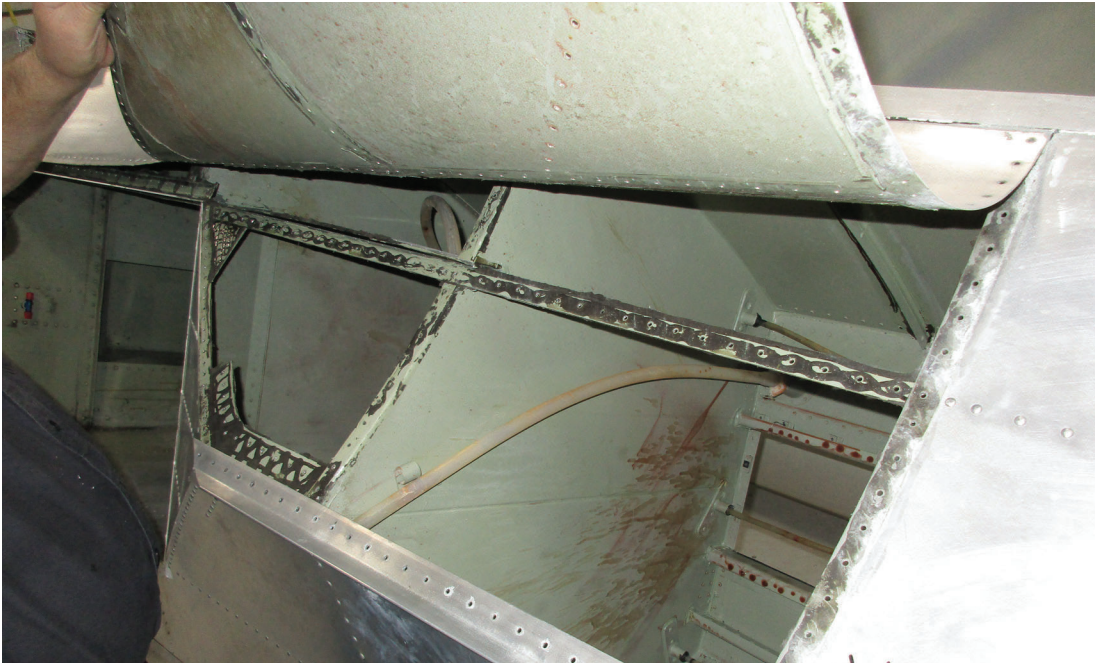
**Figure 6**

1. Support aircraft on stands. Refer to 8750 Service Manual for details.
2. Pull Amphib Pump 1 and Amphib Pump 2 circuit breakers.
3. Pull parking break.
4. Remove baggage floor, foam, bulkhead #9 panel.
5. Disconnect brake lines from bulkhead #10.
6. Remove main landing gear assembly including oleo.
7. Remove wheel well panel.
8. Drill off suction breaker between bulkheads 12-13.
9. Drill and loosen aft keel between bulkheads 11-15.
10. Drill and loosen aft skin from bulkheads 10-13, including inner side keel and next to the carry thru strap. It is not necessary to drill out the flush rivets from the aft chine to remove the carry thru strap (see Figure 6).
