## SERVICE LETTER 197

### 8750 PYLON CRACKING REPAIR

<b>Aircraft Makes/Model(s):</b>	<b>Float Model(s):</b>	<b>Compliance:</b> Optional	<b>By:</b> MAB
208 208B	8750	<b>Part Number:</b> 1011043	<b>Approved:</b> SDW
		<b>Date:</b> 3/25/2020	<b>Revision:</b> B

This service letter applies to Textron Aviation models 208 and 208B with Wipline 8750 Floats installed per STC SA1311GL.

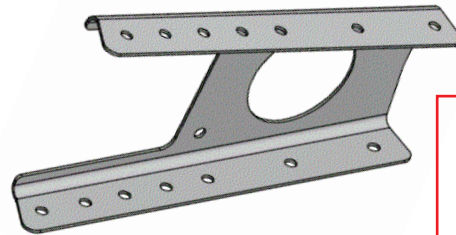
DOUBLER, RIB,  
TOP, PYLON  
(1009906)  
(1009907)

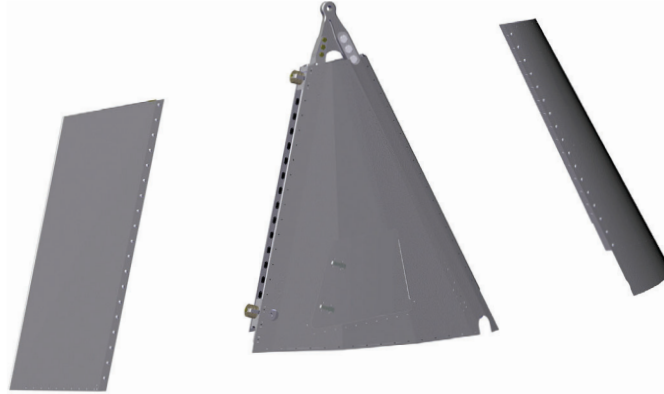
3. Remove gear fairing and belly plate if needed.
4. Remove the leading edge and trailing edge pylon fairing skins.

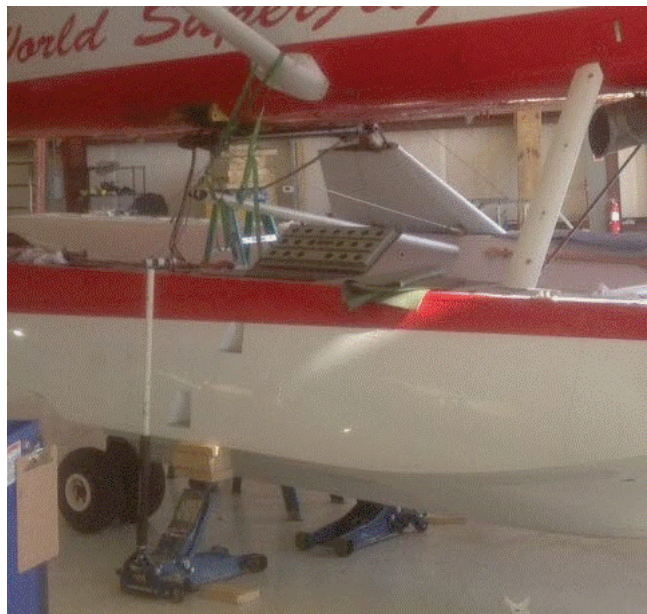
12. Relieve cable tensions for steering, balance, and retract cables as required. Remove the pulley clusters to remove the pylon.
13. Secure the aircraft so it remains level and block the tires on the float. Secure the floats with a stand or jack under float chines on both sides.

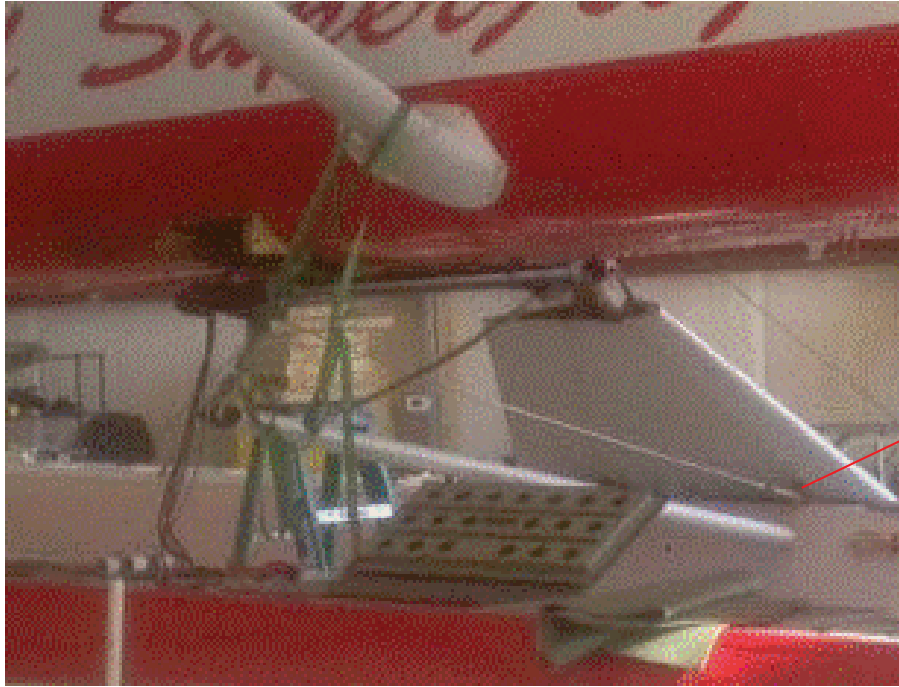
14. Note the tension of the fly wire and length prior to removal. Loosen the aft fly wire so it can be removed by removing the clevis pin at the spreader bar. Support the fly wire.

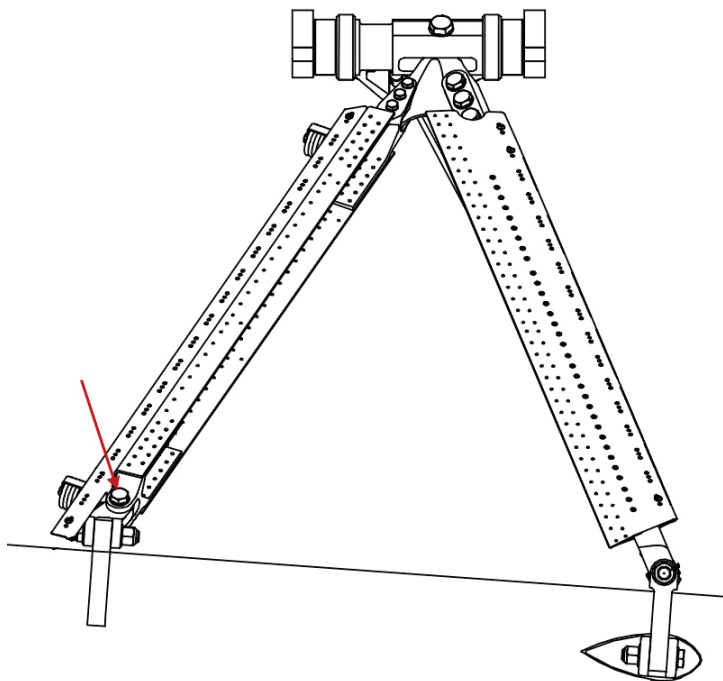
15. Assemble support crew, recommended six crew members.  
16. Remove the two main gear saddles on affected pylon.  
17. Lift aircraft enough to remove pylon.  
18. Remove pylon 10" eye bolt and aft pylon attach bolt.  
19. Remove the aft pylon bolt of the float top deck (see figures next page).

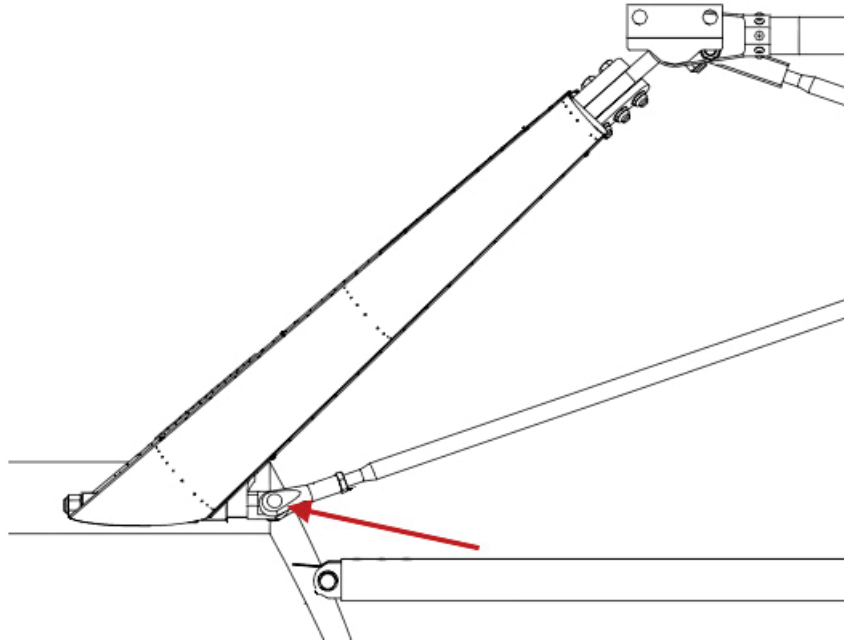
20. Remove the aft bolt that connects the pylon to the main pylon fitting.

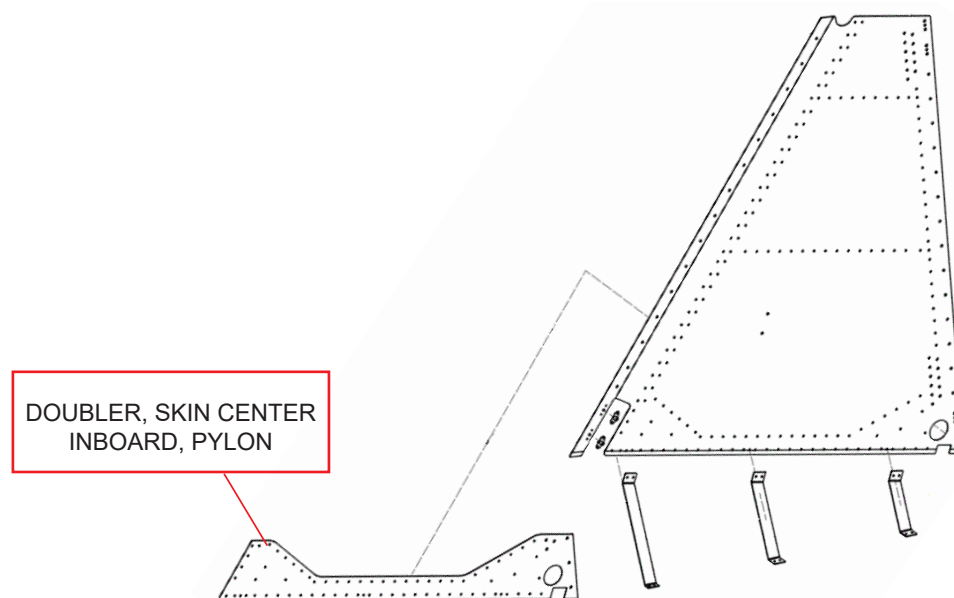
1. Locate the respective doubler on the inboard side of the pylon and transfer holes from the doubler to pylon skin.
2. Remove doubler, clean, and deburr pylon.
3. Wet install doubler with PR-1422 or equivalent and MS20470AD rivets as per original (prep and tape doubler to prevent sealant stain on pylon as desired).

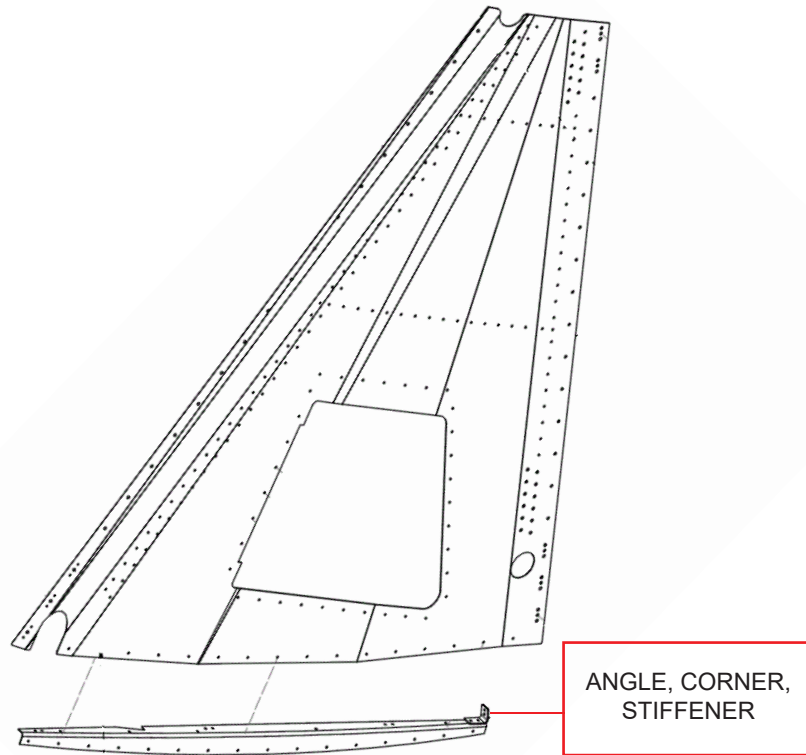
4. Install angle corner stiffener inside of the aft pylon.

**Note:** Pylon must be removed to accomplish this step.

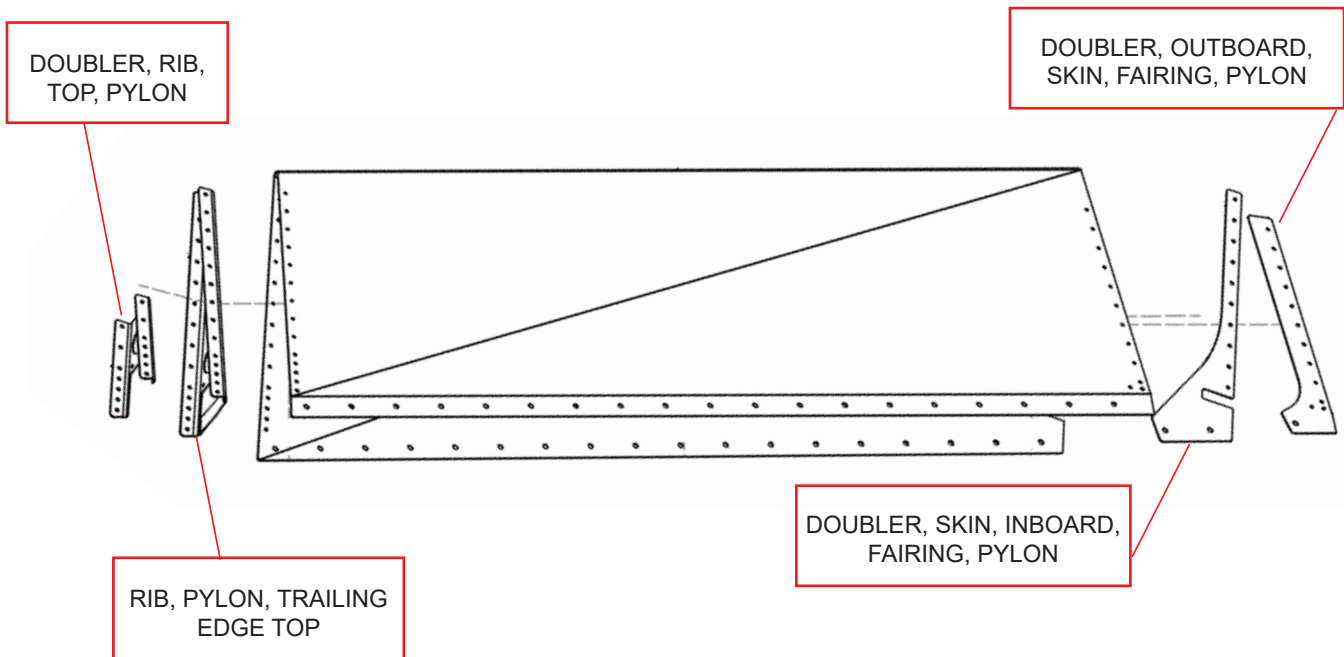
5. With trailing edge skin already removed, drill out existing rivets for the lower rib. Install fairing doublers between fairing skin and rib with MS20470AD as per original.

6. Remove upper rib and discard rib.

7. Install rib and doubler onto the top of pylon trailing edge skin.
