WIPLINE FLOATS • SKIS • MODIFICATIONS • AIRCRAFT SALES
AVIONICS • INTERIOR • MAINTENANCE • PAINT REFINISHING

SERVICE LETTER 212

2100/2350 SERIES BONDED STIFFENER CORROSION

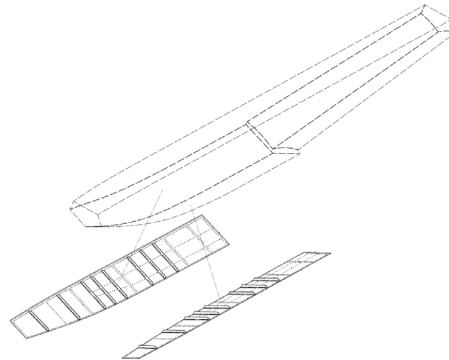
2100 Float Forward Bottom Skins & Stiffeners

2100 Left Hand Forward Bottom Skin

2100 Right Hand Forward Bottom Skin

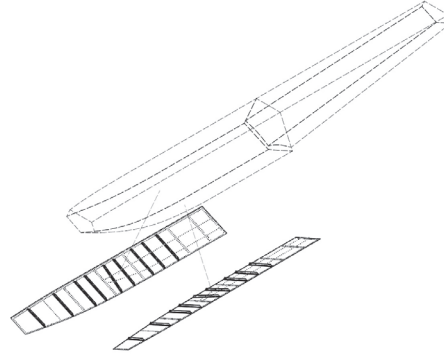
2350 Float Forward Bottom Skins & Stiffeners

2350 Left Hand Forward Bottom Skin

2350 Right Hand Forward Bottom Skin

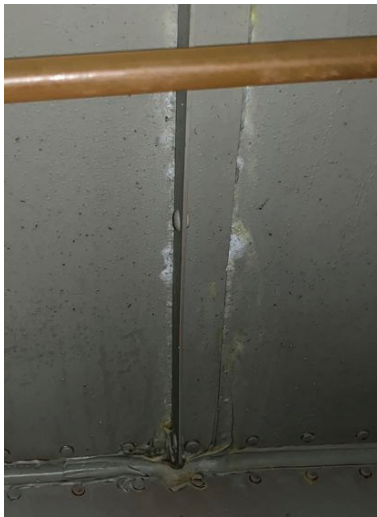
Method B - Corrosion is visible around the stiffener, and the stiffener will need to be removed for further inspection and repaired or corrosion has spread into the skins.

- Perform Work Instruction - Method B below.

Perform if corrosion is visible around the stiffener or if corrosion has spread more than 50% of skin thickness for a total length of more than 20% of the stiffener length through the skins.

1. Each stiffener is attached to the gunwall and chine with 2 to 3 rivets and adhesive. Remove rivets. If stiffener does not come off easily, use a heat gun on skin exterior to soften the adhesive (do not exceed 200°F) and remove each stiffener showing signs of corrosion.
2. Remove any corrosion on bottom skins and clean. Make sure to not remove any more material than necessary.
3. In some cases, there may be a pinhole through the skin, in which case, it is acceptable to backdrill through the pinhole and through the stiffener to 1/8" and install a rivet.
4. Alodine and prime cleaned surface.
5. Fit up replacement stiffener to skin, mark and remove any interfering existing rivets.

6. Backdrill bottom skin to match rivet rows in stiffener.
7. Generously apply PR 1422-B2 or equivalent and attach the stiffeners to the bottom skin.

NOTE: Use enough sealant so that when stiffener is pressed to the bottom skin, excess sealant seeps out along both sides of the entire stiffener. Rivet stiffeners to bottom skins at the top and bottom.

8. Rivet stiffeners to bottom skins.
9. Paint as desired.
