WIPLINE FLOATS | MODIFICATIONS | AIRCRAFT SALES  
AVIONICS | INTERIORS | MAINTENANCE | PAINT

# **STRUCTURAL REPAIR MANUAL FOR WIPLINE ALUMINUM FLOATS**

**Revision H**

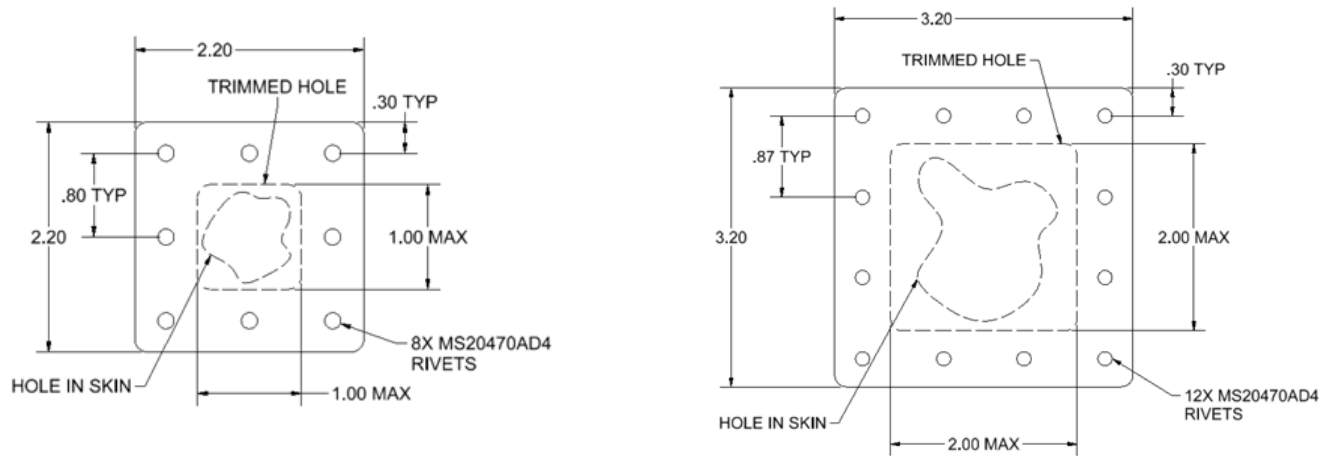
**FIGURE 4.1-1A: SHEET METAL REPAIR**

1. Trim hole as shown by dotted line
2. Patch to be same material with equal or greater thickness than original skin (See Table 4-1)
3. Prime all bare surfaces
4. Seal between patch and skin
5. Rivet in place

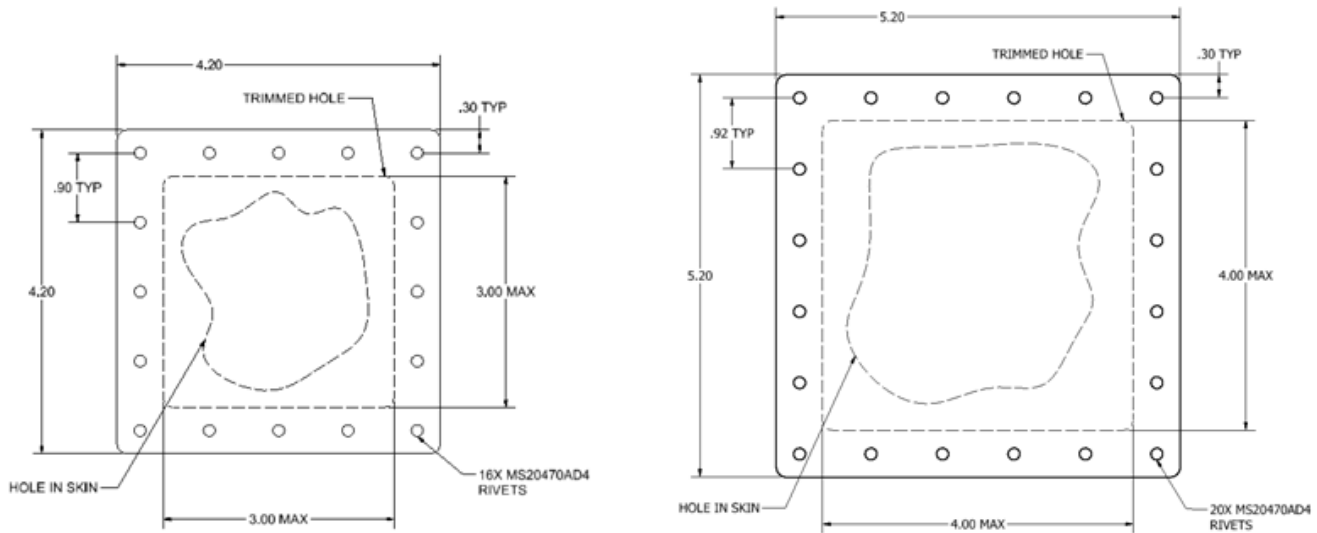
**FIGURE 4.1-1B: SHEET METAL REPAIR**

1. Trim hole as shown by dotted line
2. Patch to be same material with equal or greater thickness than original skin (See Table 4-1)
3. Prime all bare surfaces
4. Seal between patch and skin
5. Rivet in place

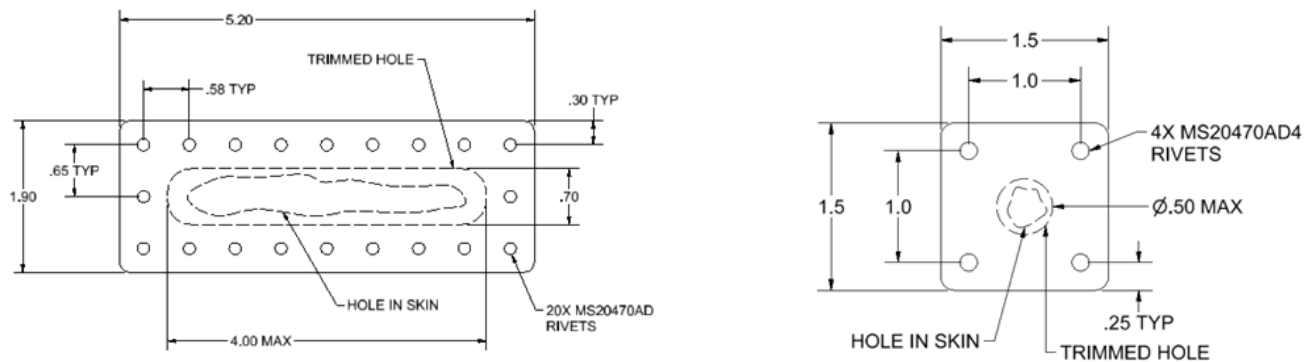
**FIGURE 4.1-1C: SHEET METAL REPAIR**

1. Trim hole as shown by dotted line
2. Patch to be same material with equal or greater thickness than original skin (See Table 4.1)
3. Prime all bare surfaces
4. Seal between patch and skin
5. Rivet in place

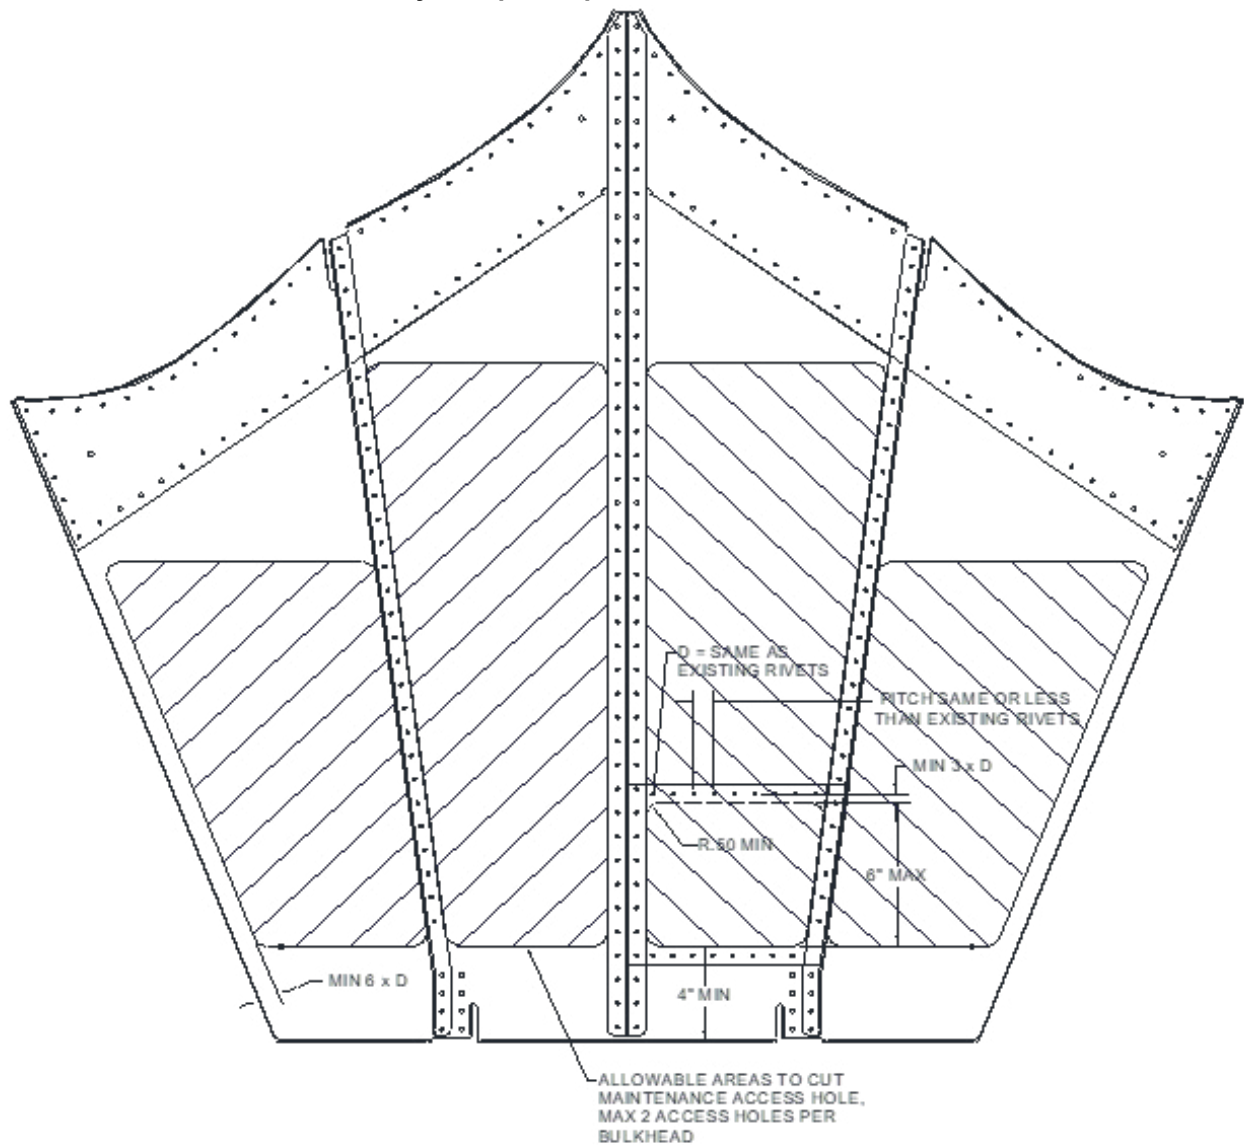
**FIGURE 4-2: BULKHEAD ACCESS HOLE REPAIR**

1. ACCESS HOLES MAY BE CUT FOR THE PURPOSE OF MAINTENANCE
2. MAX 2 ACCESS HOLES PER BULKHEAD
3. RIVET PATCH OVER ACCESS HOLE ONCE MAINTENANCE IS COMPLETE
4. PATCH MUST BE OF THE SAME, OR STRONGER ALLOY (6061-T6 OR 2024-T3), WITH THE SAME THICKNESS AS THE ORIGINAL PANEL, OR ONE GAGE THICKNESS GREATER
5. USE SOLID RIVETS OF SAME DIAMETER AS EXISTING RIVETS, OR 1 SIZE LARGER; ALTERNATELY USE CHERRY MAX (OR EQUIVALENT) FASTENER OF SAME DIAMETER, OR 1 SIZE LARGER

During extensive float maintenance of 10000 and 13000 floats, it may be desirable to cut an access hole in a solid bulkhead to enable replacement of neighboring float structure. This type of access hole can be cut and then repaired according to Figure 4-2.

**Note that this is only acceptable practice on the 10000 and 13000 floats.**

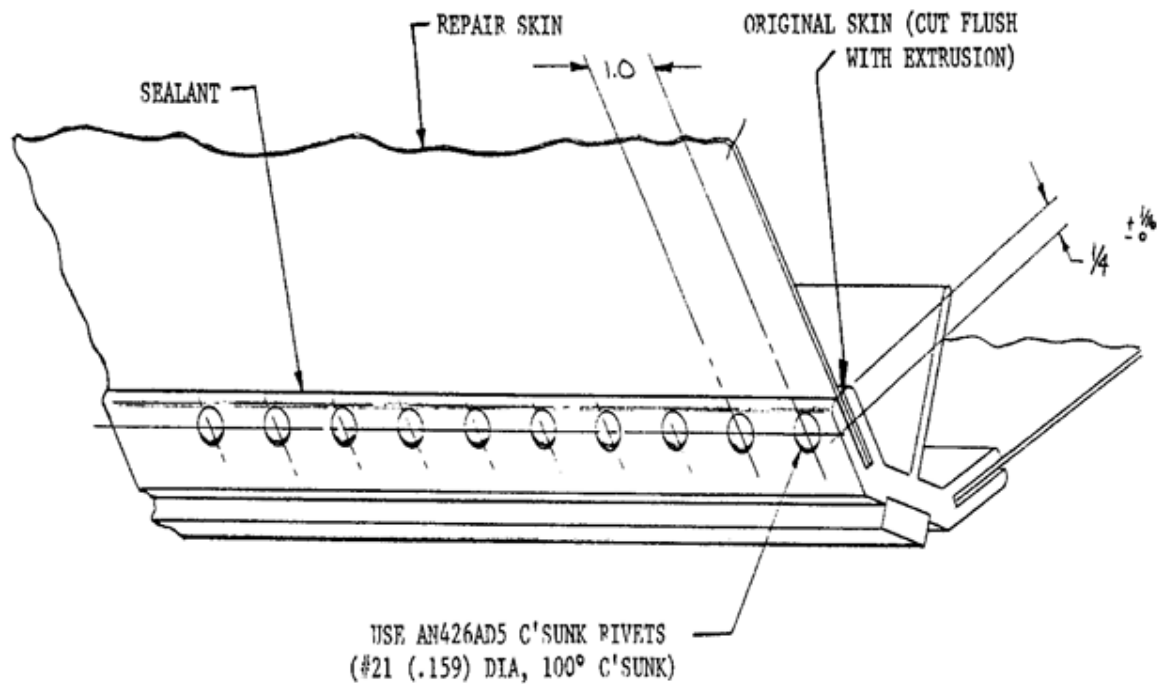
**FIGURE 4.4-1A: MODEL 3730/3900/4000/6000/6100/8000 TYPICAL REPAIR BOTTOM SKIN TO KEEL INSTRUCTIONS**

**(PREFERRED METHOD)**

1. REMOVE ORIGINAL DAMAGED SKIN CUT FLUSH WITH EXTRUSION.
2. REMOVE CAULKING FROM GROOVE OF EXTRUSION.
3. APPLY SEALANT IN GROOVE. (BE SURE TO USE PLENTY OF SEALANT!)
4. INSERT REPAIR SKIN INTO EXTRUSION.
5. DRILL AND COUNTERSINK HOLES AND RIVET INTO PLACE.

Skins may be reattached to extrusions by methods shown in Figures 4-4A, 4-4B, 4-4C. If the skin bond must be broken from an extrusion for a long distance the caulking material must first be removed from the exterior crack. Then heat the extrusion with a propane torch until the bond starts to loosen. Caution must be taken not to heat and loosen bonds not needing replacement.

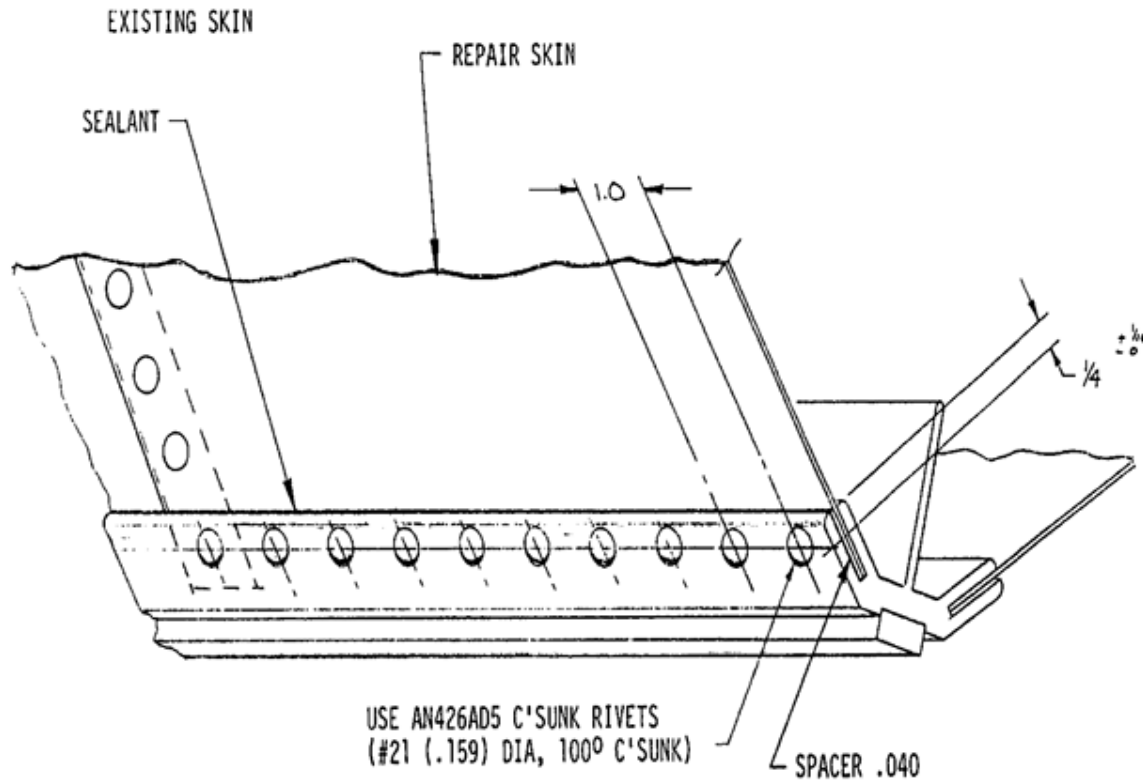
**FIGURE 4.4-1B: MODEL 3730/3900/4000/6000/6100/8000 TYPICAL REPAIR BOTTOM SKIN TO KEEL INSTRUCTIONS**

1. REMOVE ORIGINAL DAMAGED SKIN FROM EXTRUSION.
2. REMOVE CAULKING FROM GROOVE OF EXTRUSION.
3. APPLY SEALANT IN GROOVE. (BE SURE TO USE PLENTY OF SEALANT!)
4. INSERT REPAIR SKIN INTO EXTRUSION.
5. INSTALL SPACER BETWEEN REPAIR SKIN AND EXTRUSION.
6. DRILL AND COUNTERSINK HOLES AND RIVET INTO PLACE.

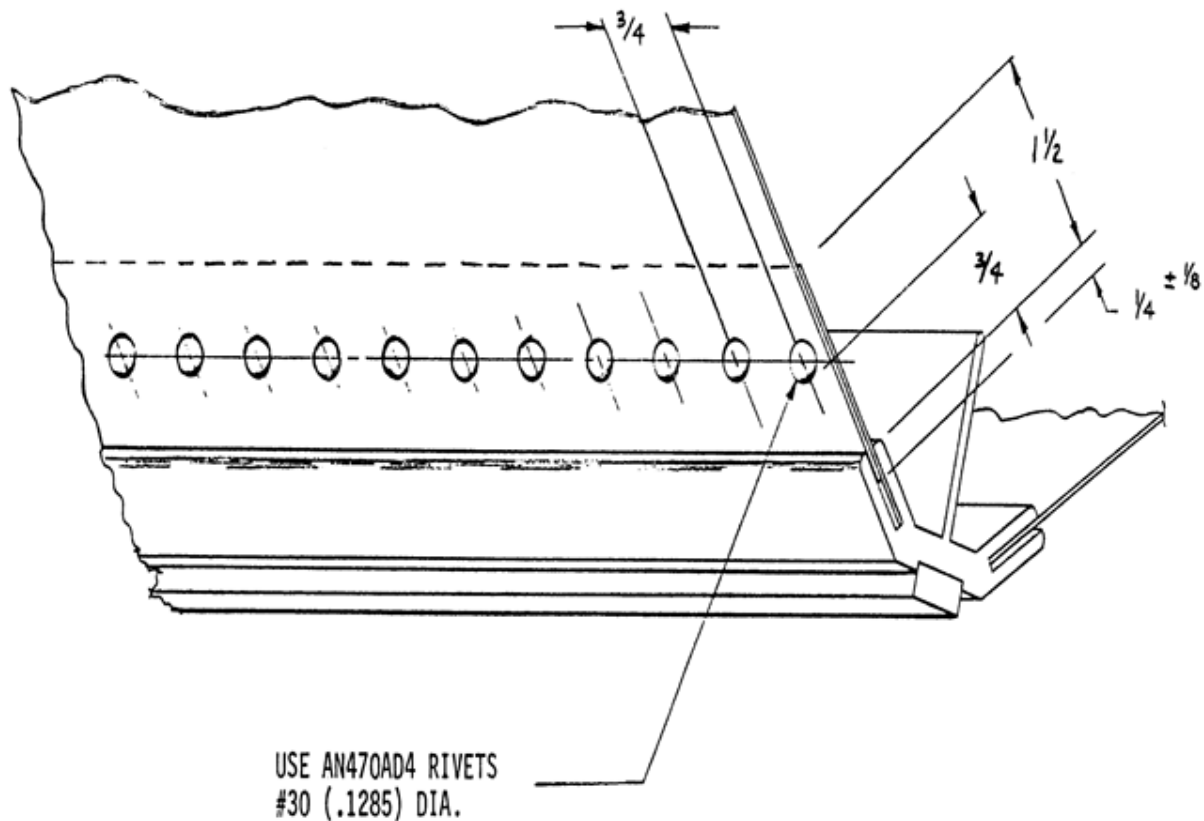
**FIGURE 4.4-1C: MODEL 3730/3900/4000/6000/6100/8000 TYPICAL REPAIR BOTTOM SKIN TO KEEL (ALT) INSTRUCTIONS (ALTERNATE METHOD)**

1. REMOVE ORIGINAL DAMAGED SKIN LEAVING APPROXIMATELY 1 1/2" OF SKIN PROTRUDING FROM EXTRUSION.
2. REMOVE CAULKING FROM GROOVE IN EXTRUSION.
3. INSTALL SEALANT IN GROOVE. (BE SURE TO USE PLENTY OF SEALANT!)
4. INSERT REPAIR SKIN IN GROOVE APPROXIMATELY 1/4".
5. LAYOUT HOLE PATTERN, DRILL, DE-CHIP, SEAL AND RIVET.

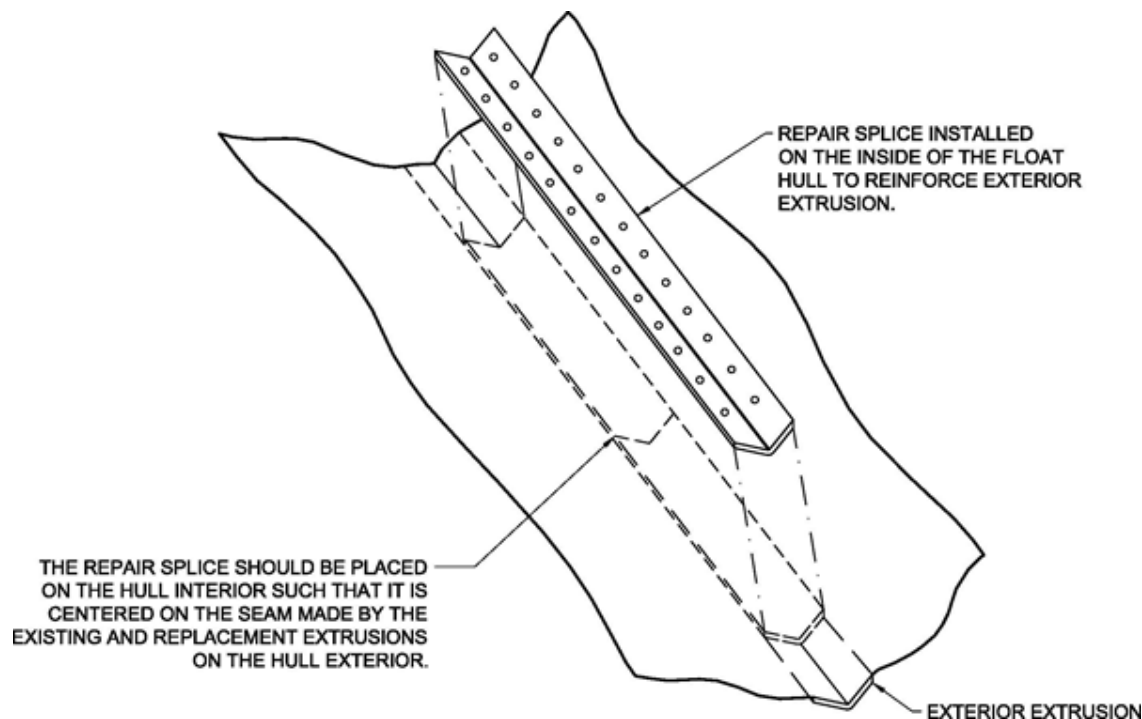
**FIGURE 5.1-1: SIMPLE EXTRUSION SPLICE REPAIR**

8. Use existing piece to back drill holes for attachment making sure the distance from the end of the splice to the center of the first hole is greater than or equal to 2 times the diameter of the rivet used.

The most used and simplest repair is a splice of an extrusion that is a simple one bend angle where the skins attach to each flange. Figure 5.1-1 depicts the general method of this splice repair. The replacement extrusion can be purchased from Wipaire, or in some cases, fabricated per the figures in this section. The internal splices may either be purchased from Wipaire or fabricated per the figures in this section. Consult the Table of Contents at the beginning of this manual to locate applicable figures for your repair.

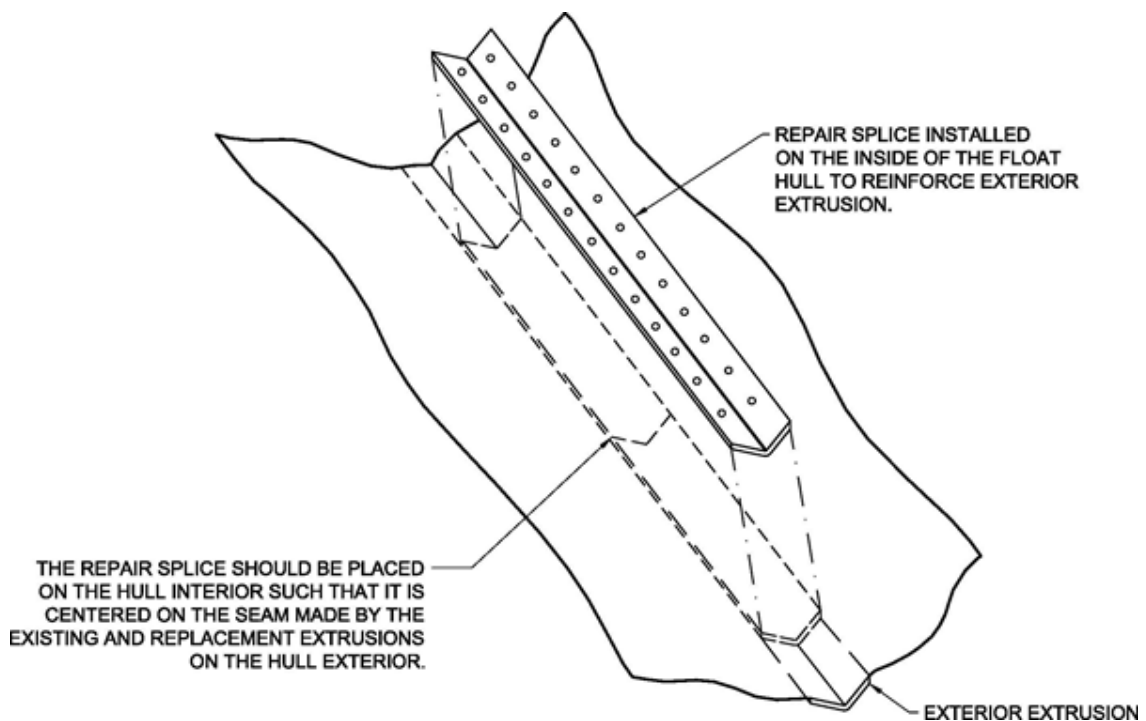
**FIGURE 5.2-1: SIMPLE EXTRUSION SPLICE REPAIR**

8. Use existing piece to back drill holes for attachment making sure the distance from the end of the splice to the center of the first hole is greater than or equal to 2 times the diameter of the rivet used.

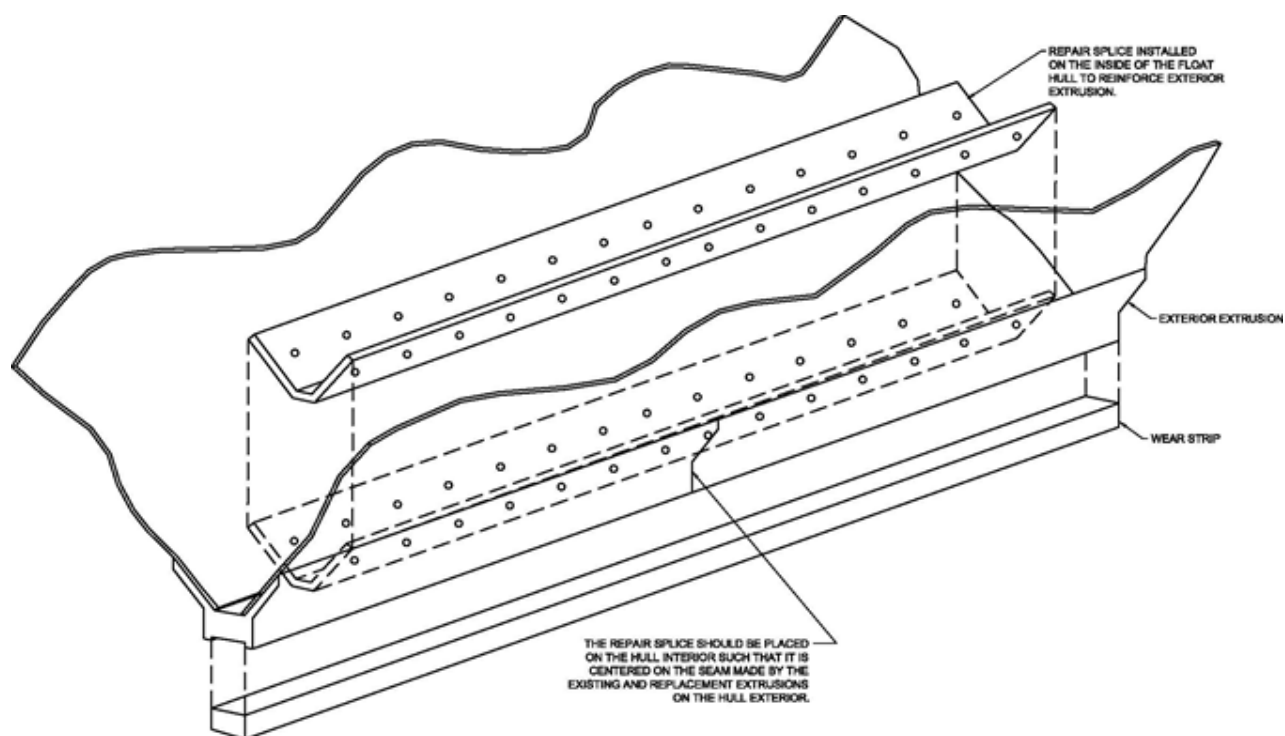
**FIGURE 5.2-6: MAIN KEEL SIMPLE EXTRUSION SPLICE REPAIR**

- f. Secure strip to keel with AN507C832-8 screws, AN960-8 washers, and AN365-832 nuts.

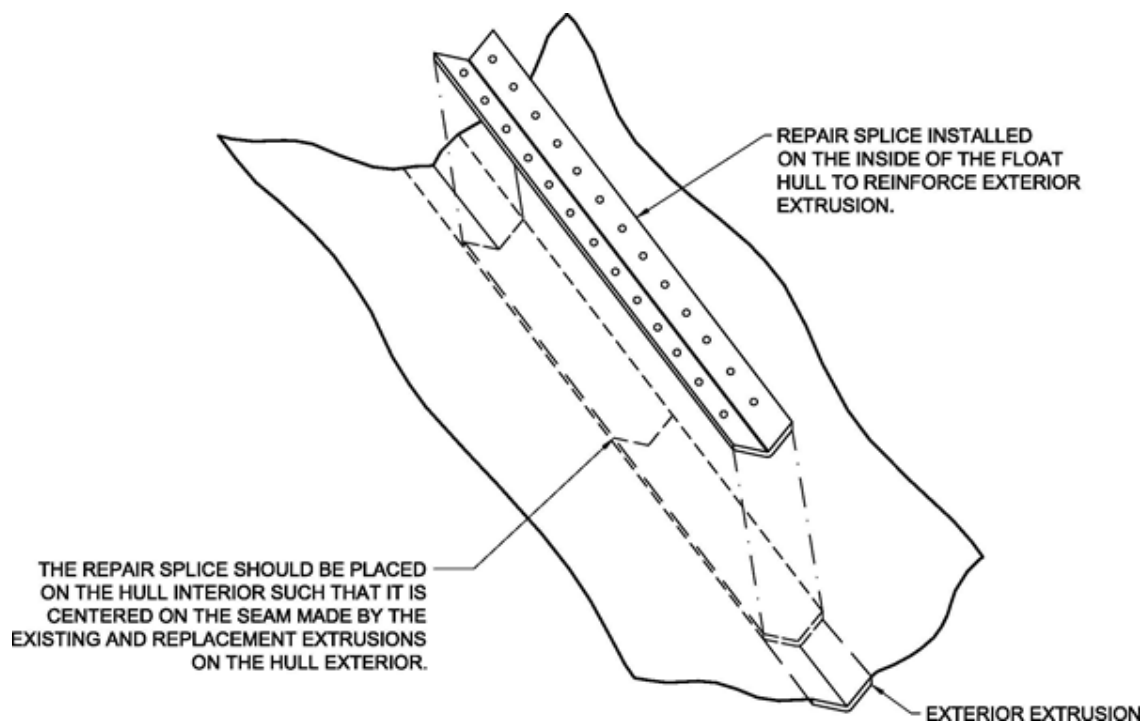
**FIGURE 5.3-1: SIMPLE EXTRUSION SPLICE REPAIR**

5. File to remove rough edges.
6. See Section 3.0 of this manual for appropriate fastener options.
7. Add internal splices, making sure the repair seam is located in the middle of the splice, and that the splice is centered between the bulkheads. Use existing piece to back drill holes for attachment making sure the distance from the end of the splice to the center of the first hole is greater than or equal to 2 times the diameter of the rivet used.

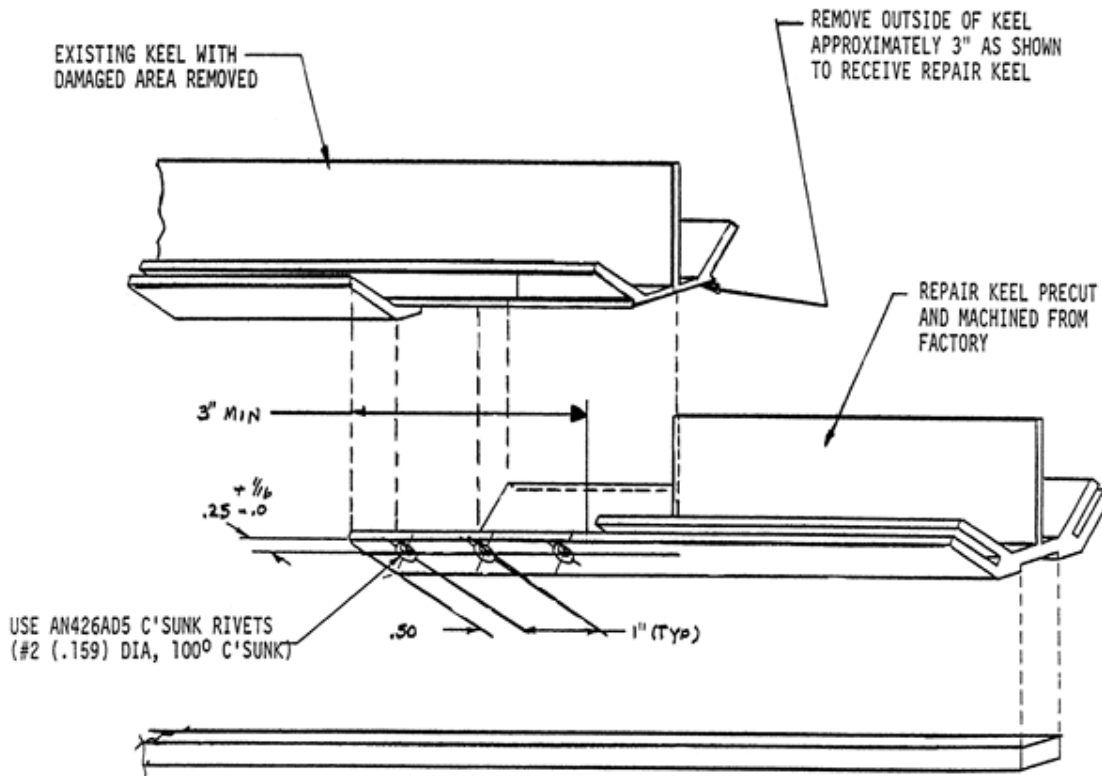
**FIGURE 5.3-3: COMPLEX EXTRUSION SPLICE REPAIR**

- f. Secure strip to keel with AN507C832-8 screws, AN960-8 washers, and AN365-832 nuts.

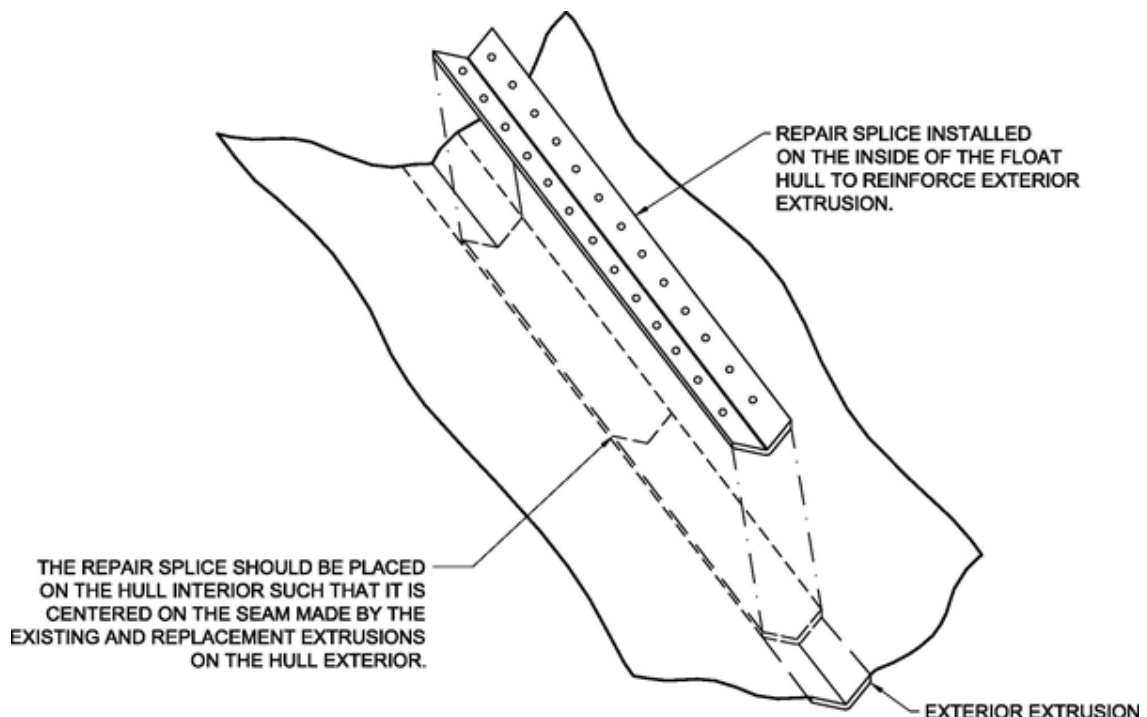
**FIGURE 5.4-1: SIMPLE EXTRUSION SPLICE REPAIR**

8. Use existing piece to back drill holes for attachment making sure the distance from the end of the splice to the center of the first hole is greater than or equal to 2 times the diameter of the rivet used.

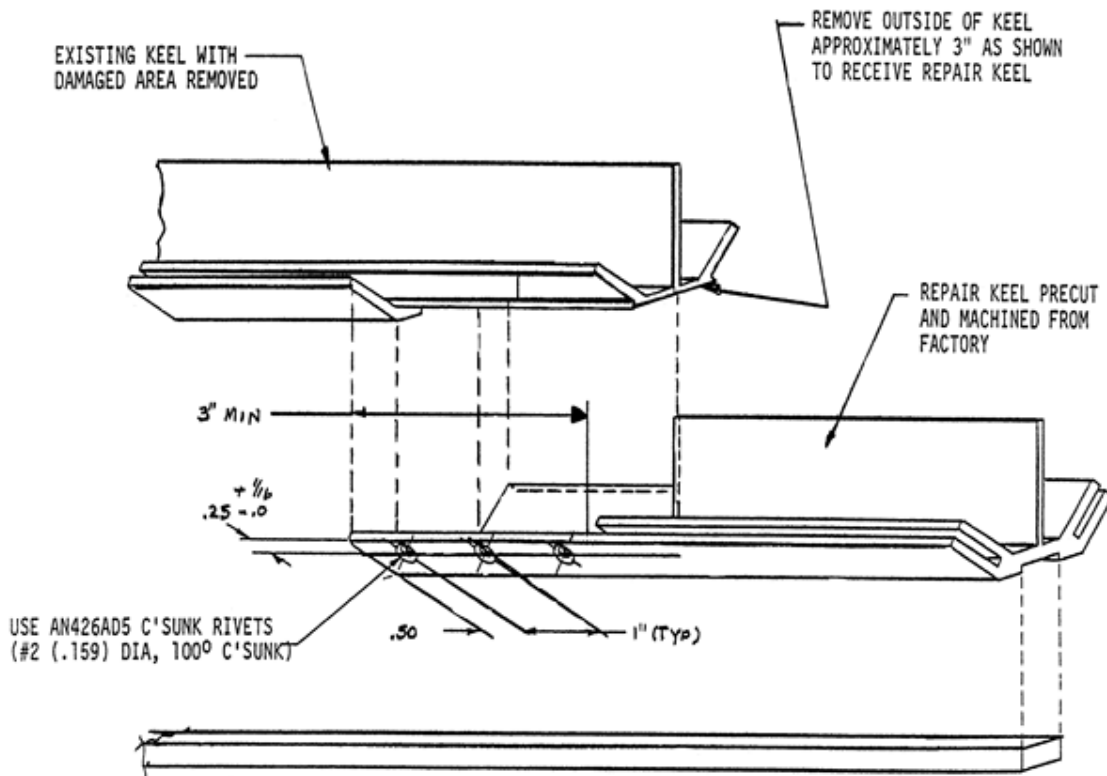
**FIGURE 5.4-3: COMPLEX EXTRUSION SPLICE REPAIR**

- f. Secure strip to keel with AN507C832-8 screws, AN960-8 washers, and AN365-832 nuts.

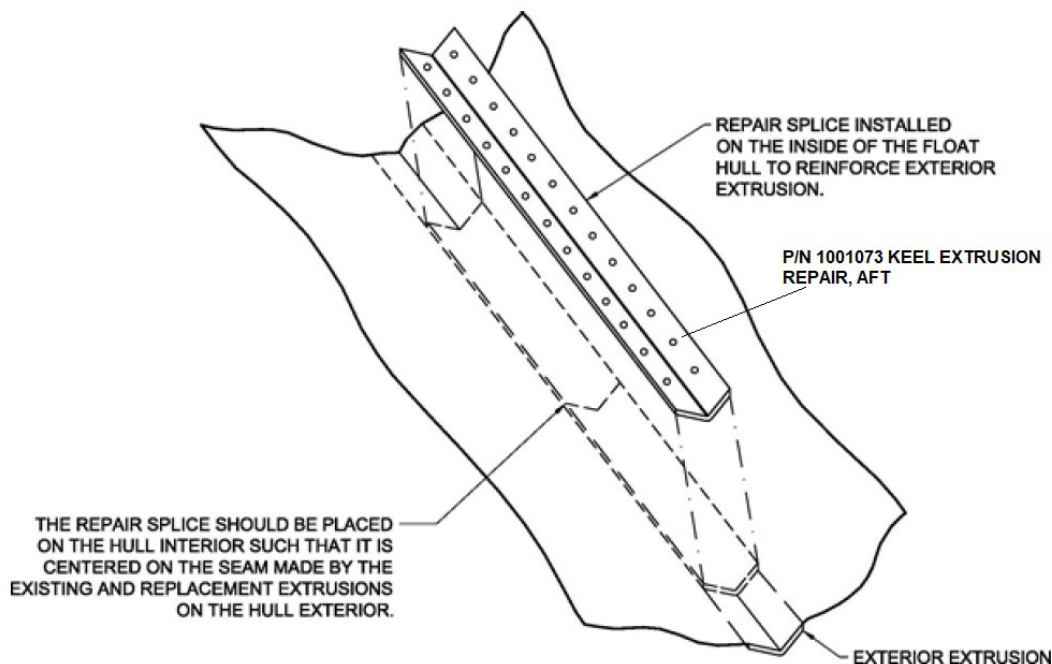
**FIGURE 5.5-1: SIMPLE EXTRUSION SPLICE REPAIR**

5. File to remove rough edges.
6. See Section 3.0 of this manual for appropriate fastener options.
7. Add internal splices (1001073), making sure the repair seam is located in the middle of the splice, and that the splice is centered between the bulkheads. Use existing piece to back drill holes for attachment making sure the distance from the end of the splice to the center of the first hole is greater than or equal to 2 times the diameter of the rivet used.

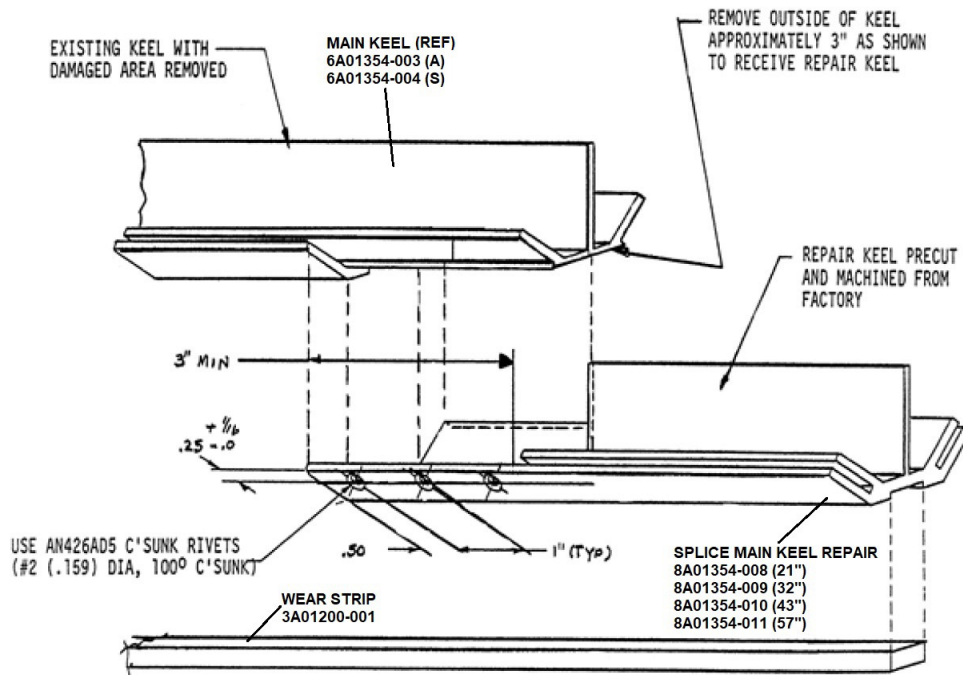
**FIGURE 5.5-3: COMPLEX EXTRUSION SPLICE REPAIR**

- f. Secure strip to keel with AN507C832-8 screws, AN960-8 washers, and AN365-832 nuts.

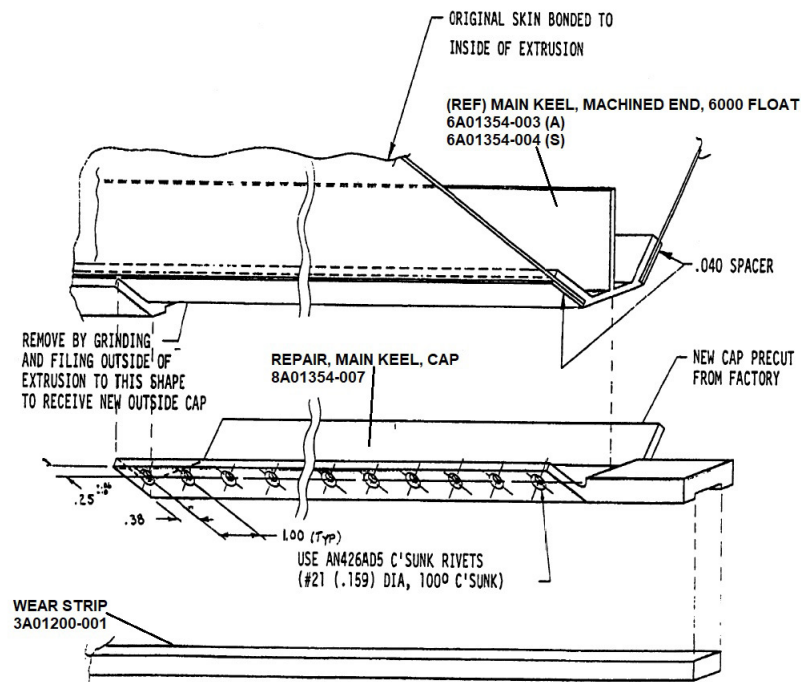
**FIGURE 5.5-4: TYPICAL CAP SPLICE TO KEEL**

1. Lay out new repair cap on damaged extrusion.
2. Remove outside of damaged extrusion by filing or grinding to inside shape of repair cap.
3. Match drill or lay out and drill hole pattern as shown.
4. Rivet outside cap and spacer to existing inside extrusion.
5. Apply keel wear strip with any good 2-part epoxy.

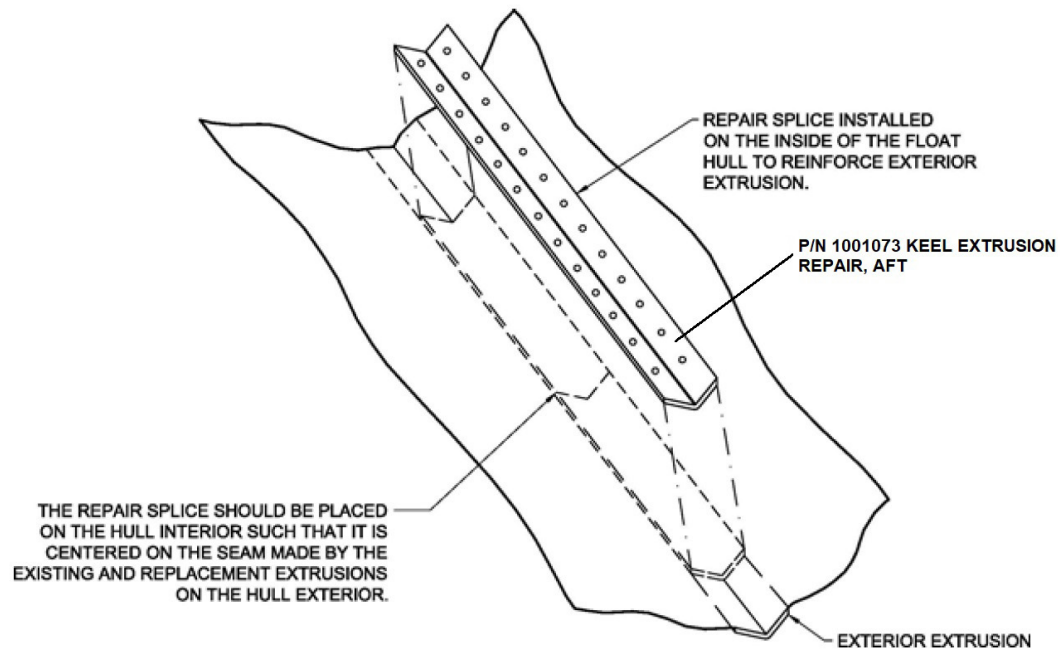
**FIGURE 5.7-1: SIMPLE EXTRUSION SPLICE REPAIR**

5. File to remove rough edges.
6. See Section 3.0 of this manual for appropriate fastener options.
7. Add internal splices (1001073), making sure the repair seam is located in the middle of the splice, and that the splice is centered between the bulkheads. Use existing piece to back drill holes for attachment making sure the distance from the end of the splice to the center of the first hole is greater than or equal to 2 times the diameter of the rivet used.

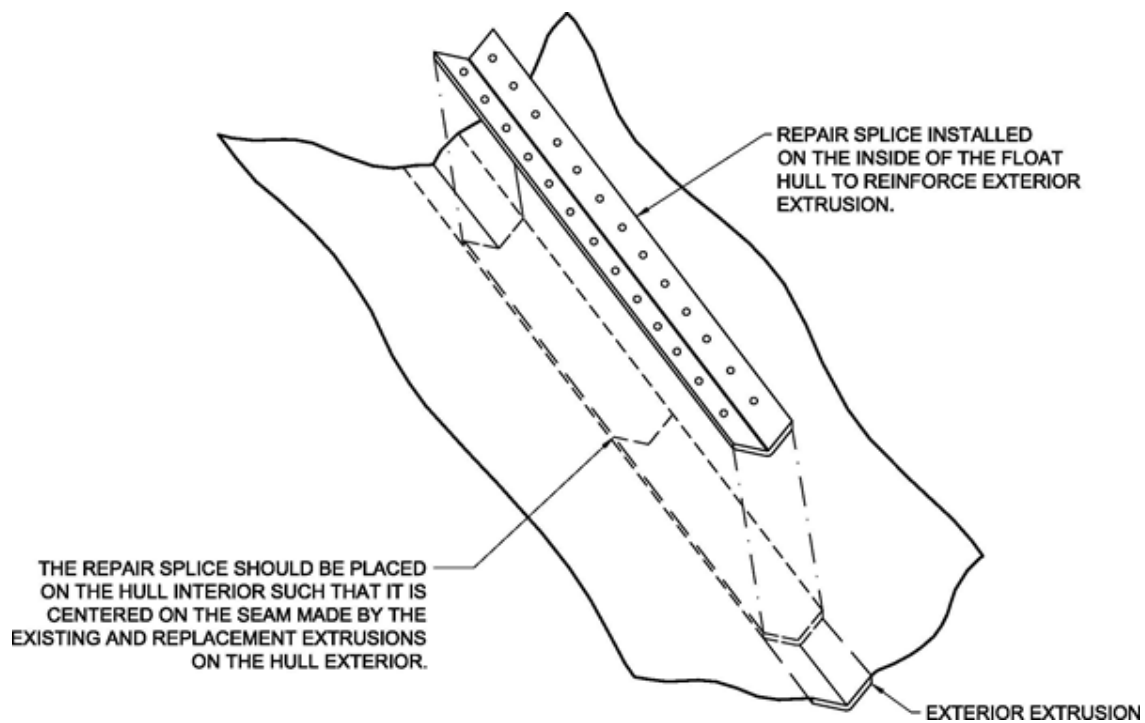
**FIGURE 5.9-1: SIMPLE EXTRUSION SPLICE REPAIR**

8. Use existing piece to back drill holes for attachment making sure the distance from the end of the splice to the center of the first hole is greater than or equal to 2 times the diameter of the rivet used.

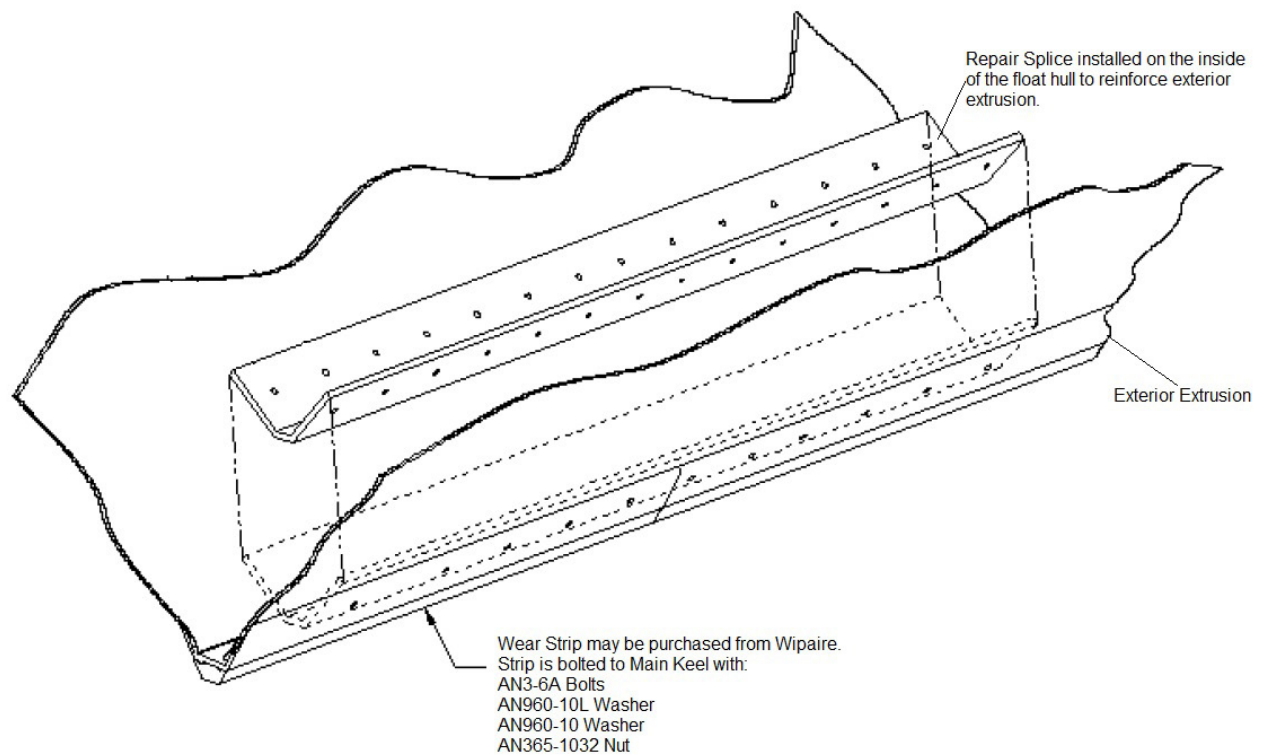
**FIGURE 5.9-6: MAIN KEEL SIMPLE EXTRUSION SPLICE REPAIR**

- f. Secure strip to keel with AN507C832-8 screws, AN960-8 washers, and AN365-832 nuts.

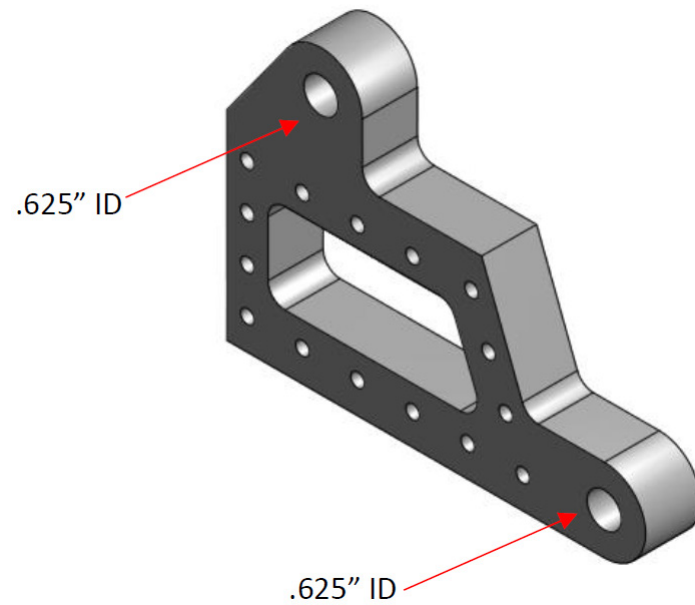
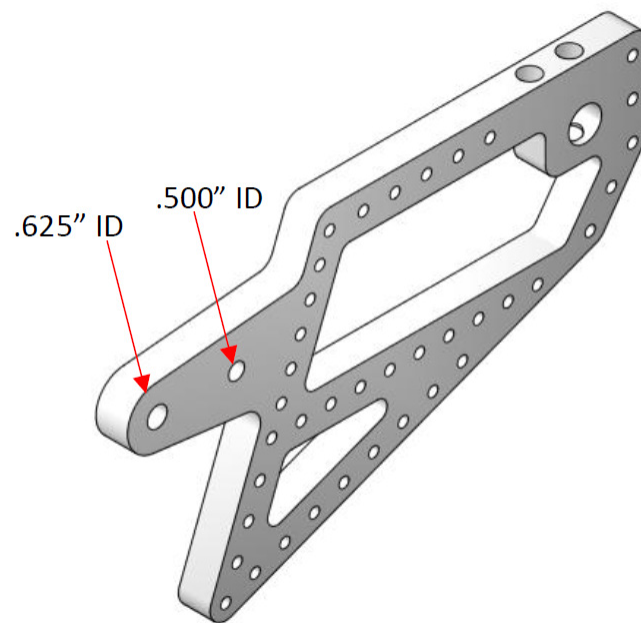
**FIGURE 5.9-8: 10000 Front Strut Fitting 13A01082-001**

9. The bushing should be flush or recessed so that it does not interfere with the strut fitting upon assembly.
10. After installing the bushing, prime the area and apply a corrosion inhibiting compound prior to strut installation.

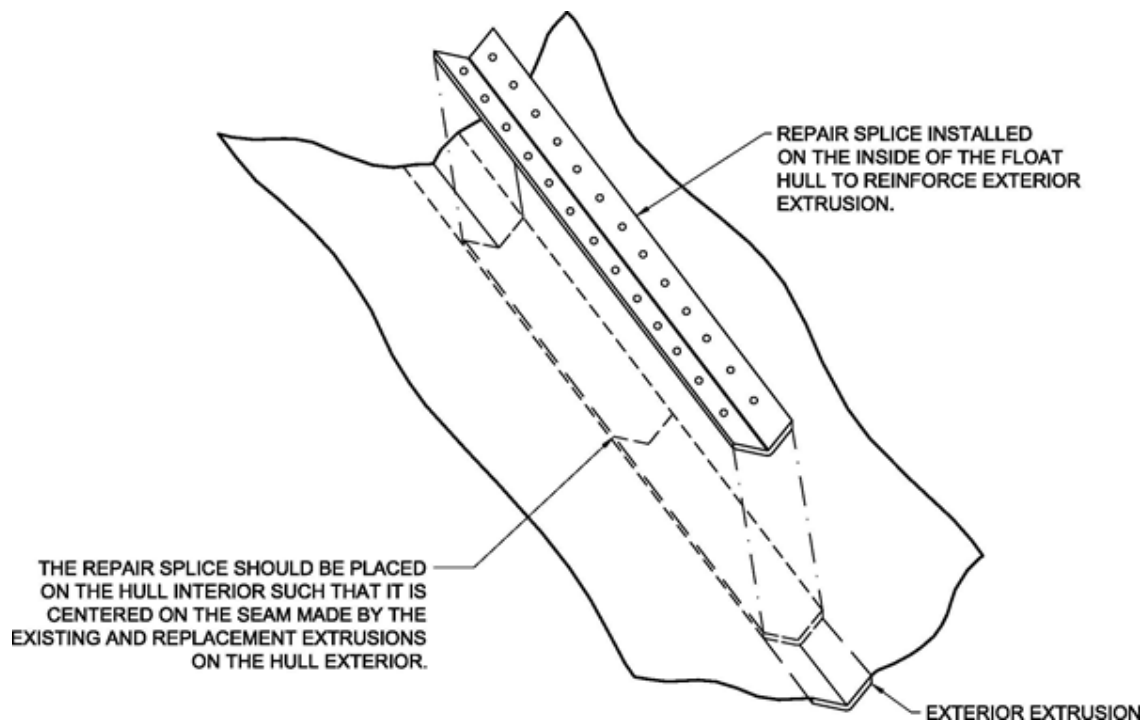
**FIGURE 5.10-1: SIMPLE EXTRUSION SPLICE REPAIR**

8. Use existing piece to back drill holes for attachment making sure the distance from the end of the splice to the center of the first hole is greater than or equal to 2 times the diameter of the rivet used.

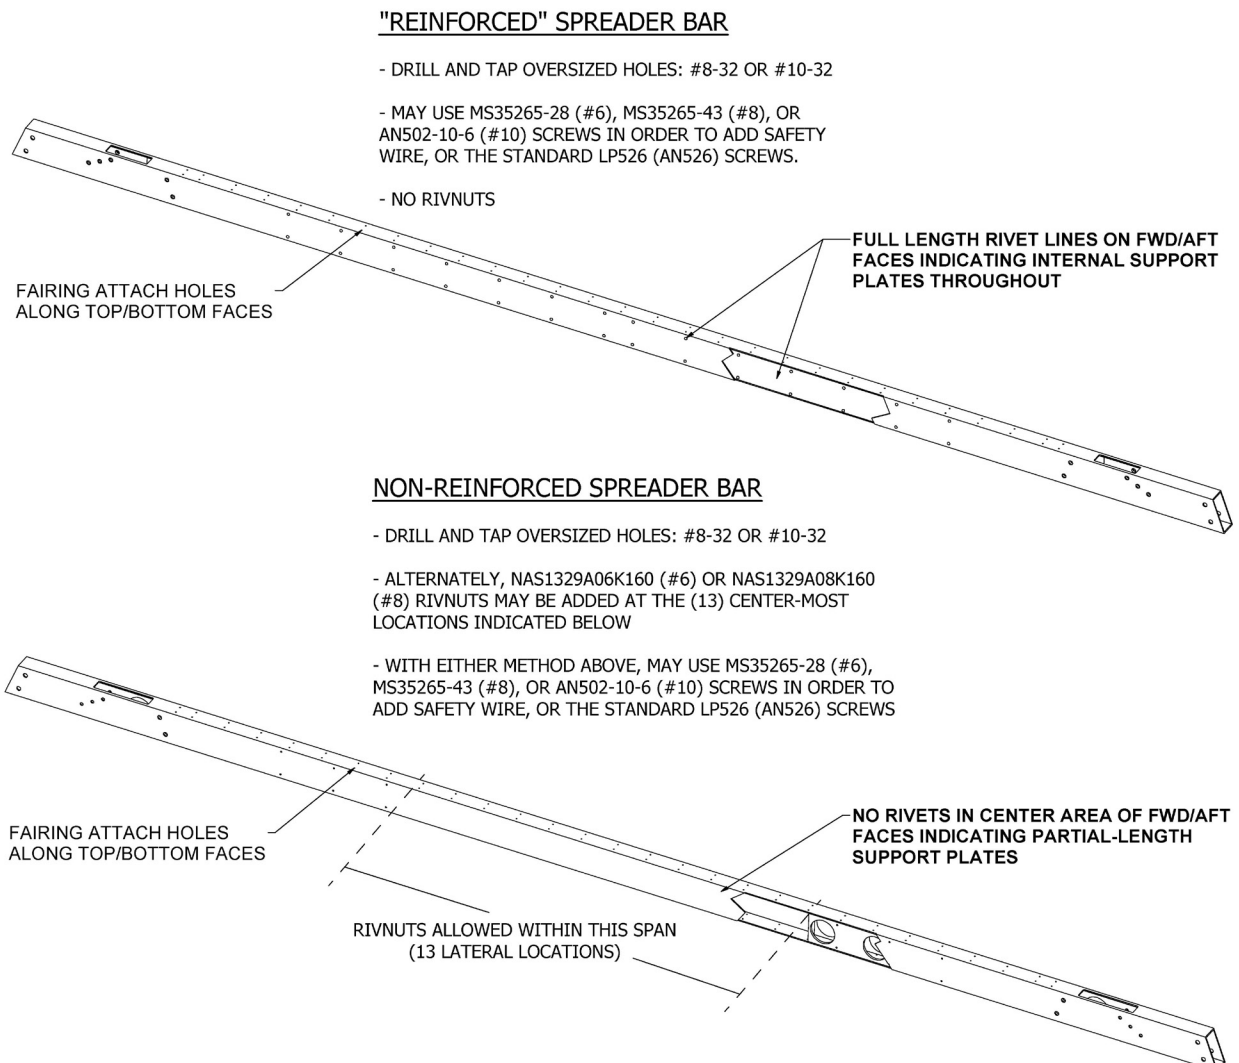
**FIGURE 7.1: 8000 SPREADER BAR THREADED FAIRING HOLE REPAIR**

**Note:** A "reinforced" spreader bar to aid ground operations was optionally added to seaplane floats via Service Letter 58, and later became standard. The geometry of this version will not accommodate blind rivet nuts. Figure 7.1 provides representational images to help identify the two varieties.

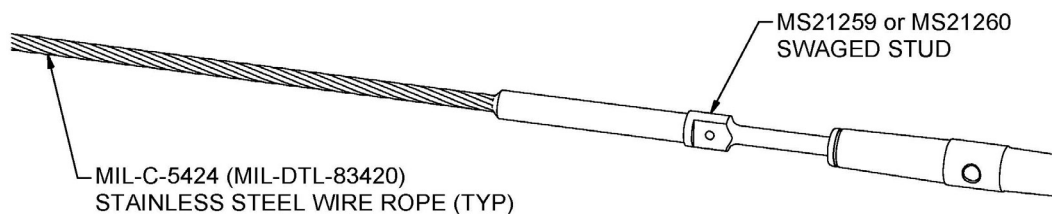
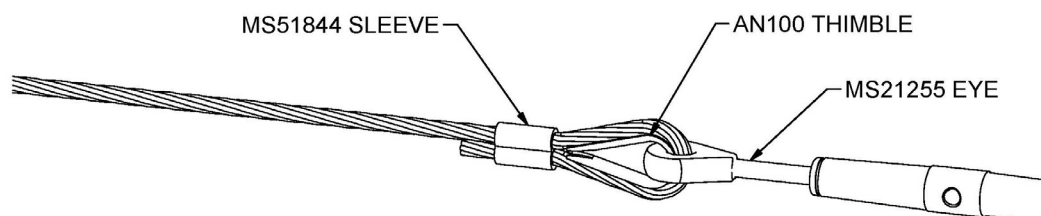
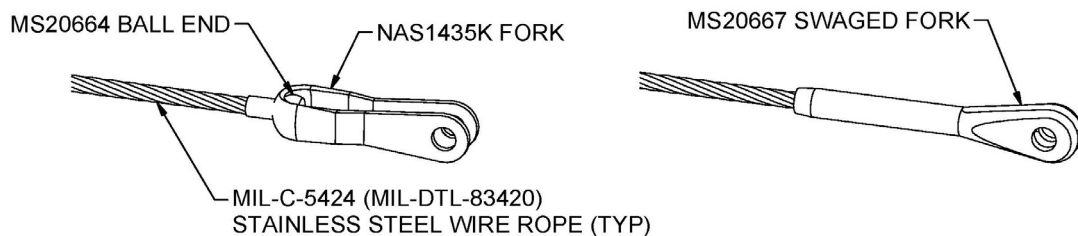
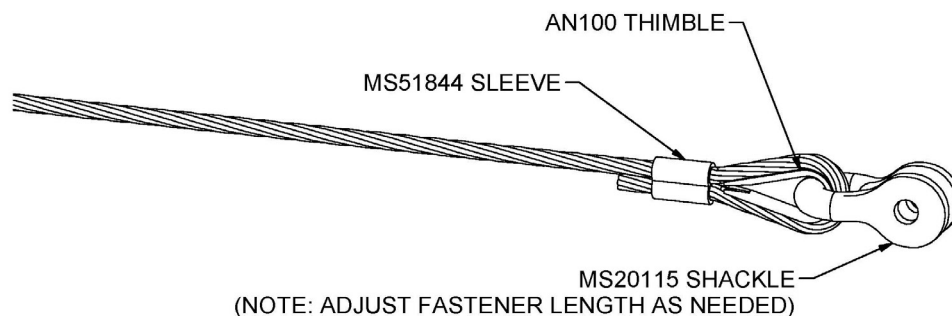
**FIGURE 7.2: STEERING AND RETRACT CABLE - ALTERNATE REPAIR COMPONENTS**

ORIGINAL: SWAGED STUD TO TURNBUCKLE BARREL

REPAIR OPTION: EYE SPLICE TO TURNBUCKLE BARREL

ORIGINAL: BALL END AND FORK -OR- SWAGED FORK

REPAIR OPTION: EYE SPLICE TO SHACKLE
