WIPLINE FLOATS | MODIFICATIONS | AIRCRAFT SALES
AVIONICS | INTERIORS | MAINTENANCE | PAINT

STRUCTURAL REPAIR MANUAL FOR WIPLINE ALUMINUM FLOATS

Revision K

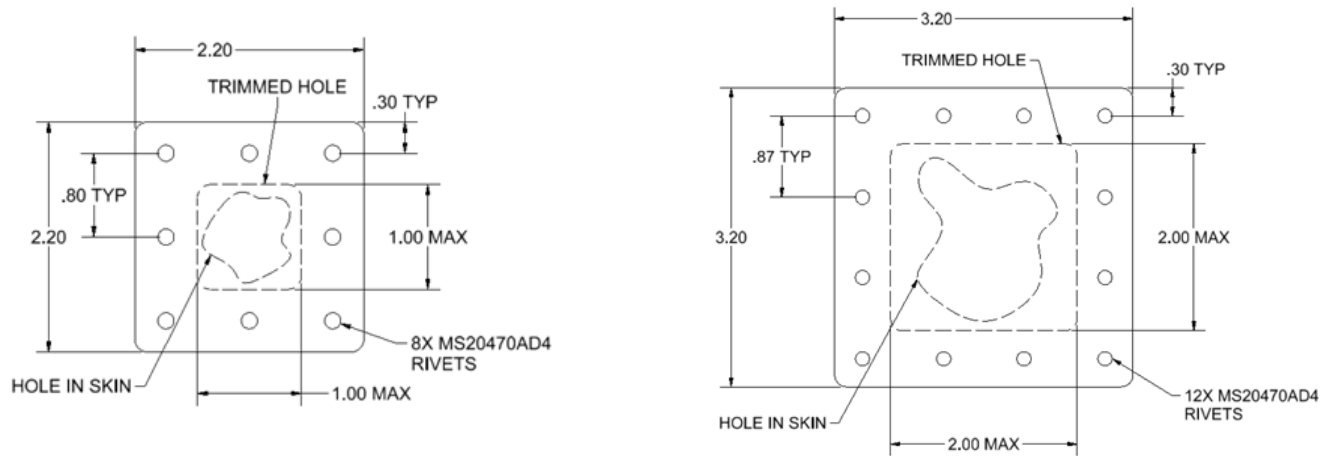
FIGURE 4.1-1A: SHEET METAL REPAIR

1. Trim hole as shown by dotted line
2. Patch to be same material with equal or greater thickness than original skin (See Table 4-1)
3. Prime all bare surfaces
4. Seal between patch and skin
5. Rivet in place

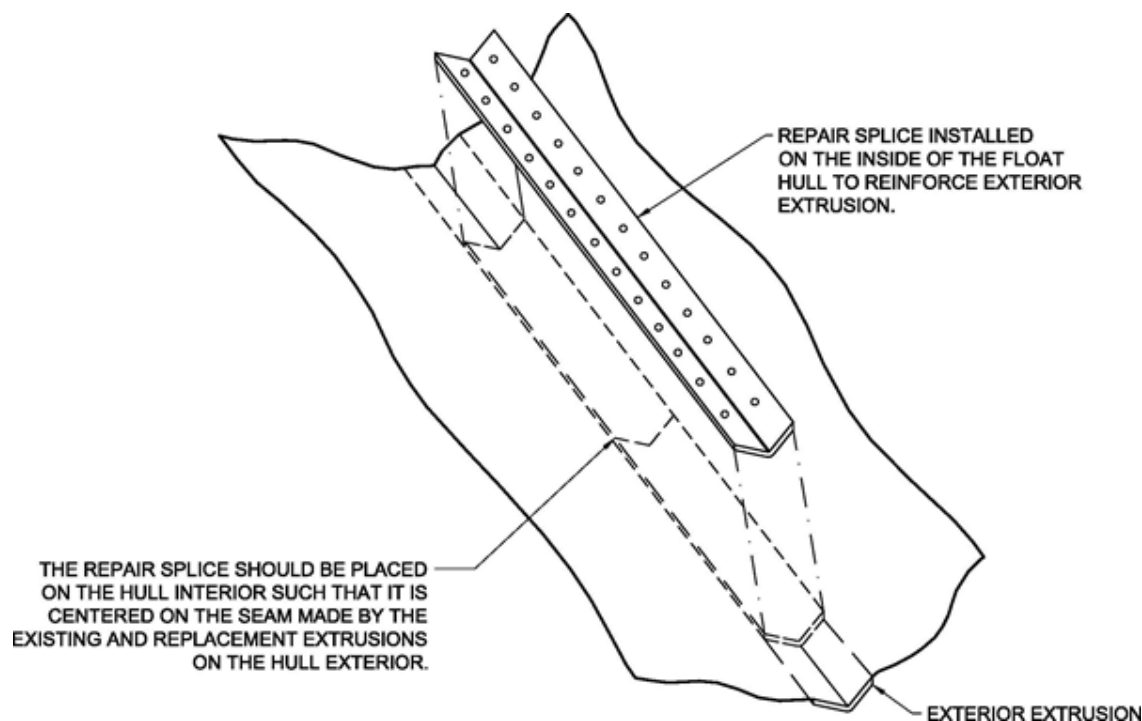
FIGURE 5.1-1: SIMPLE EXTRUSION SPLICE REPAIR

8. Use existing piece to back drill holes for attachment making sure the distance from the end of the splice to the center of the first hole is greater than or equal to 2 times the diameter of the rivet used.

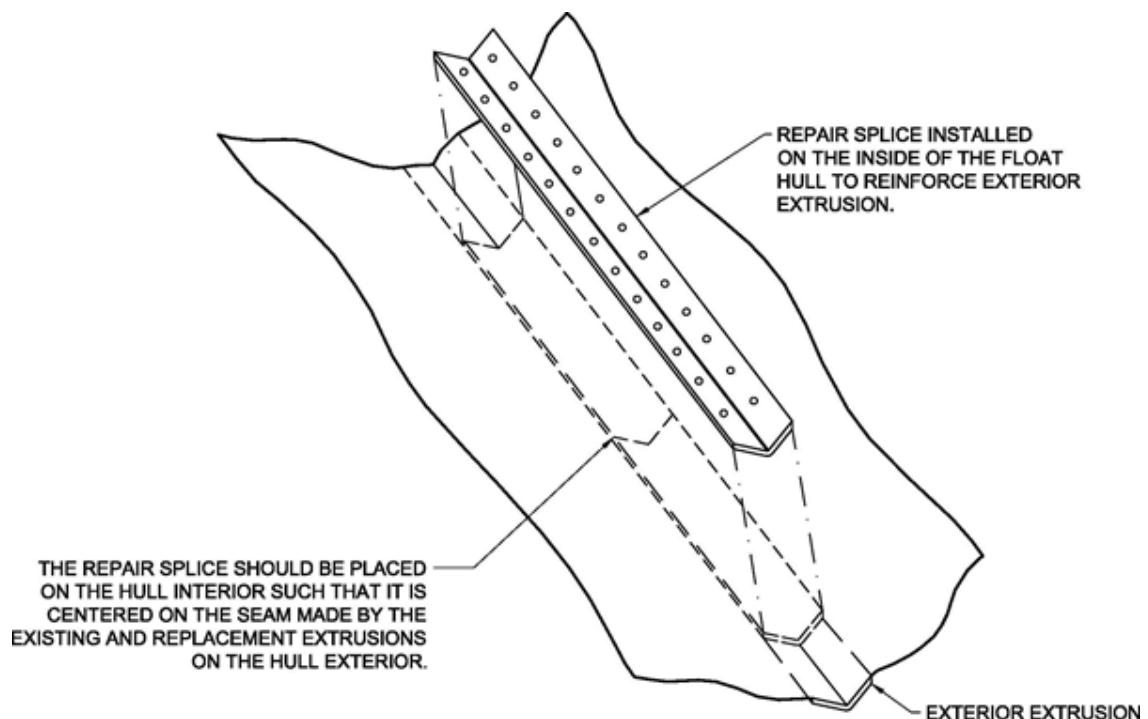
FIGURE 5.2-1: SIMPLE EXTRUSION SPLICE REPAIR

8. Use existing piece to back drill holes for attachment making sure the distance from the end of the splice to the center of the first hole is greater than or equal to 2 times the diameter of the rivet used.

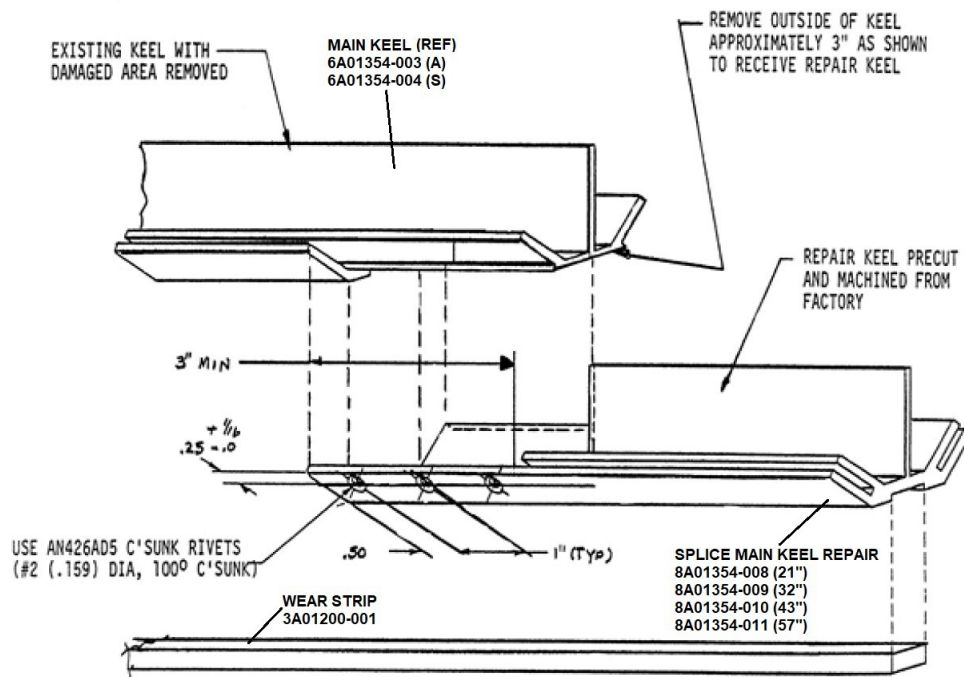
FIGURE 5.5-3: COMPLEX EXTRUSION SPLICE REPAIR

- f. Secure strip to keel with MS24693-C50 screws, NAS1149FN832P washers, and MS21044N08 nuts.

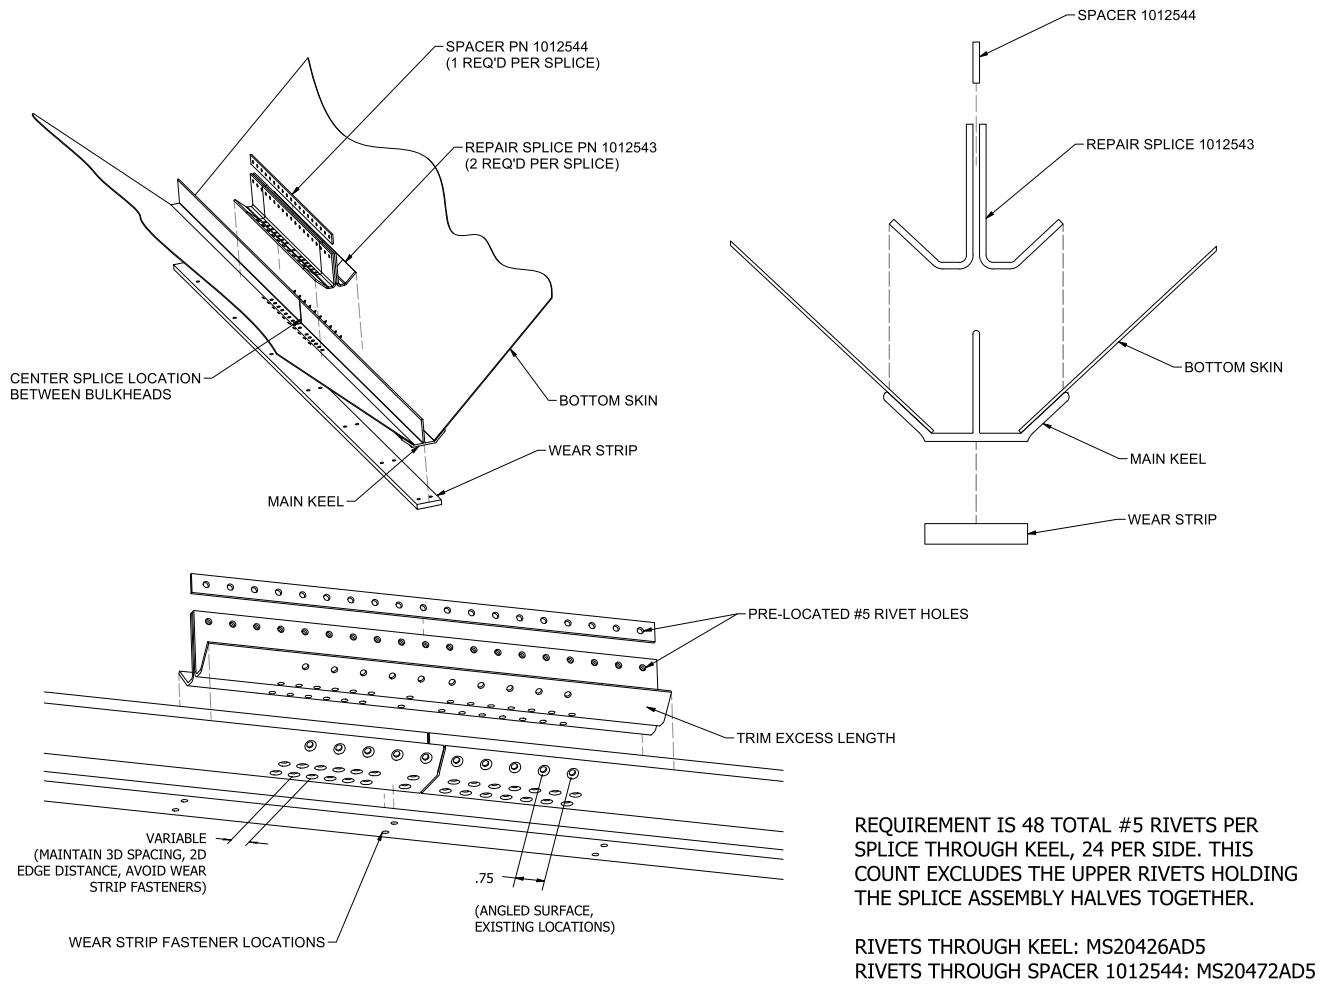
FIGURE 5.5-5: SPLICE REPAIR FOR RIVETED MAIN KEEL

8. After dry fitting, remove and deburr all parts, countersink wear strip and Main Keel holes, and "wet rivet" using polysulfide sealant between all parts.

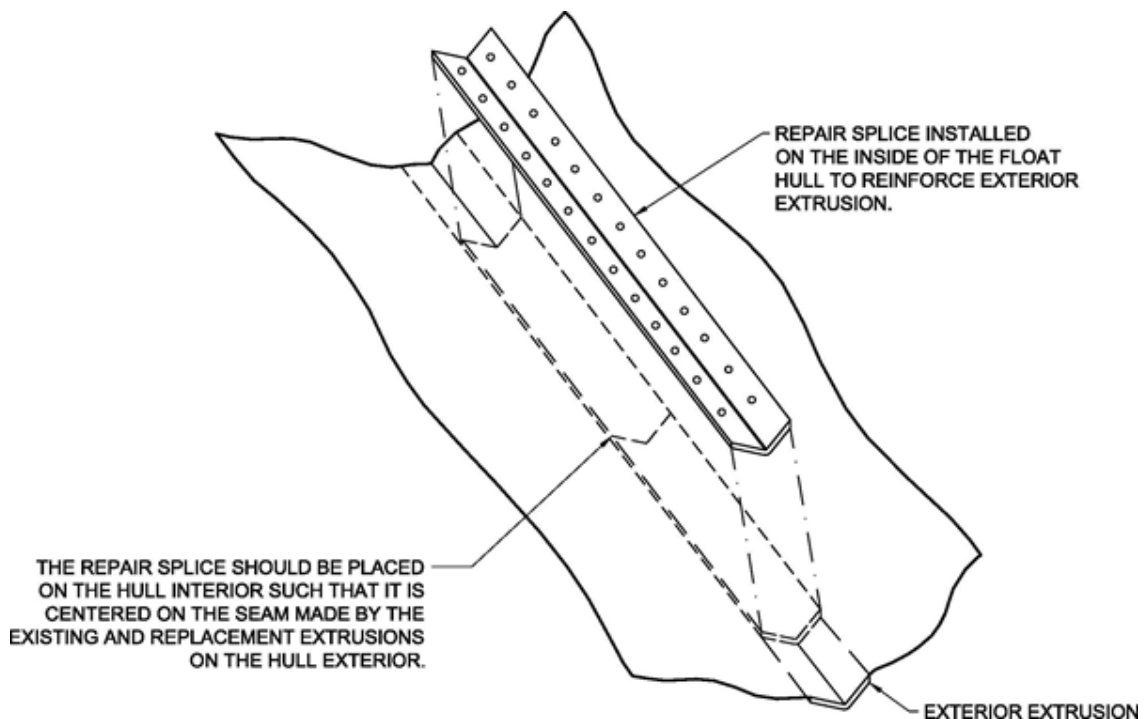
FIGURE 5.6-1: SIMPLE EXTRUSION SPLICE REPAIR

8. Use existing piece to back drill holes for attachment making sure the distance from the end of the splice to the center of the first hole is greater than or equal to 2 times the diameter of the rivet used.

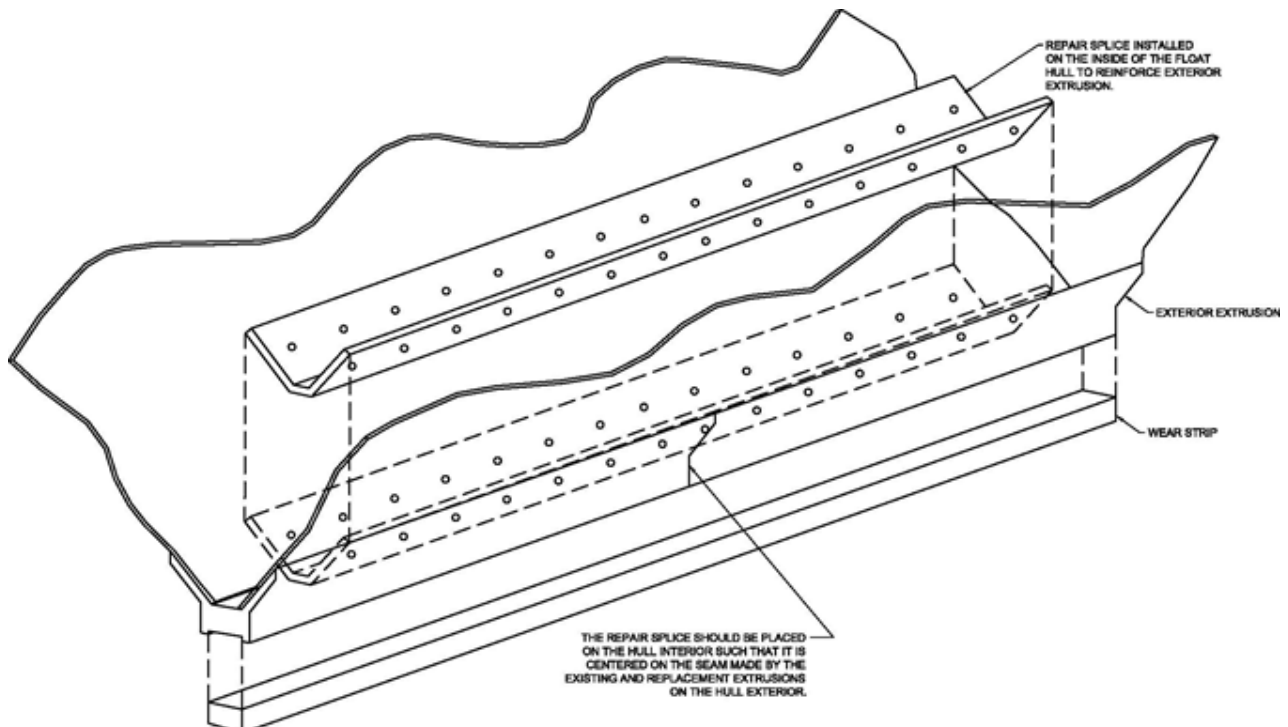
FIGURE 5.6-5: MAIN KEEL SIMPLE EXTRUSION SPLICE REPAIR

- f. Secure strip to keel with MS24693-C50 screws, NAS1149FN832P washers, and MS21044N08 nuts.

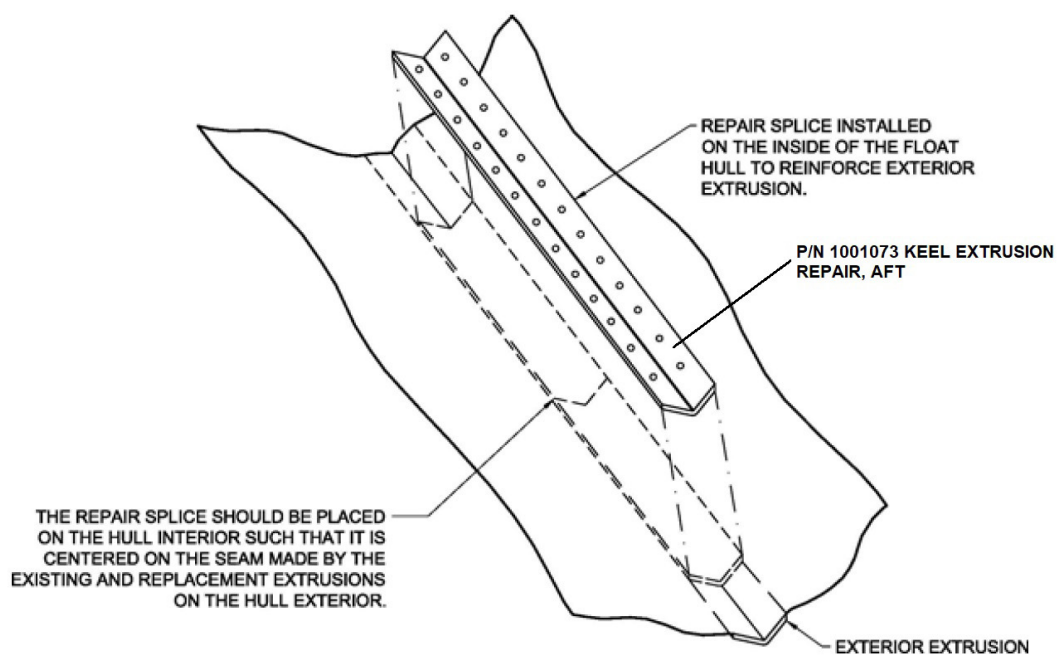
FIGURE 5.7-1: SIMPLE EXTRUSION SPLICE REPAIR

5. File to remove rough edges.
6. See Section 3.0 of this manual for appropriate fastener options.
7. Add internal splices (1001073), making sure the repair seam is located in the middle of the splice, and that the splice is centered between the bulkheads. Use existing piece to back drill holes for attachment making sure the distance from the end of the splice to the center of the first hole is greater than or equal to 2 times the diameter of the rivet used.

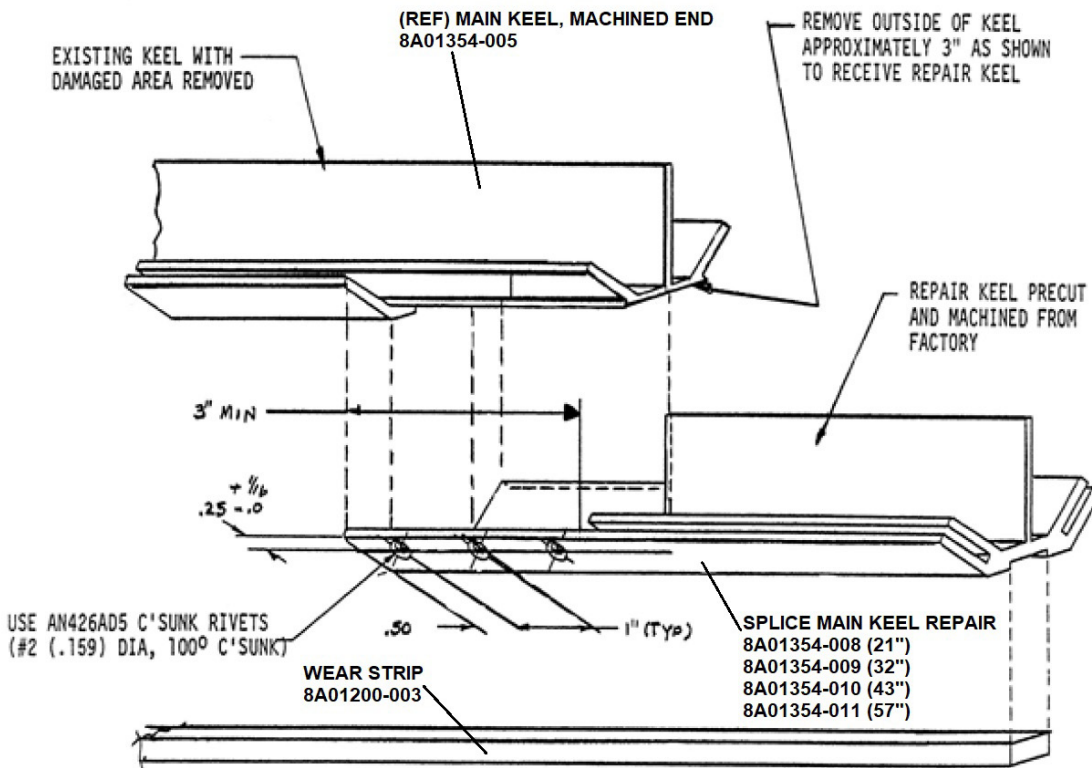
FIGURE 5.7-3: COMPLEX EXTRUSION SPLICE REPAIR

- f. Secure strip to keel with MS24693-C50 screws.

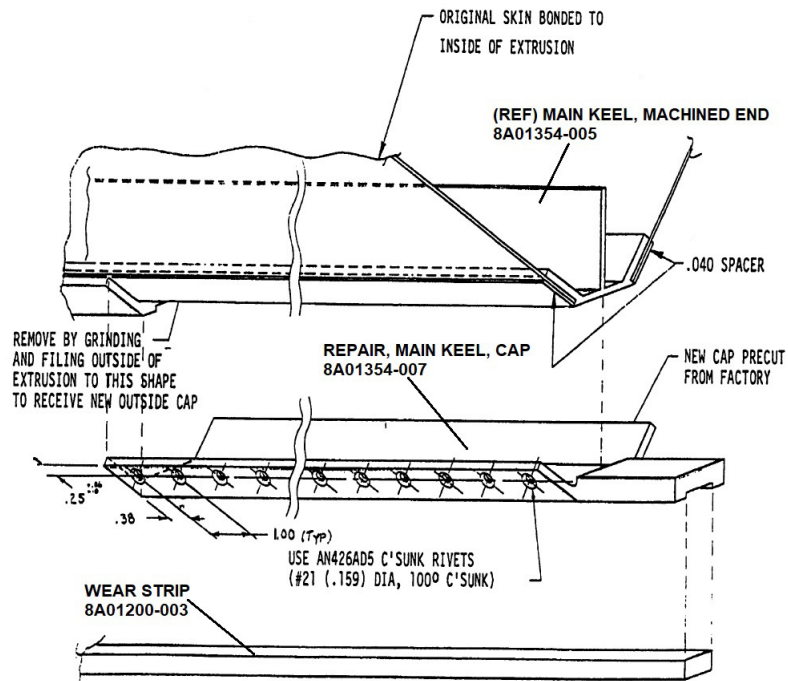
TABLE 5.7-4: TYPICAL CAP SPLICE TO KEEL

1. Lay out new repair cap on damaged extrusion.
2. Remove outside of damaged extrusion by filing or grinding to inside shape of repair cap.
3. Match drill or lay out and drill hole pattern as shown.
4. Rivet outside cap and spacer to existing inside extrusion.
5. Apply keel wear strip with any good 2-part epoxy.

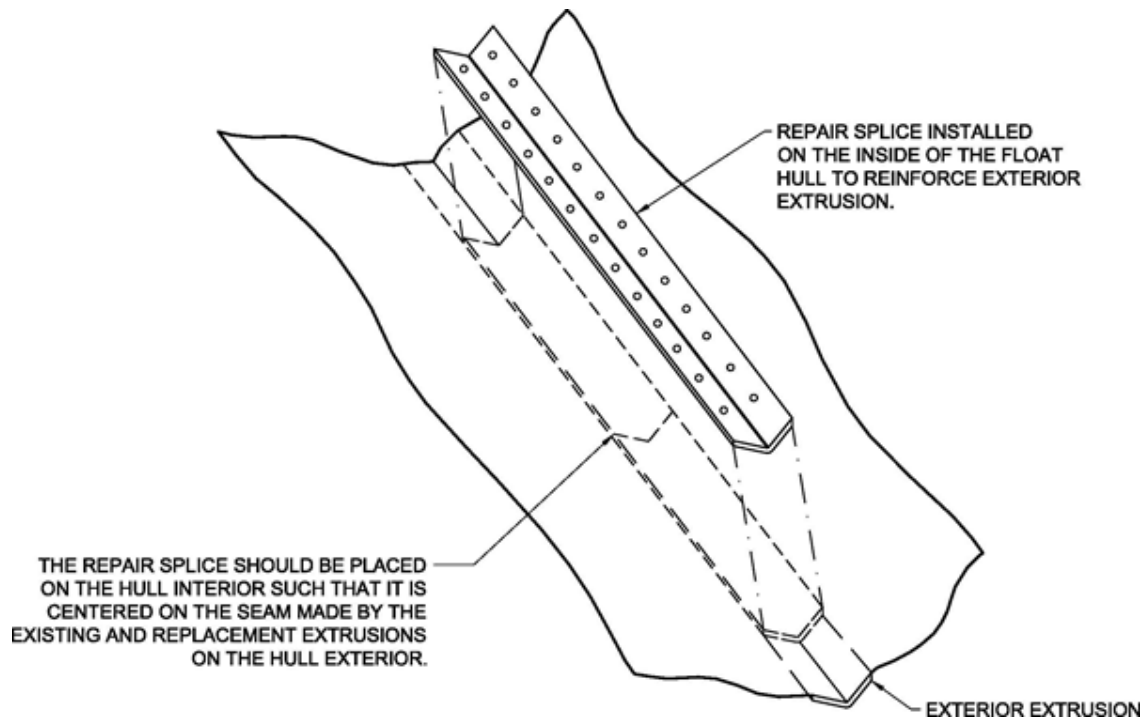
FIGURE 5.8-1: SIMPLE EXTRUSION SPLICE REPAIR

7. Add internal splices, making sure the repair seam is located in the middle of the splice, and that the splice is centered between the bulkheads.
8. Use existing piece to back drill holes for attachment making sure the distance from the end of the splice to the center of the first hole is greater than or equal to 2 times the diameter of the rivet used.

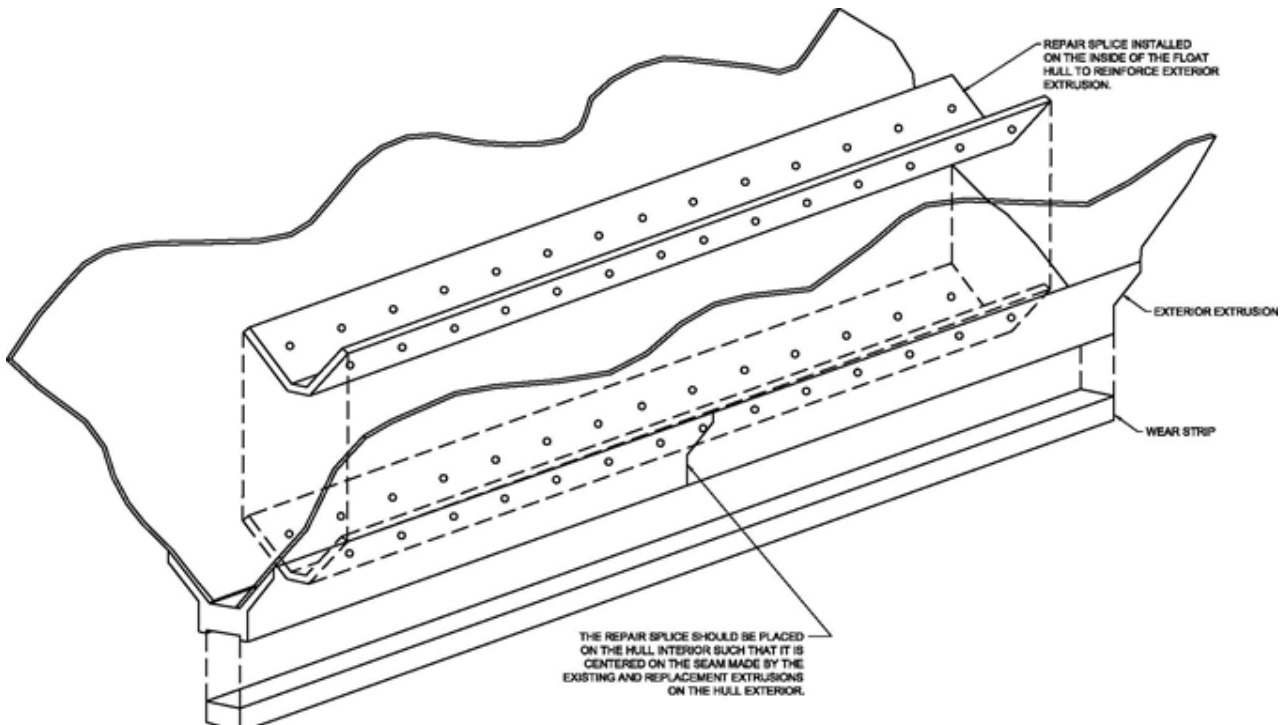
FIGURE 5.8-5: MAIN KEEL SIMPLE EXTRUSION SPLICE REPAIR

- f. Secure strip to keel with MS24693-C50 screws, NAS1149FN832P washers, and MS21044N08 nuts.

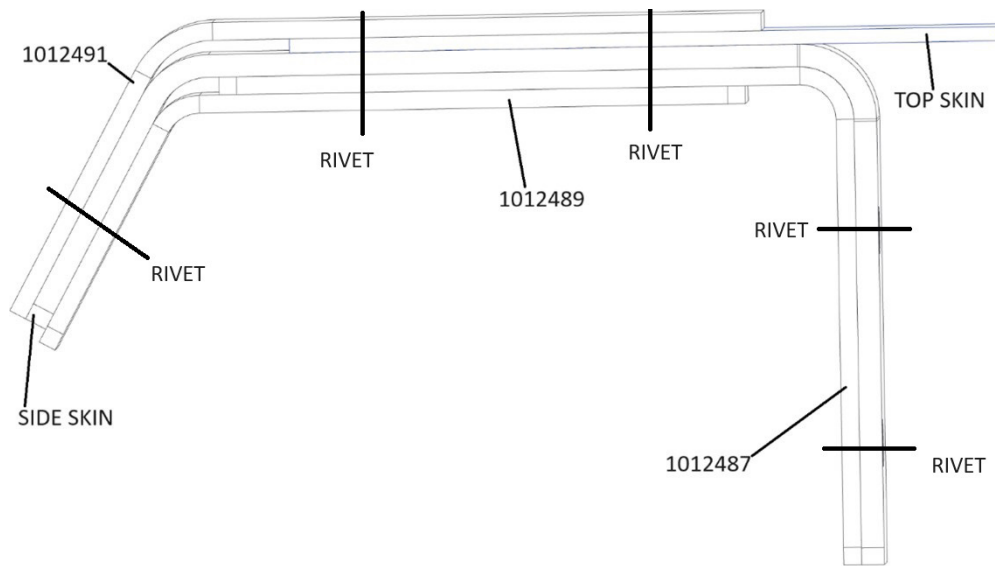
FIGURE 5.8-7: AFT GUNWALL REPAIR SECTION VIEW

5. Match drill the inner gunwall doublers and the outer doubler using all existing holes.
6. You will need to add a row of rivets MS20426AD5- to the top side of the outer doubler 1 inch apart interspersing them from the rivets on the side skin per 43.13-1B.
7. All parts should be assembled with PR-1422 or equivalent.
8. During assembly LS5931A72 filler washers should be used in places where the rivets were drilled out, connecting the side skin to the gunwall.

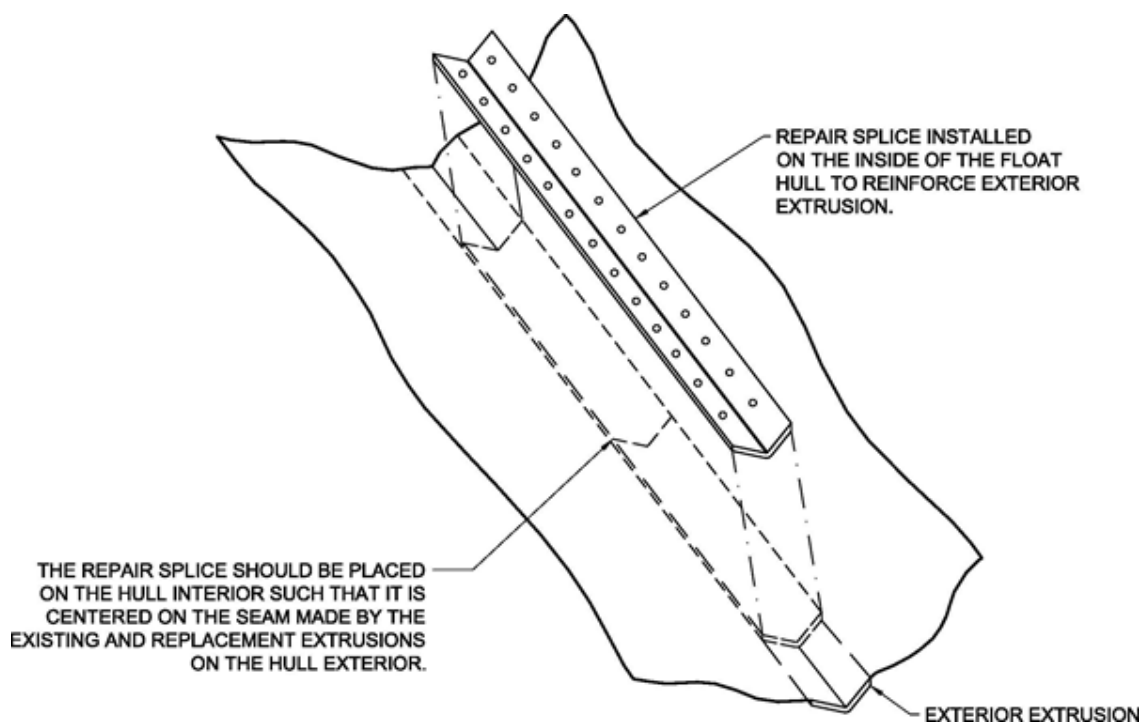
FIGURE 5.9-1: SIMPLE EXTRUSION SPLICE REPAIR

8. Use existing piece to back drill holes for attachment making sure the distance from the end of the splice to the center of the first hole is greater than or equal to 2 times the diameter of the rivet used.

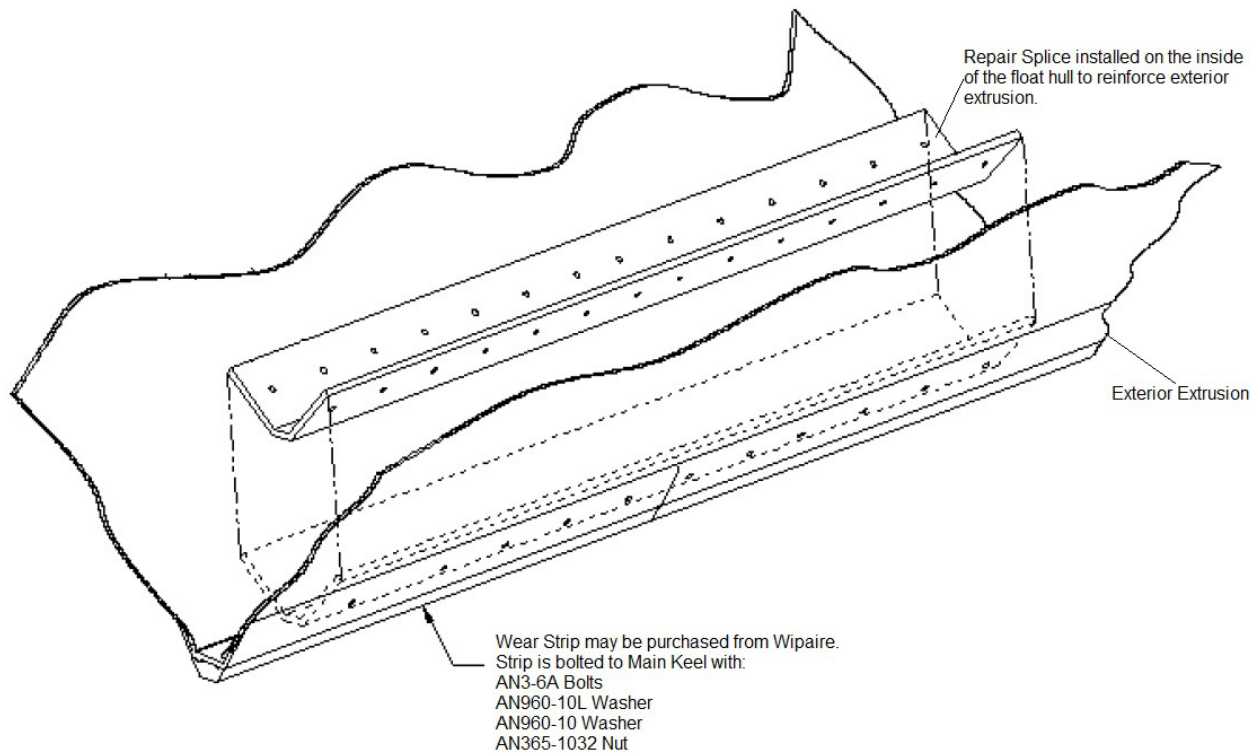
FIGURE 5.9-6: MAIN KEEL SIMPLE EXTRUSION SPLICE REPAIR

- f. Secure strip to keel with MS24693-C50 screws, NAS1149FN832P washers, and MS21044N08 nuts.

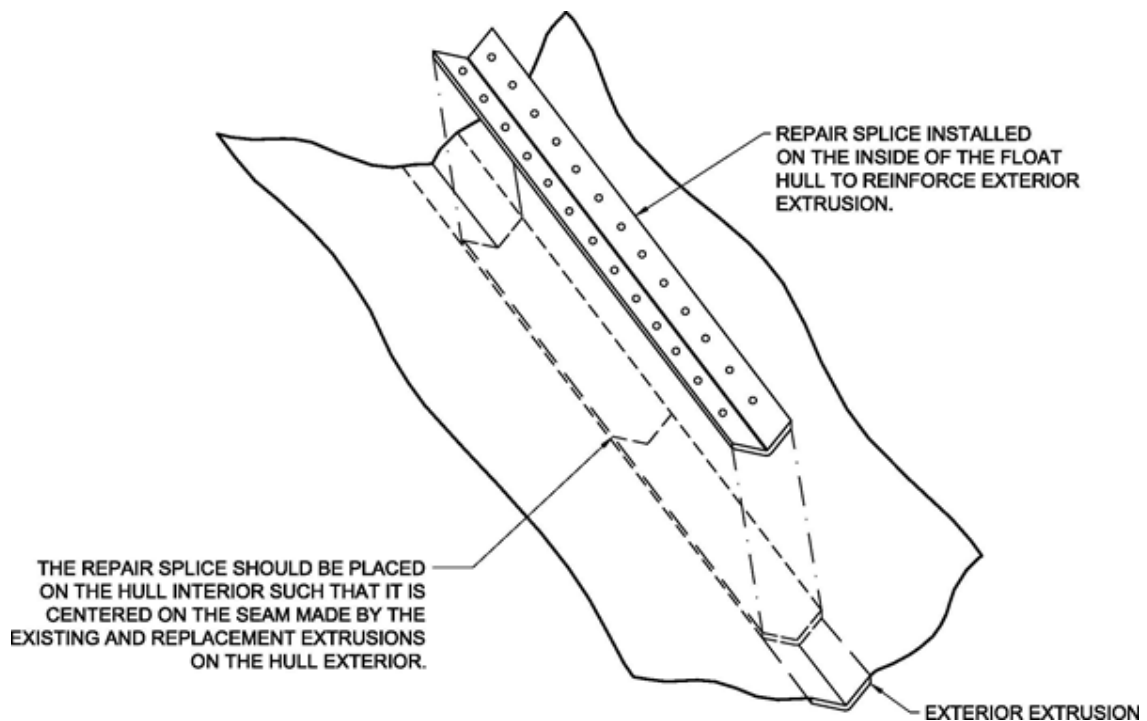
FIGURE 5.10-1: SIMPLE EXTRUSION SPLICE REPAIR

8. Use existing piece to back drill holes for attachment making sure the distance from the end of the splice to the center of the first hole is greater than or equal to 2 times the diameter of the rivet used.

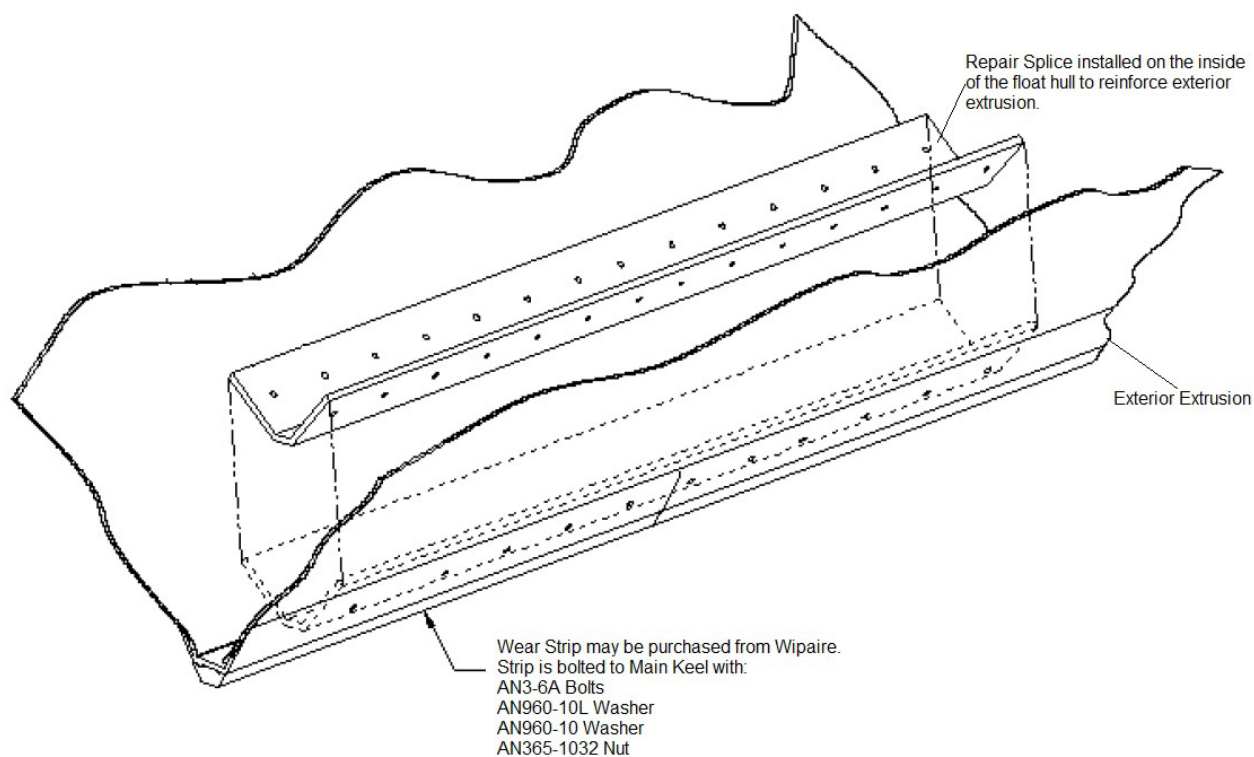
FIGURE 5.10-6: MAIN KEEL SIMPLE EXTRUSION SPLICE REPAIR

- f. Secure strip to keel with MS24693-C50 screws, NAS1149F0832P washers, and MS 20365-832 nuts.

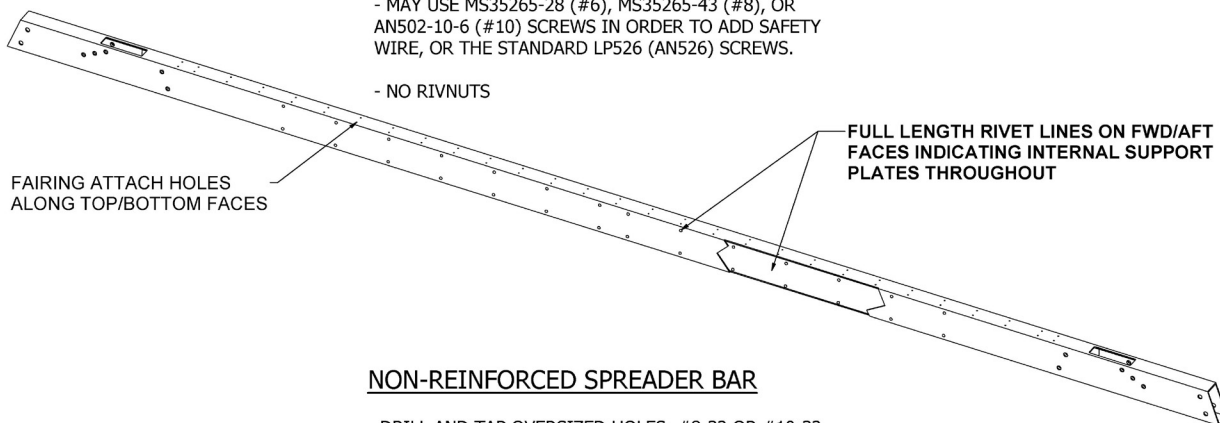
NON-REINFORCED SPREADER BAR

- DRILL AND TAP OVERSIZED HOLES: #8-32 OR #10-32
- MAY USE MS35265-28 (#6), MS35265-43 (#8), OR AN502-10-6 (#10) SCREWS IN ORDER TO ADD SAFETY WIRE, OR THE STANDARD LP526 (AN526) SCREWS.
- NO RIVNUTS

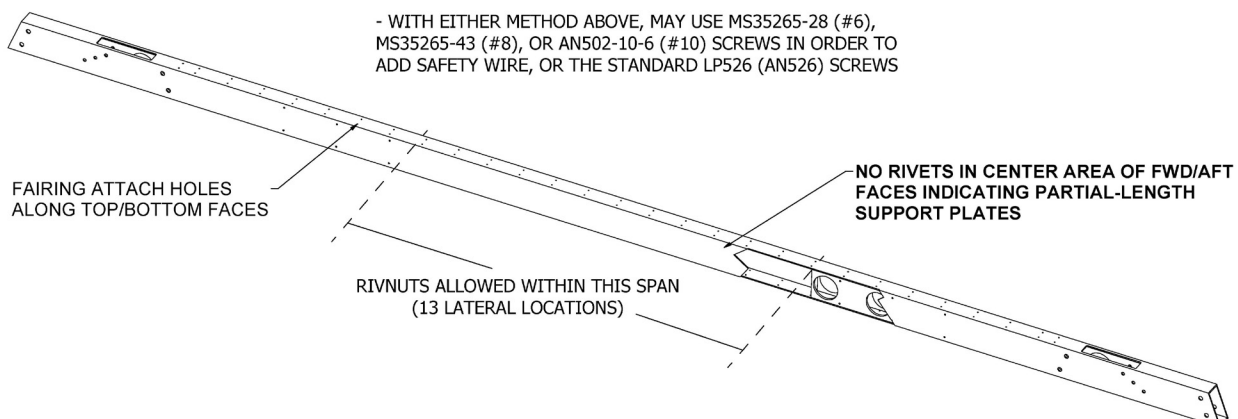
FIGURE 7.1: 8000 SPREADER BAR THREADED FAIRING HOLE REPAIR

- DRILL AND TAP OVERSIZED HOLES: #8-32 OR #10-32
- ALTERNATELY, NAS1329A06K160 (#6) OR NAS1329A08K160 (#8) RIVNUTS MAY BE ADDED AT THE (13) CENTER-MOST LOCATIONS INDICATED BELOW
- WITH EITHER METHOD ABOVE, MAY USE MS35265-28 (#6), MS35265-43 (#8), OR AN502-10-6 (#10) SCREWS IN ORDER TO ADD SAFETY WIRE, OR THE STANDARD LP526 (AN526) SCREWS

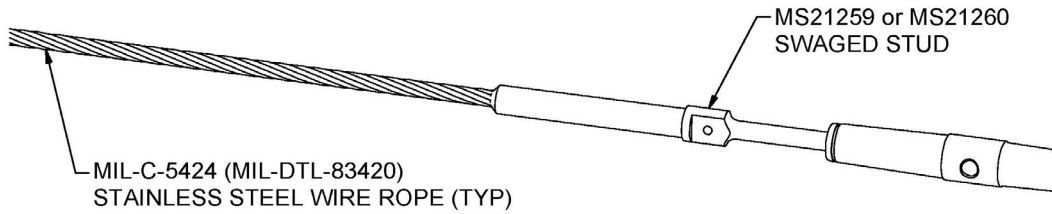
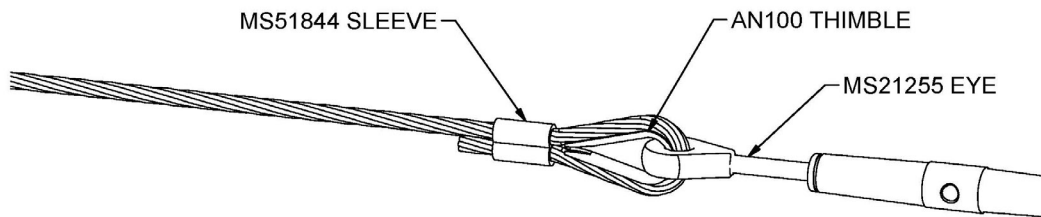
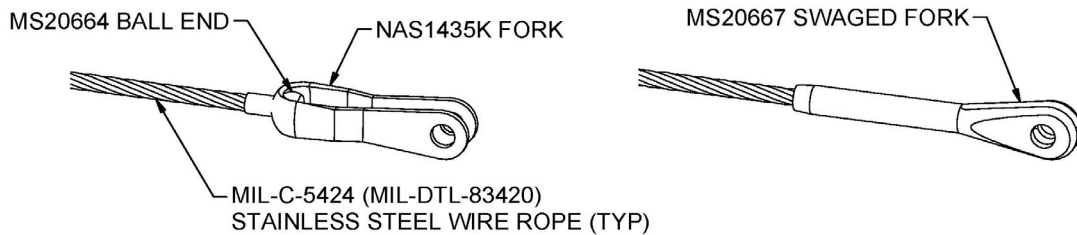
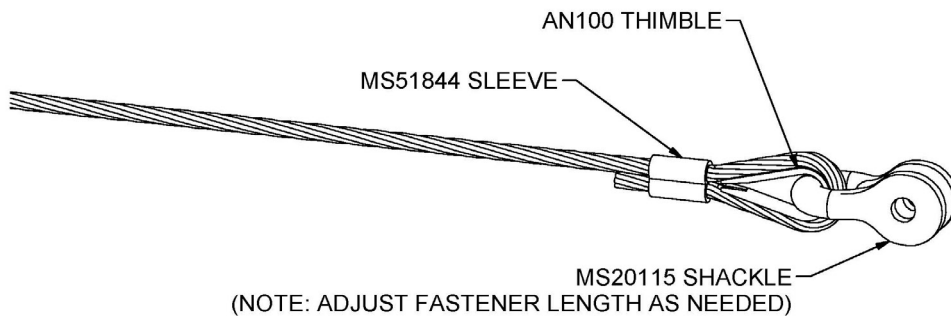
FIGURE 7.2: STEERING AND RETRACT CABLE - ALTERNATE REPAIR COMPONENTS

ORIGINAL: SWAGED STUD TO TURNBUCKLE BARREL

REPAIR OPTION: EYE SPLICE TO TURNBUCKLE BARREL

ORIGINAL: BALL END AND FORK -OR- SWAGED FORK

REPAIR OPTION: EYE SPLICE TO SHACKLE
