WIPLINE FLOATS • SKIS • MODIFICATIONS • AIRCRAFT SALES
AVIONICS • INTERIOR • MAINTENANCE • PAINT REFINISHING

SERVICE LETTER 211

3000/3450 SERIES BONDED STIFFENER CORROSION

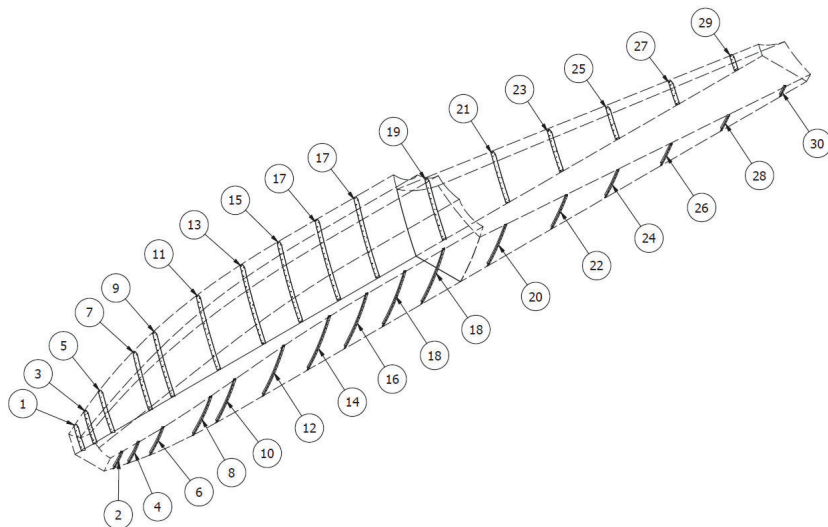
Stiffeners and skins are showing signs of corrosion in the locations where the stiffeners are glued to the float side skins.

Inspect stiffeners and skins and, if required, install new stiffeners per the Work Instruction section of this service letter.
