SERVICE LETTER 211

3000/3450 SERIES BONDED STIFFENER CORROSION

Aircraft Makes/Model(s):	Float Model(s):	Compliance: Mandatory	By: MAS
Textron Aviation 180, 182,185, 206 Maule M-6-235, M-7-235, -B, -C, M-7-260, -C, M-7-420A, -AC, MT-7- 235, MT-7-260, MX-7-235	3000 and 3450 Series	Part Number: 1011440	Approved: DRH
		Date: 4/17/2023	Revision: B

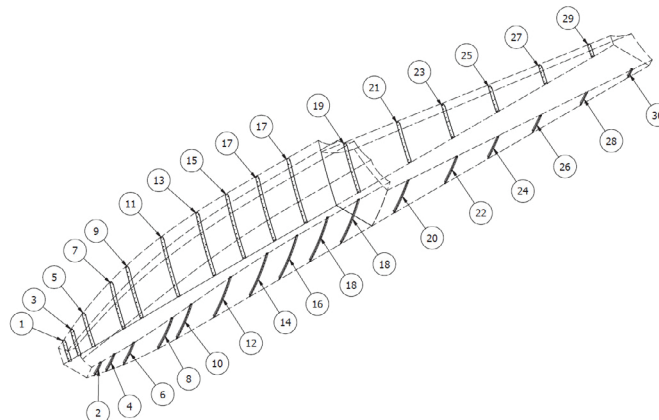
Stiffeners and skins are showing signs of corrosion in the locations where the stiffeners are glued to the float side skins.

Inspect stiffeners and skins and, if required, install new stiffeners per the Work Instruction section of this service letter.
