SERVICE LETTER 223

Scout 8GCBC Hydraulic Pump Replacement on 2100A Floats

This service letter applies to American Champion model Scout 8GCBC with Wipline 2100 Amphibian Floats installed per STC SA00763CH.

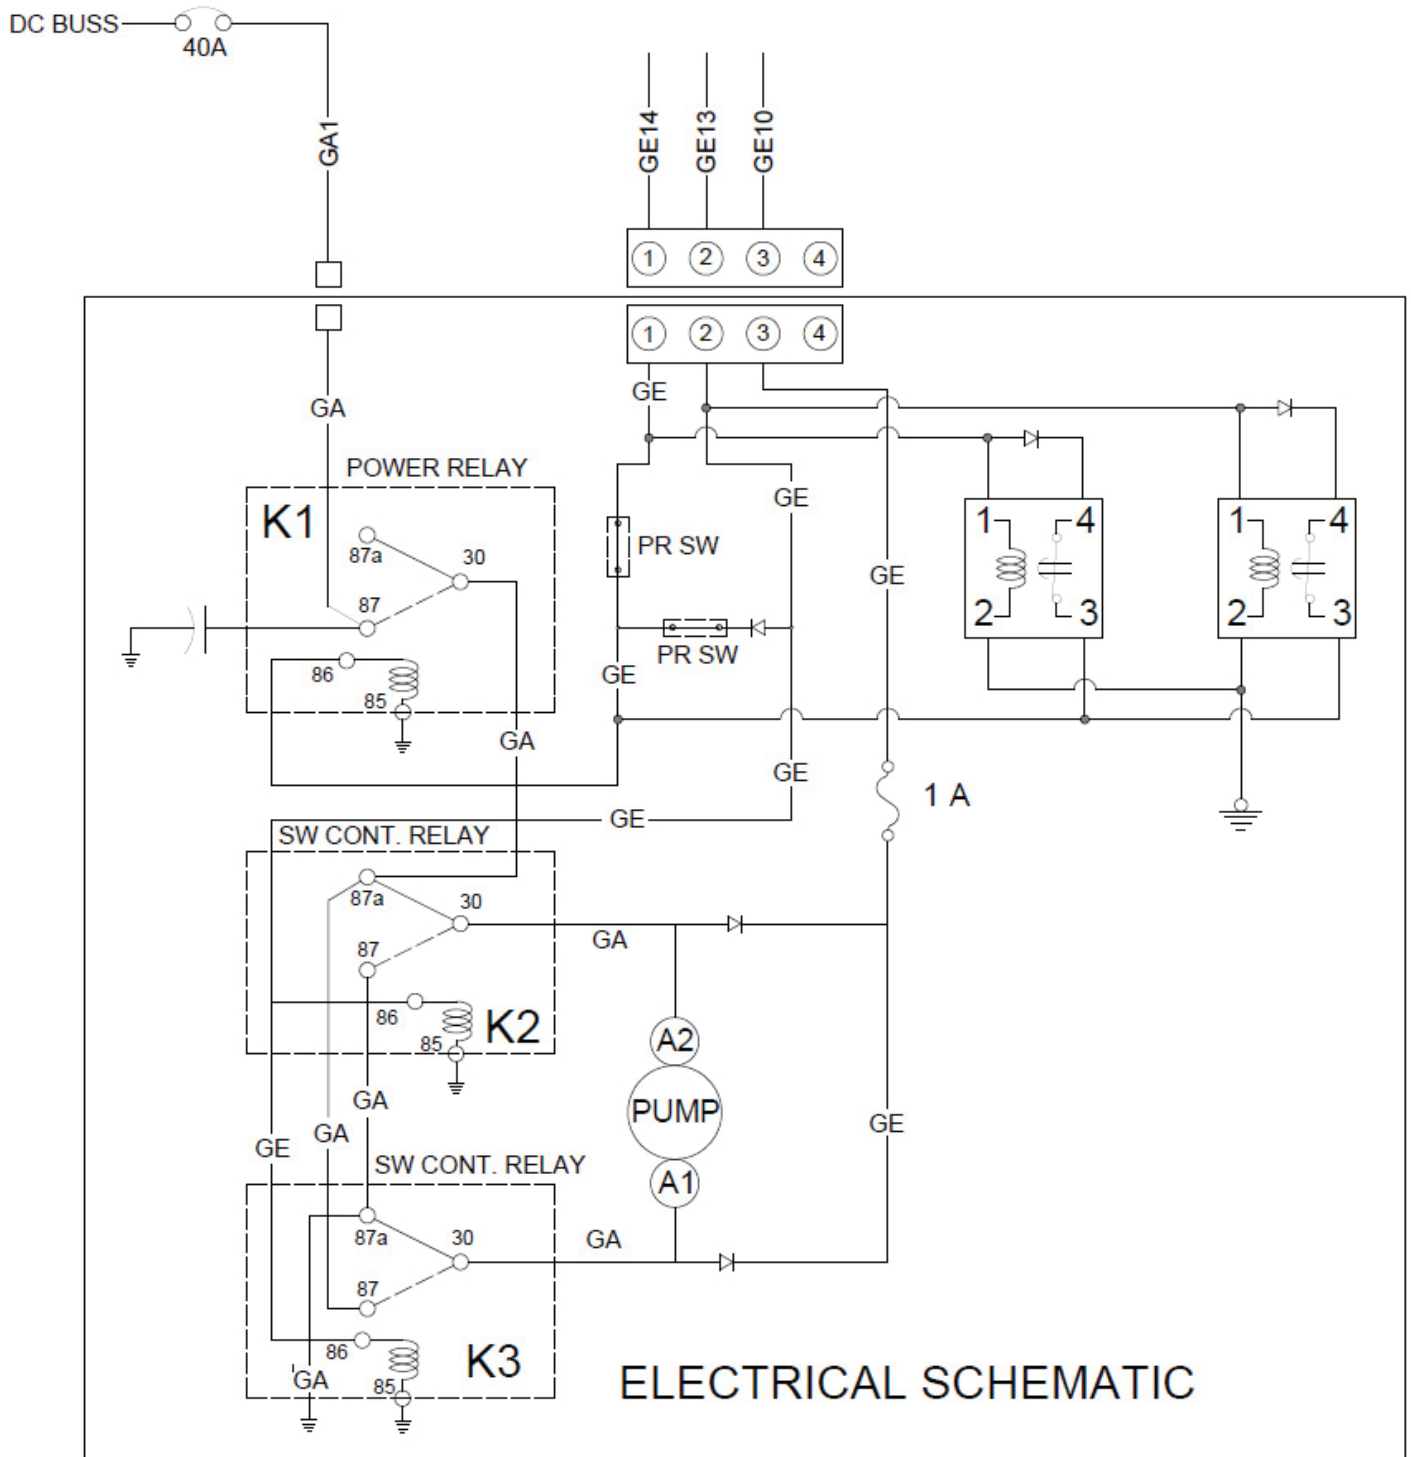
NEW
HYDRAULIC PUMP 1011760

The Hydraulic Pump Assembly p/n 21A09000-216 has been discontinued. This service letter provides the option to replace it with pump p/n 1011760.

1. Disconnect aircraft battery.
2. Disconnect single pin Molex connector for GA1 wire.
3. Disconnect 4 pin CPC connector from hydraulic power pack assembly 21A09000-216.

15. Reconnect aircraft battery, service pump reservoir with MIL-H-5606 hydraulic fluid, and perform a retraction/extension test to make sure system is functioning correctly. Watch the system for leaks and add MIL-H-5606 hydraulic fluid as needed.
